# **SCHOOL-RELATED CRASH INFRASTRUCTURE REVIEW**

## **MONTGOMERY COUNTY DEPARTMENT OF TRANSPORTATION (MCDOT)**

- Location: Intersection of Jones Lane and Falconbridge Drive
- Crash Date: 4/11/25
- Crash Time: 3:30 pm (crash report identifies 13:30 during school dismissal, time assumed as incorrect. since MCPS calendar shows regular schedule on 4/11/25)
- School Name: Jones Lane Elementary School
- School Walkshed Boundary (☒ Inside ☐ Borderline ☐ Just Outside)
- Local Case No: 250016207
- Review Date: 10/10/25

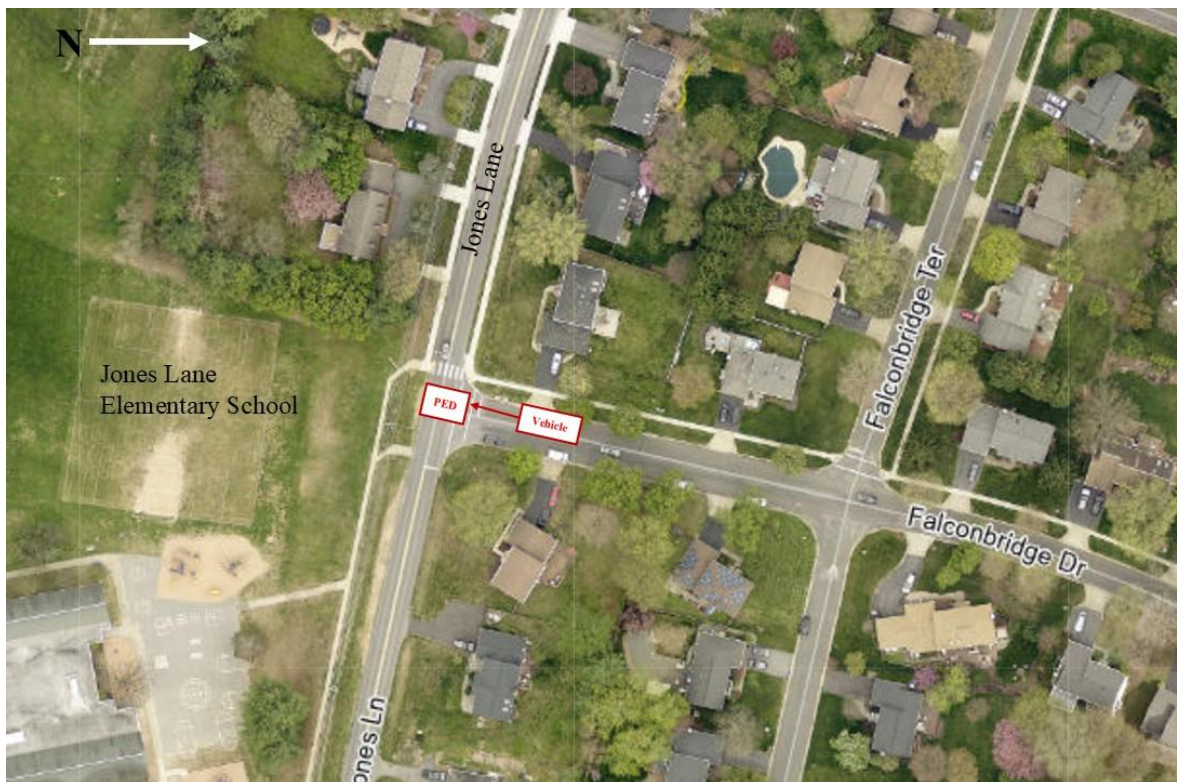
Figure 1: Crash Diagram

On Friday, April 11, 2025, a hit-and-run incident occurred during student dismissal at Jones Lane Elementary School. At approximately 3:30 p.m., a westbound vehicle struck a school crossing guard in the intersection of Jones Lane and Falconbridge Drive. Traffic is controlled by all-way stop signs and marked crosswalks at this location.

**Figure 1** illustrates the crash location and direction of pedestrian and vehicle travel.

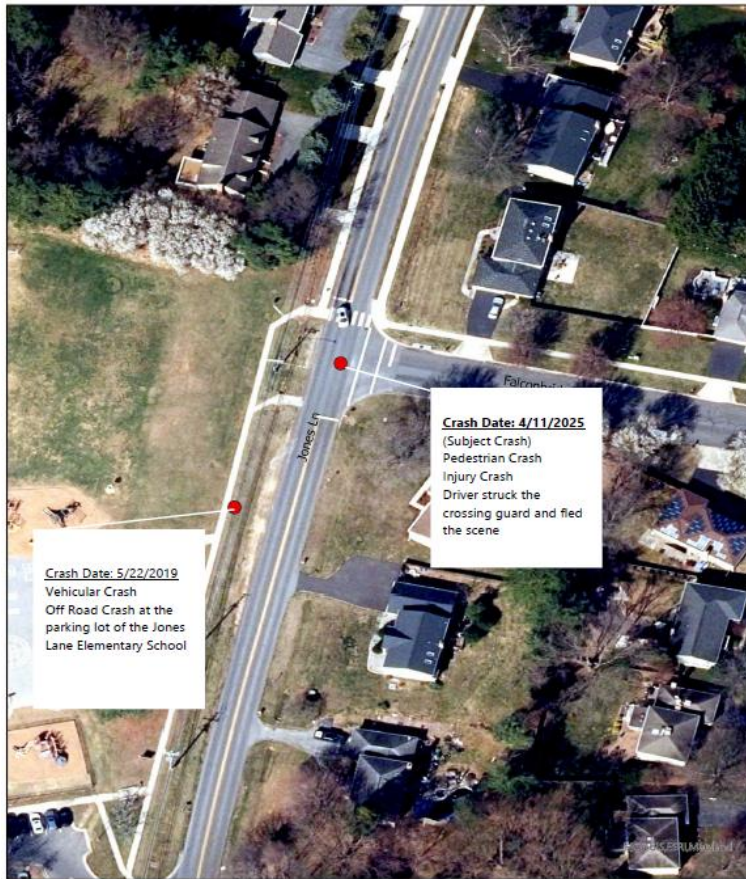
Figure 2: Crash map showing past crashes

- Total Crashes (Last 10 Years):2
  - Pedestrian/Bicycle Involved:1
  - Student-Involved Crashes:0
  - Crashes During School Hours:1
  - Recurrent Patterns (Time/Type): None

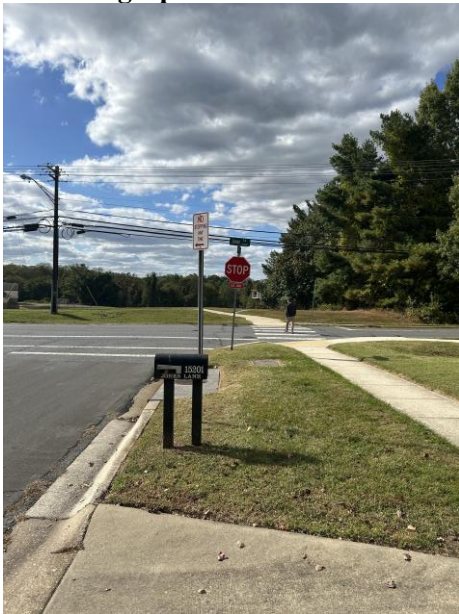
The crosswalks at the intersection of Jones Lane and Falconbridge Drive show signs of wear, including cracking and fading. The crosswalk over Falconbridge Drive is a standard style, consisting of two parallel lines. The crosswalk over Jones Lane is a continental style, characterized by high-visibility vertical striping. The degraded condition of both crosswalks, especially the standard style one, could impact pedestrian safety, as continental markings are generally more conspicuous to drivers.

Figure 3: Photo taken looking west along Falconbridge Drive approaching Jones Lane.

1. Crosswalk and stop bars are faded, reinstalling all crosswalks and stop bars at the subject intersection.
2. Upgrade crosswalk across Falconbridge Drive at Jones Lane from standard style to continental style crosswalk for better visibility.

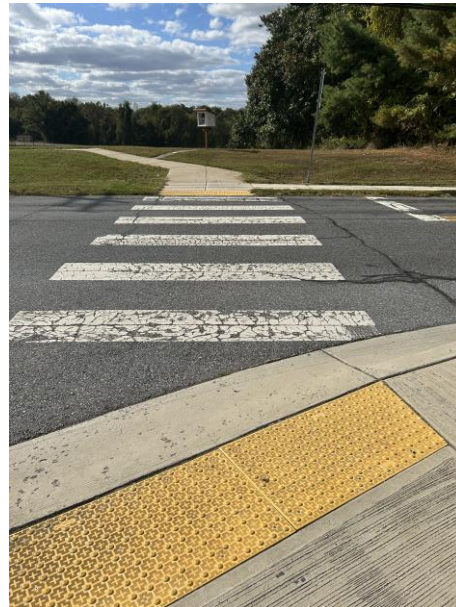
Figure 4: Photo taken looking west at northeast corner of Jones Lane / Falconbridge Drive intersection.

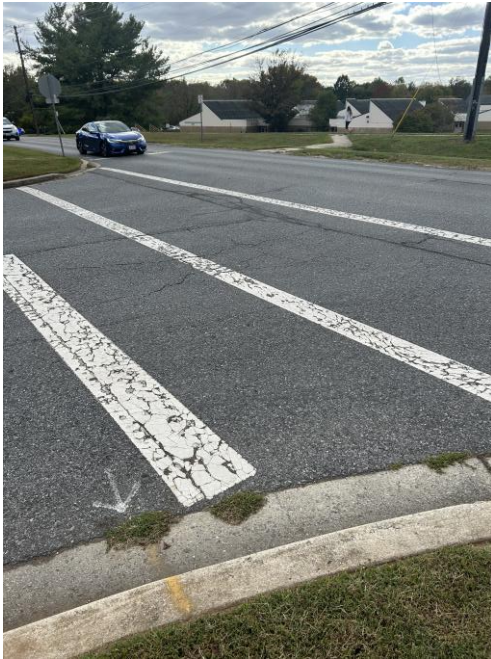
Figure 5: Photo taken looking south at northeast corner of Jones Lane / Falconbridge Drive intersection

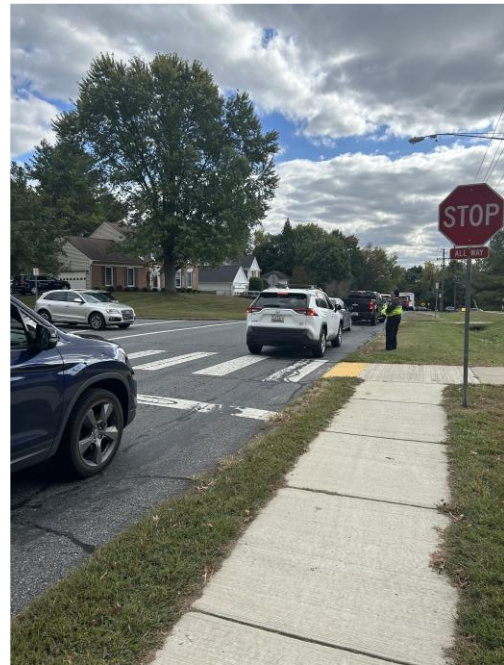
Traffic congestion was observed at the intersection of Jones Lane and Falconbridge Drive during student dismissal. The congestion was caused by southbound traffic on Jones Lane backing up from the school driveway, leading to intersection gridlock that lasted for approximately five minutes.

Figure 6: Photo looking south from northwest corner of Jones Lane / Falconbridge Drive intersection. Southbound vehicles queued from school driveway.
