FATAL CRASH REVIEW

Location: New Hampshire Avenue (Route 650) and Elton Road
Accident Date/Time: Friday, January 15, 2021 at approximately 8:20 PM
Local Case No.: 210001908
Police District: District 3
Review Date: Wednesday, January 27, 2021

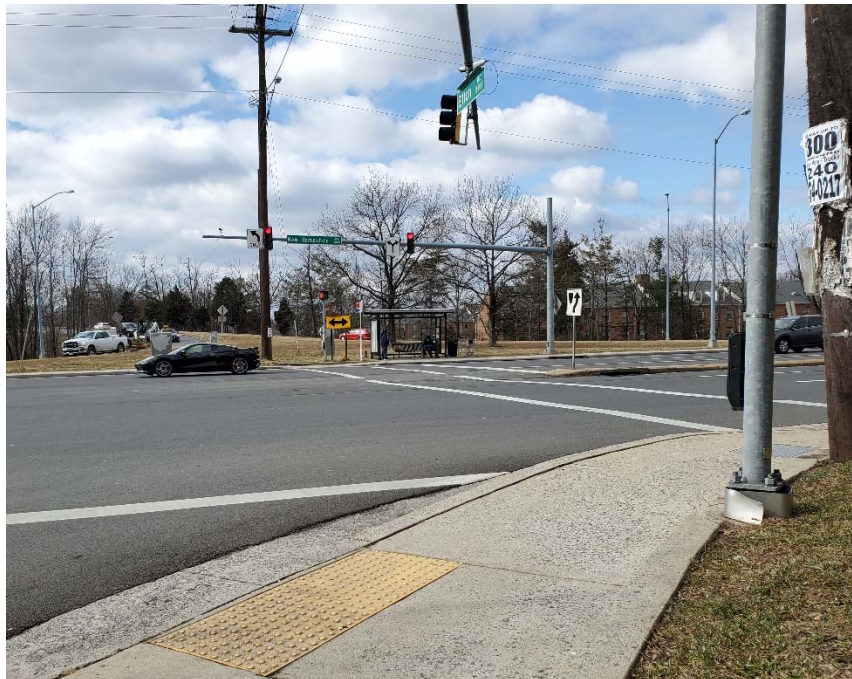
Picture 2: Looking from the northeast quadrant across northern leg of New Hampshire Avenue.

when a crossing is permissible. One noted issue was that the pedestrian crossing plaque for the push button to cross New Hampshire Avenue from the eastern side is backward. Also, during the field review several instances of pedestrians, including older and mobility impaired, were observed crossing New Hampshire Avenue outside the crosswalk during the green phase, taking refuge on the narrow median.

- Due to the potential for older pedestrians and pedestrians with possible disabilities who use the crosswalk on New Hampshire Avenue, assess whether the crossing time should be extended to better permit these pedestrians to cross the seven lanes of New Hampshire Avenue.
- Correct the pedestrian-arrow plaque on the push button to remove possible crossing confusion.
