Fatal Crash Review

Location: Fairland Road near Fairridge Drive

Accident Date: Sunday, December 19, 2021

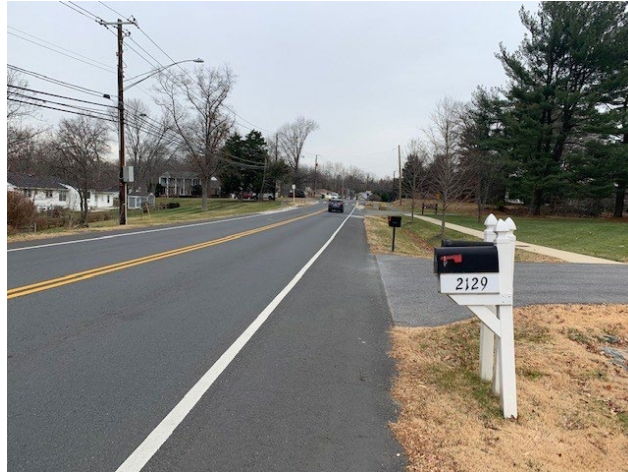
Westbound Fairland Road east of Crash Site

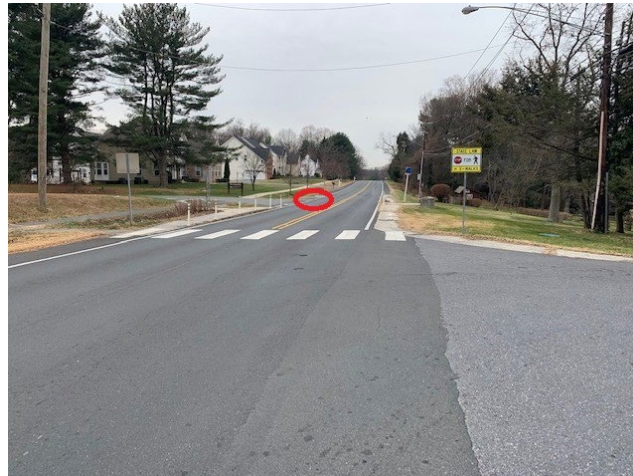
Eastbound Fairland Road near crash site
