## Fatal Crash Review

Location: Grosvenor Lane at King Charles Way

Accident Date: Monday, April 4, 2022

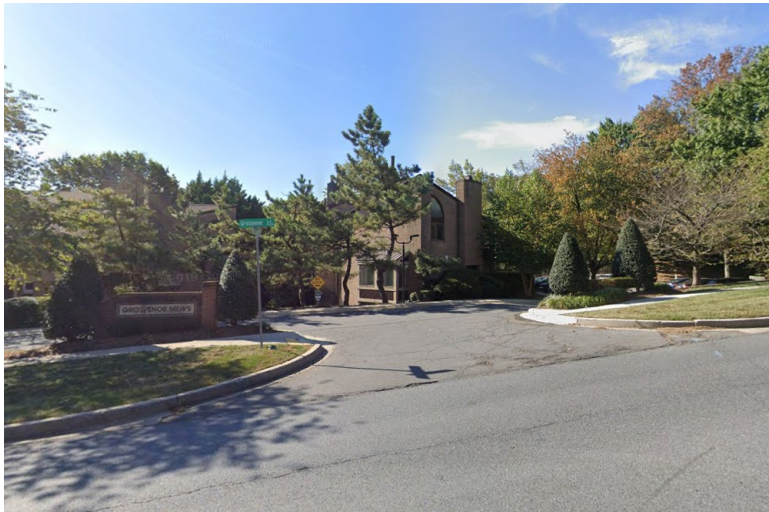
Crash site – Entrance of Grosvenor Mews Apartment

All required traffic control is in place and in good condition. It is recommended that the four small trees be removed to provide better visibility of pedestrians on the sidewalk. Once the trees

are removed a follow up sight distance evaluation should be conducted to determine if the gateway sign should be modified or removed.

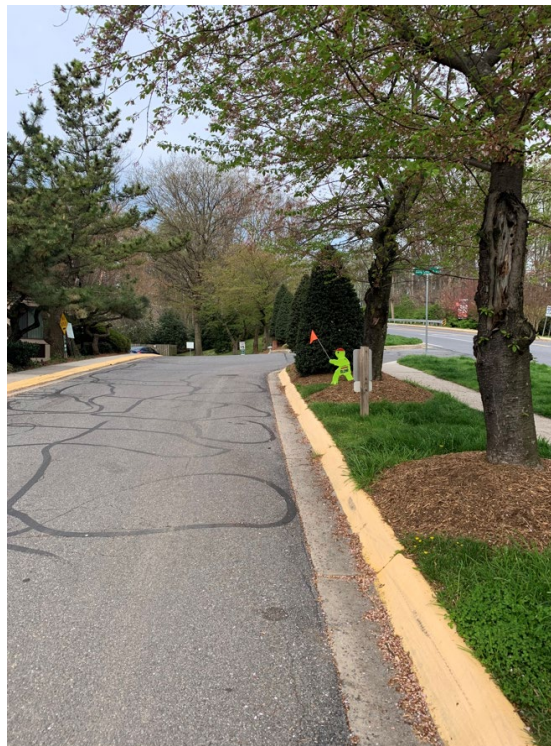
Westbound King Charles Way approaching Grosvenor Lane/Apartment Entrance

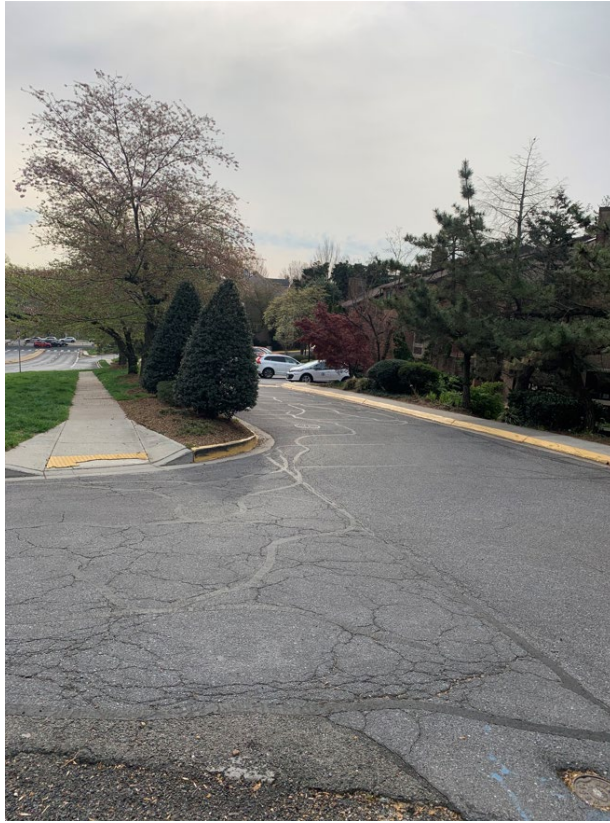
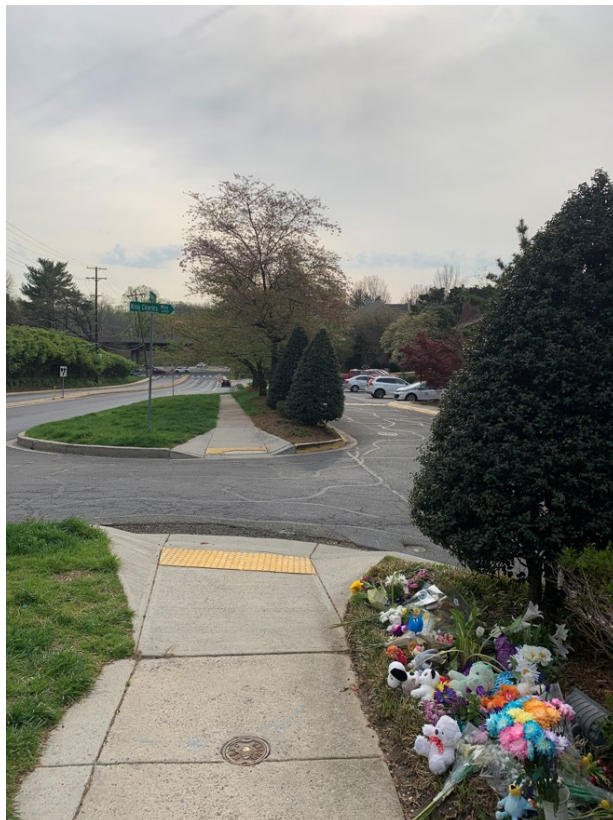
standing at the southwest corner (where pedestrians got hit) looking east at King Charles Way
