Fatal Crash Review

Location: East Randolph Road near Laurie Drive

Crash Date: Friday, October 24, 2022

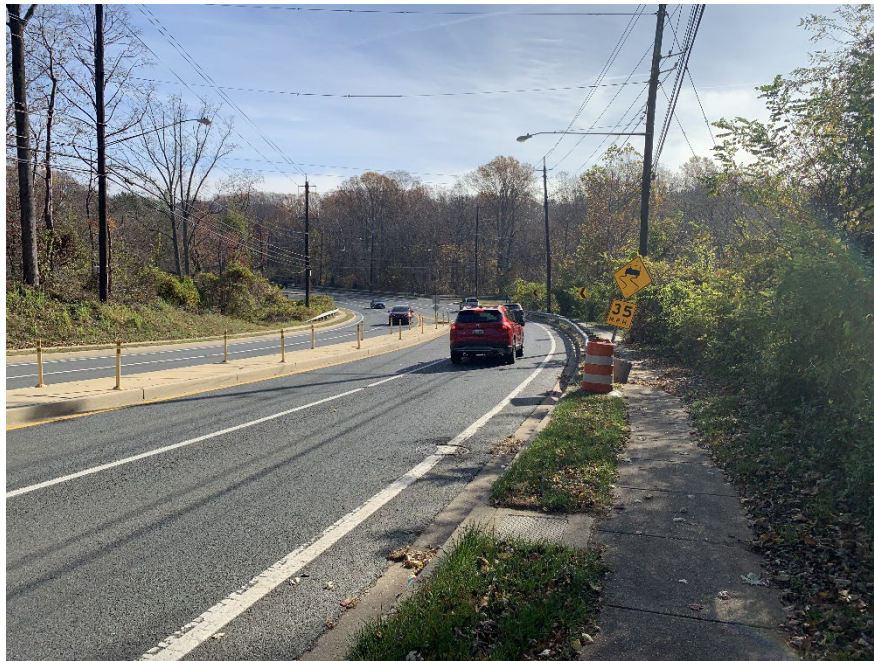
Eastbound East Randolph Road east of Laurie Drive

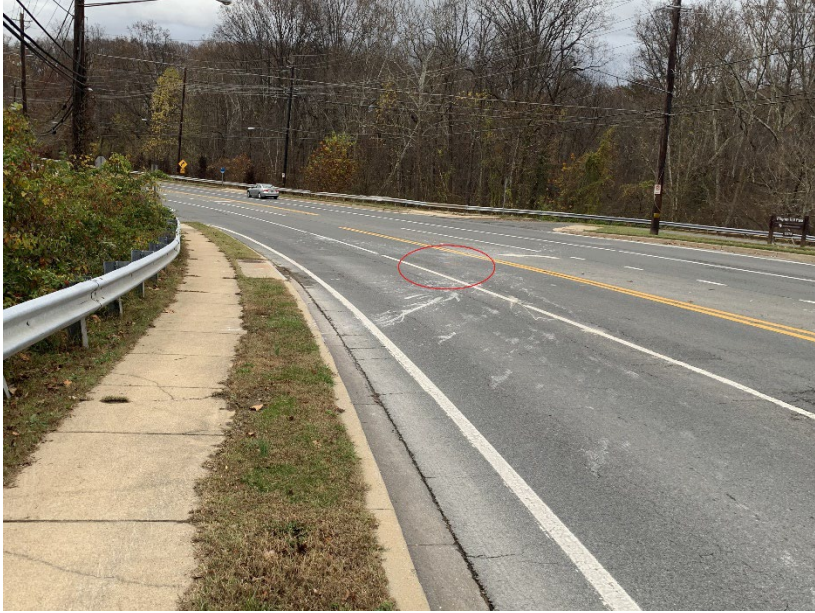
East Randolph Road at the Crash site

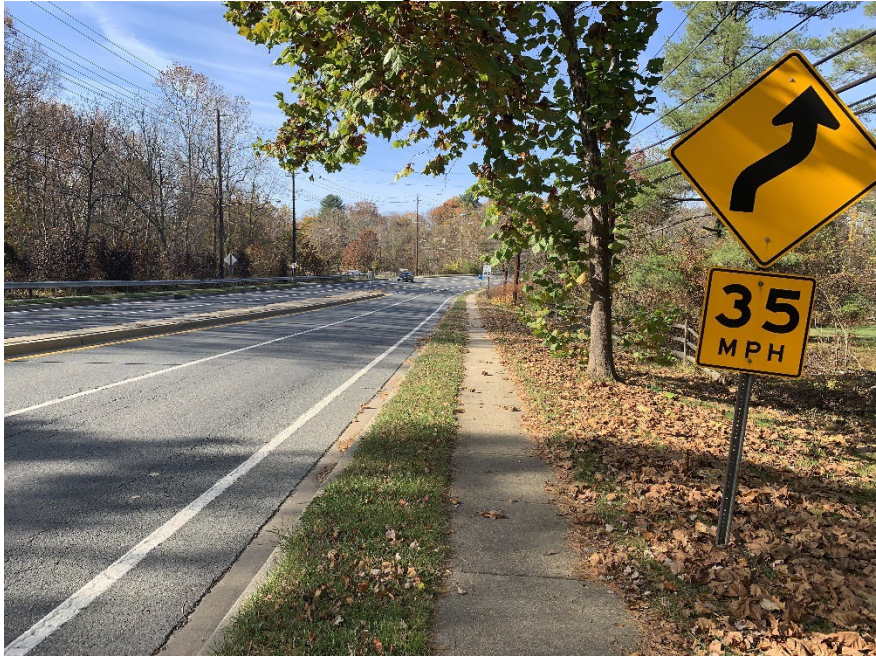
Westbound East Randolph Road east of the Crash site
