## Fatal Crash Review

Location: Wightman Road & Aspenwood Lane

Crash Date: April 23, 2023

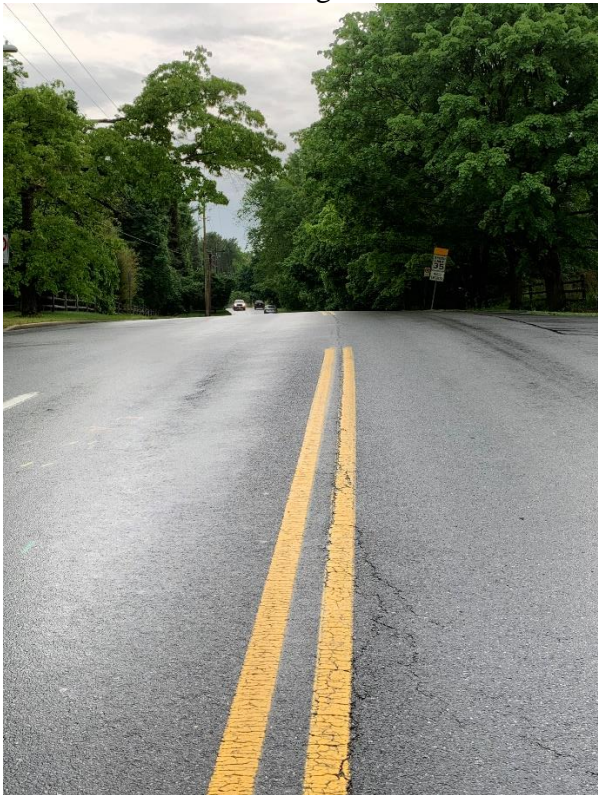
Southbound Wightman Road

A field investigation was conducted at the crash site on May 09, 2023. Along the southbound Wightman Road approach to Aspenwood Lane there is a moderate upgrade to the slight over-vertical at Aspenwood Lane. There are intersection advance warning signs posted along both Wightman Road approaches to Aspenwood Lane and there is sufficient sight distance in all direction at the intersection. Intersection lighting is provided on a utility pole at the NE corner of the intersection, the county streetlight map indicates it is operational. Several signs near the intersection are old, faded, and the knocked down Adopt-A-Road sign is covered up by mud.

Refresh old and faded Stop and No Parking signs at the intersection and remove/replace the damaged Adopt-A-Road sign.
