Fatal Crash Review

Local case number 240009925

Location and Site Description:

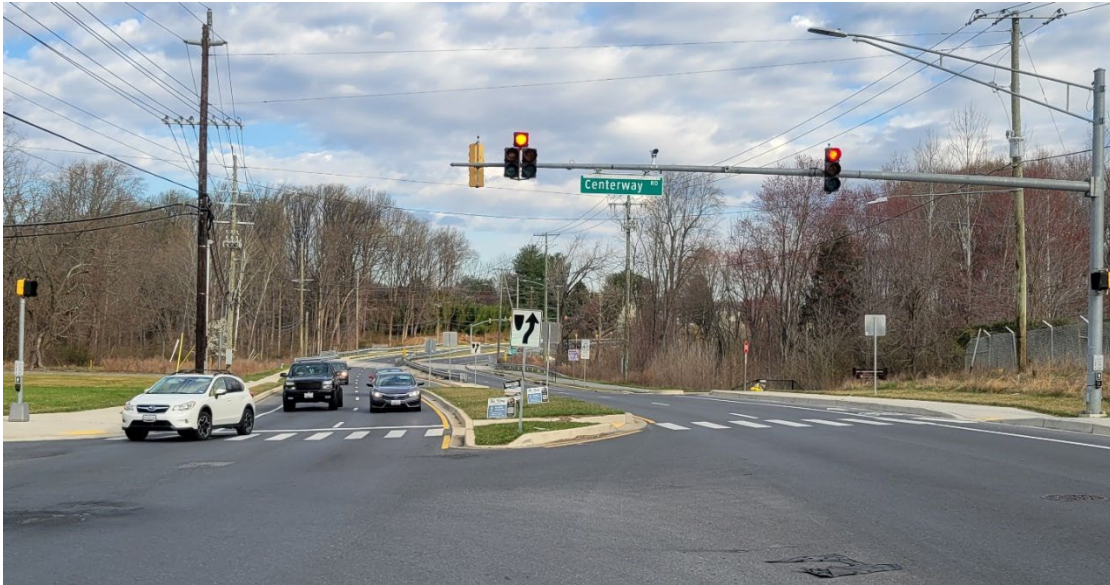
Northbound Snouffer School Road at Centerway Road

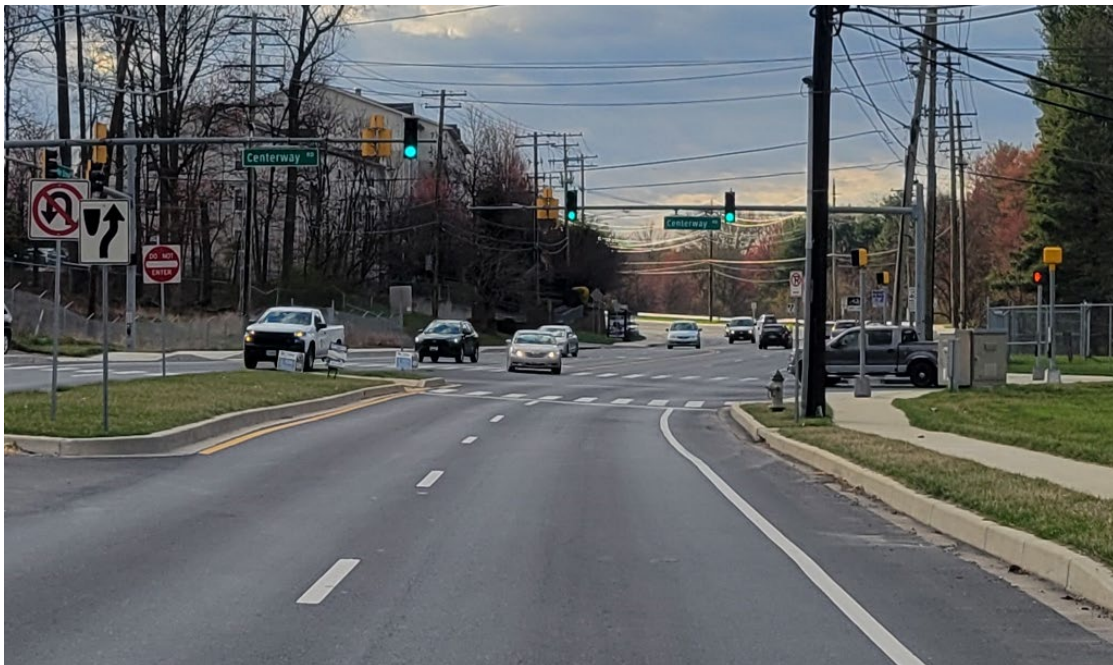
Southbound Snouffer School Road Approaching Centerway Road

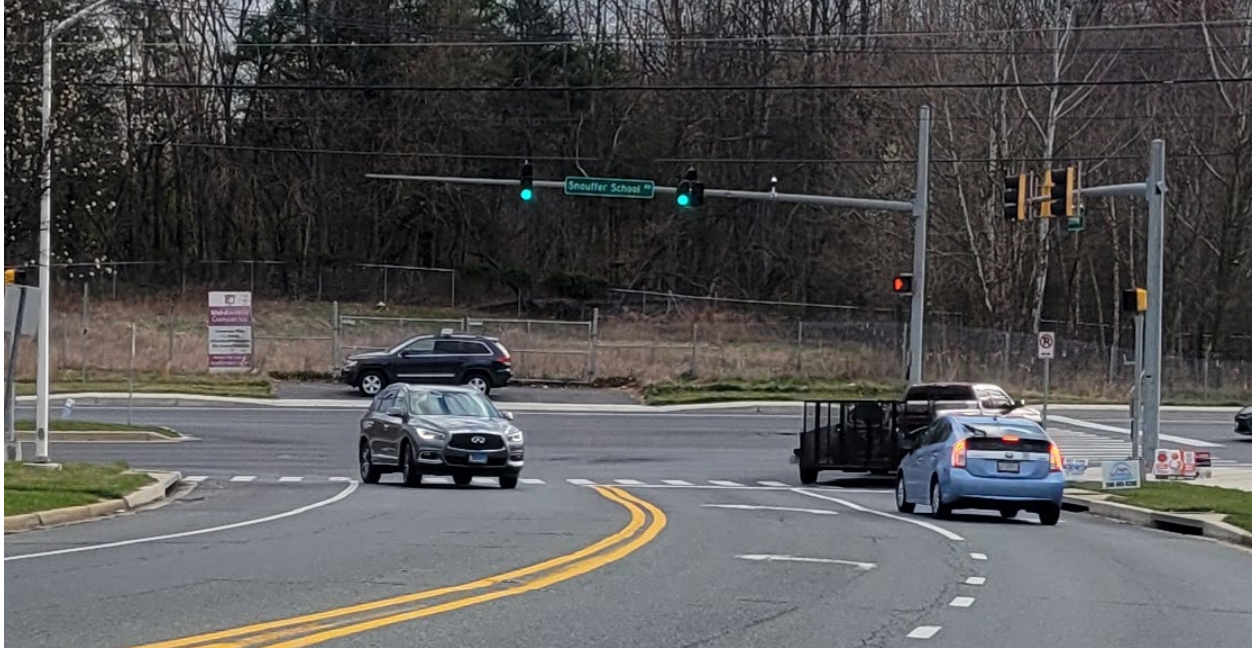
Westbound Centerway Road Approaching Snouffer School Road
