## Fatal Crash Review

Location: 9000 block of Cedar Lane near Amherst Lane

Crash Date: Wednesday, January 22, 2025

Local Case Number: 250003002

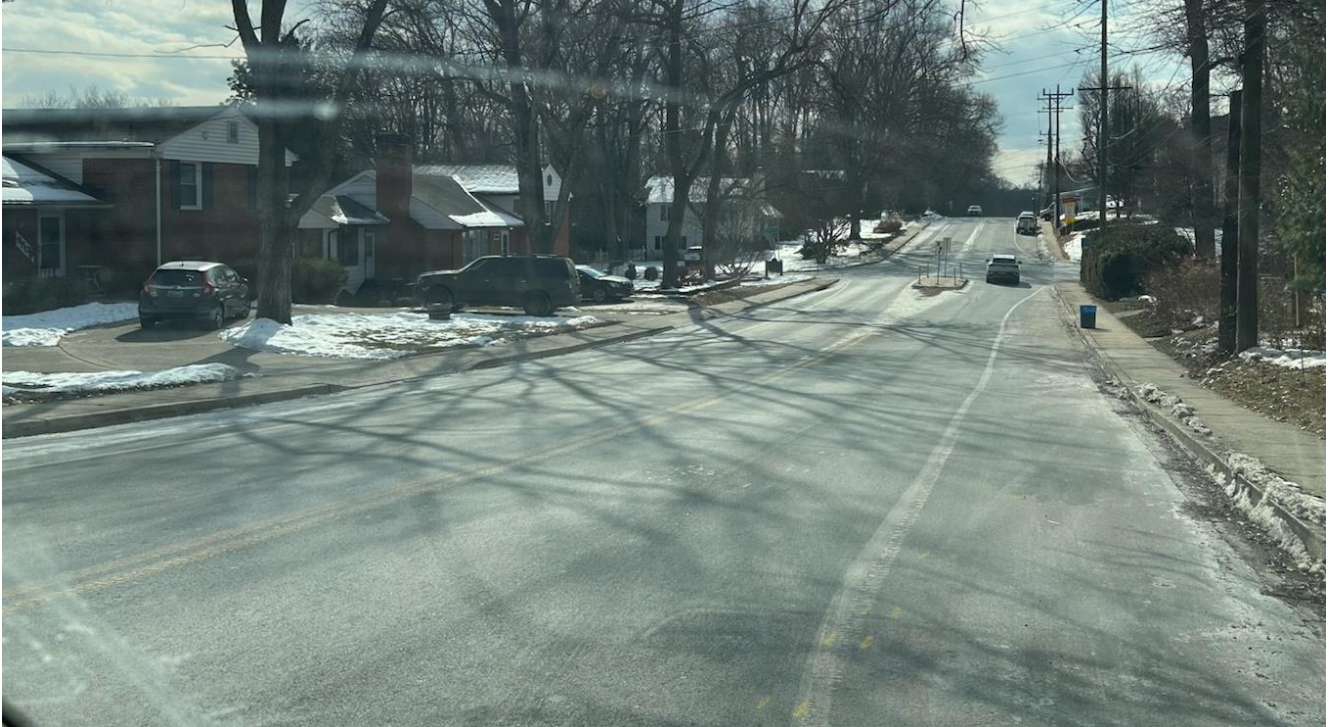
**Southbound Cedar Lane, approaching crash location**

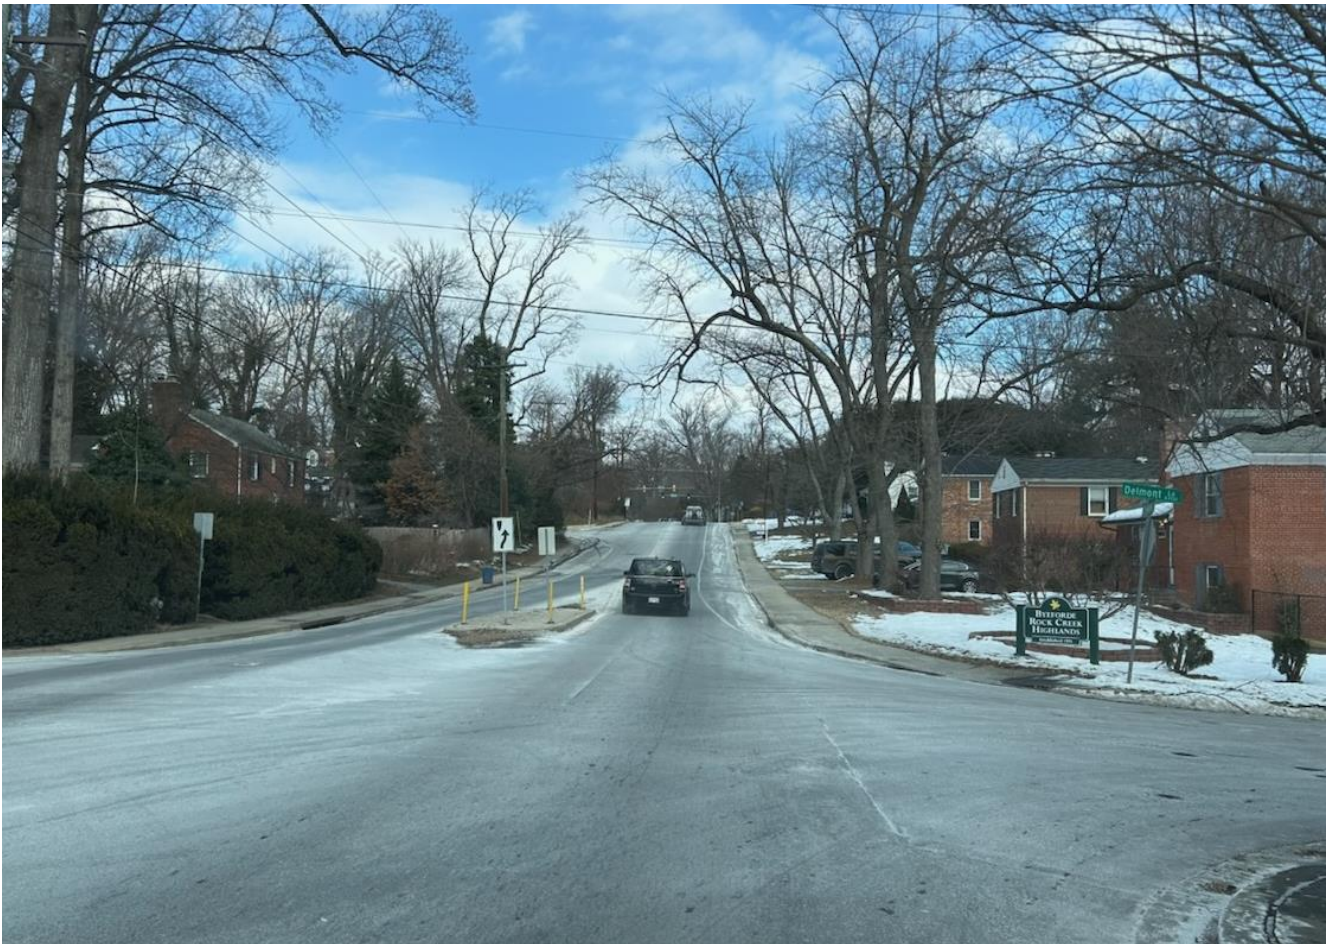
**Northbound Cedar Lane, approaching crash location`**
