## **Welcome to Wheaton Revitalization News!**

## **Look Ahead - Week of October 22 to October 28**

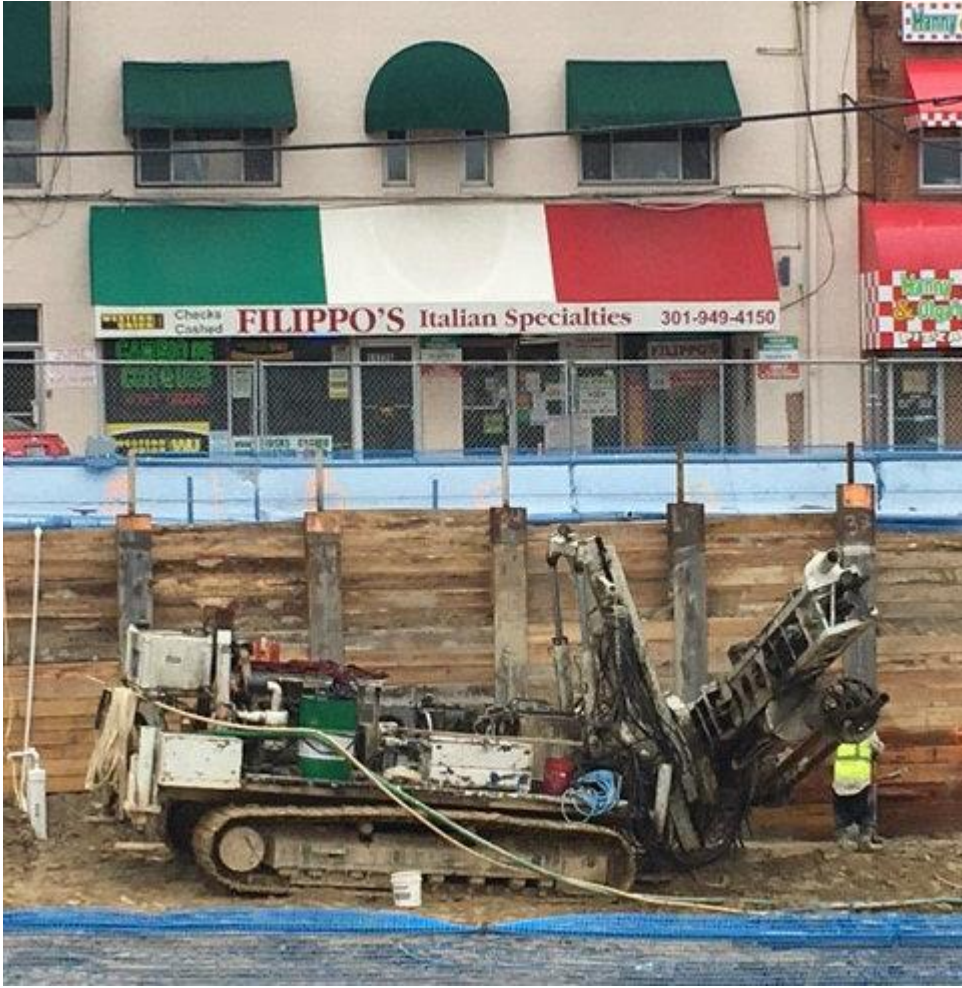
The Support of Excavation will advance with the depth of excavation. Installation of tie-back anchors (see photo) continue as the excavation deepens. In all, three (3) horizontal tiers of tie-backs will be installed as excavation advances to the bottom of the hole. Installation of the first tier is nearly complete. As noted in previous reports, tie-back anchors are an integral part of the Support of Excavation system. The Support of Excavation will advance to the bottom of the hole.

**Tie Back Anchor Machine**

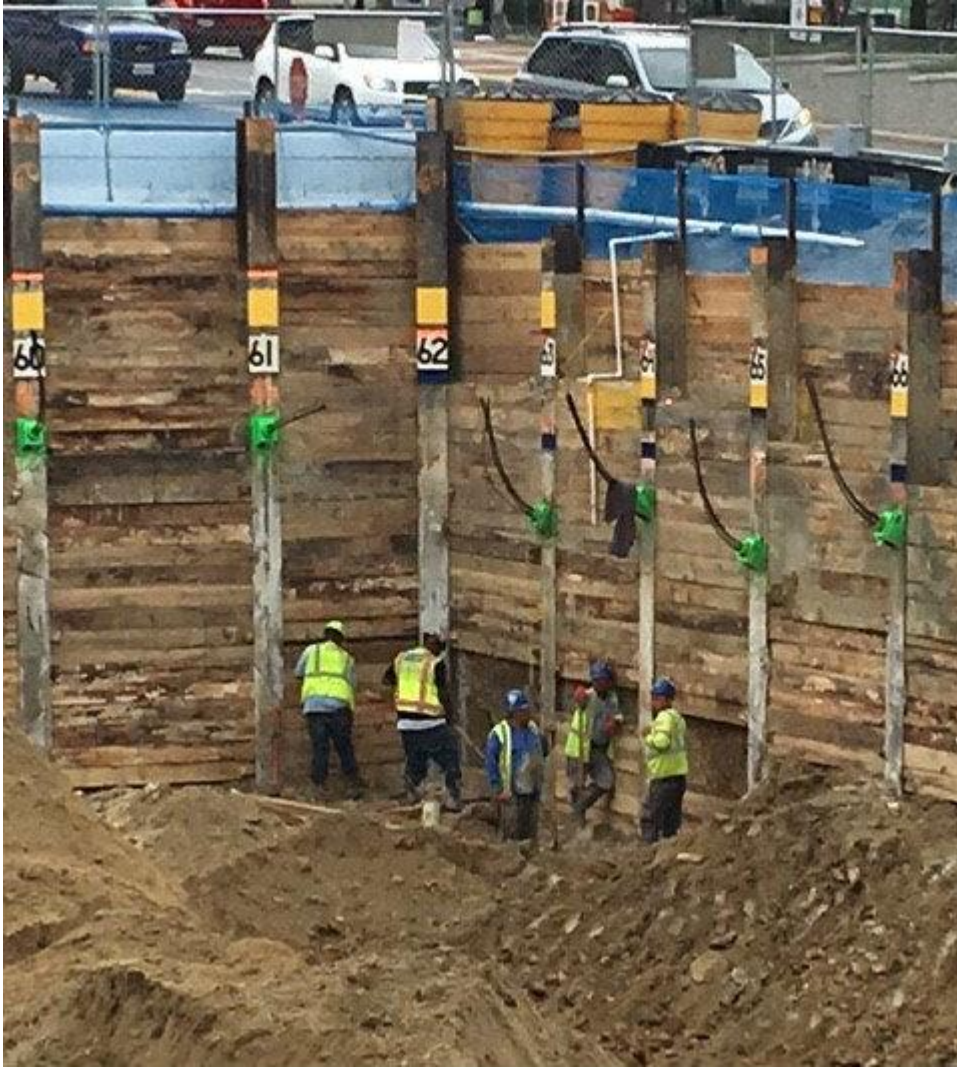
Mass excavation for the building foundation continues. At present, the contractor has excavated approximately 25-foot deep (see photo), is excavating daily, and is continuing towards a 50-foot deep hole. Excavation is currently 50-percent complete. The bottom of the hole is expected to be reached in early-January 2018, weather permitting.

### Excavation Reaching 25-feet Deep at South End of Project
