**Attachment K:**  
Natural Resources Inventory  
Memorandum

**Date:** July 27, 2017  
**To:** Joana Conklin – Montgomery County Department of Transportation (MCDOT)  
**From:** Sarah Falcone – RK&K  
**CC:** Erron Ramsey, Greg O’Hare, and Michelle Harden – RK&K  
**Re:** US 29 Bus Rapid Transit Corridor Planning Study – Natural Resources Inventory

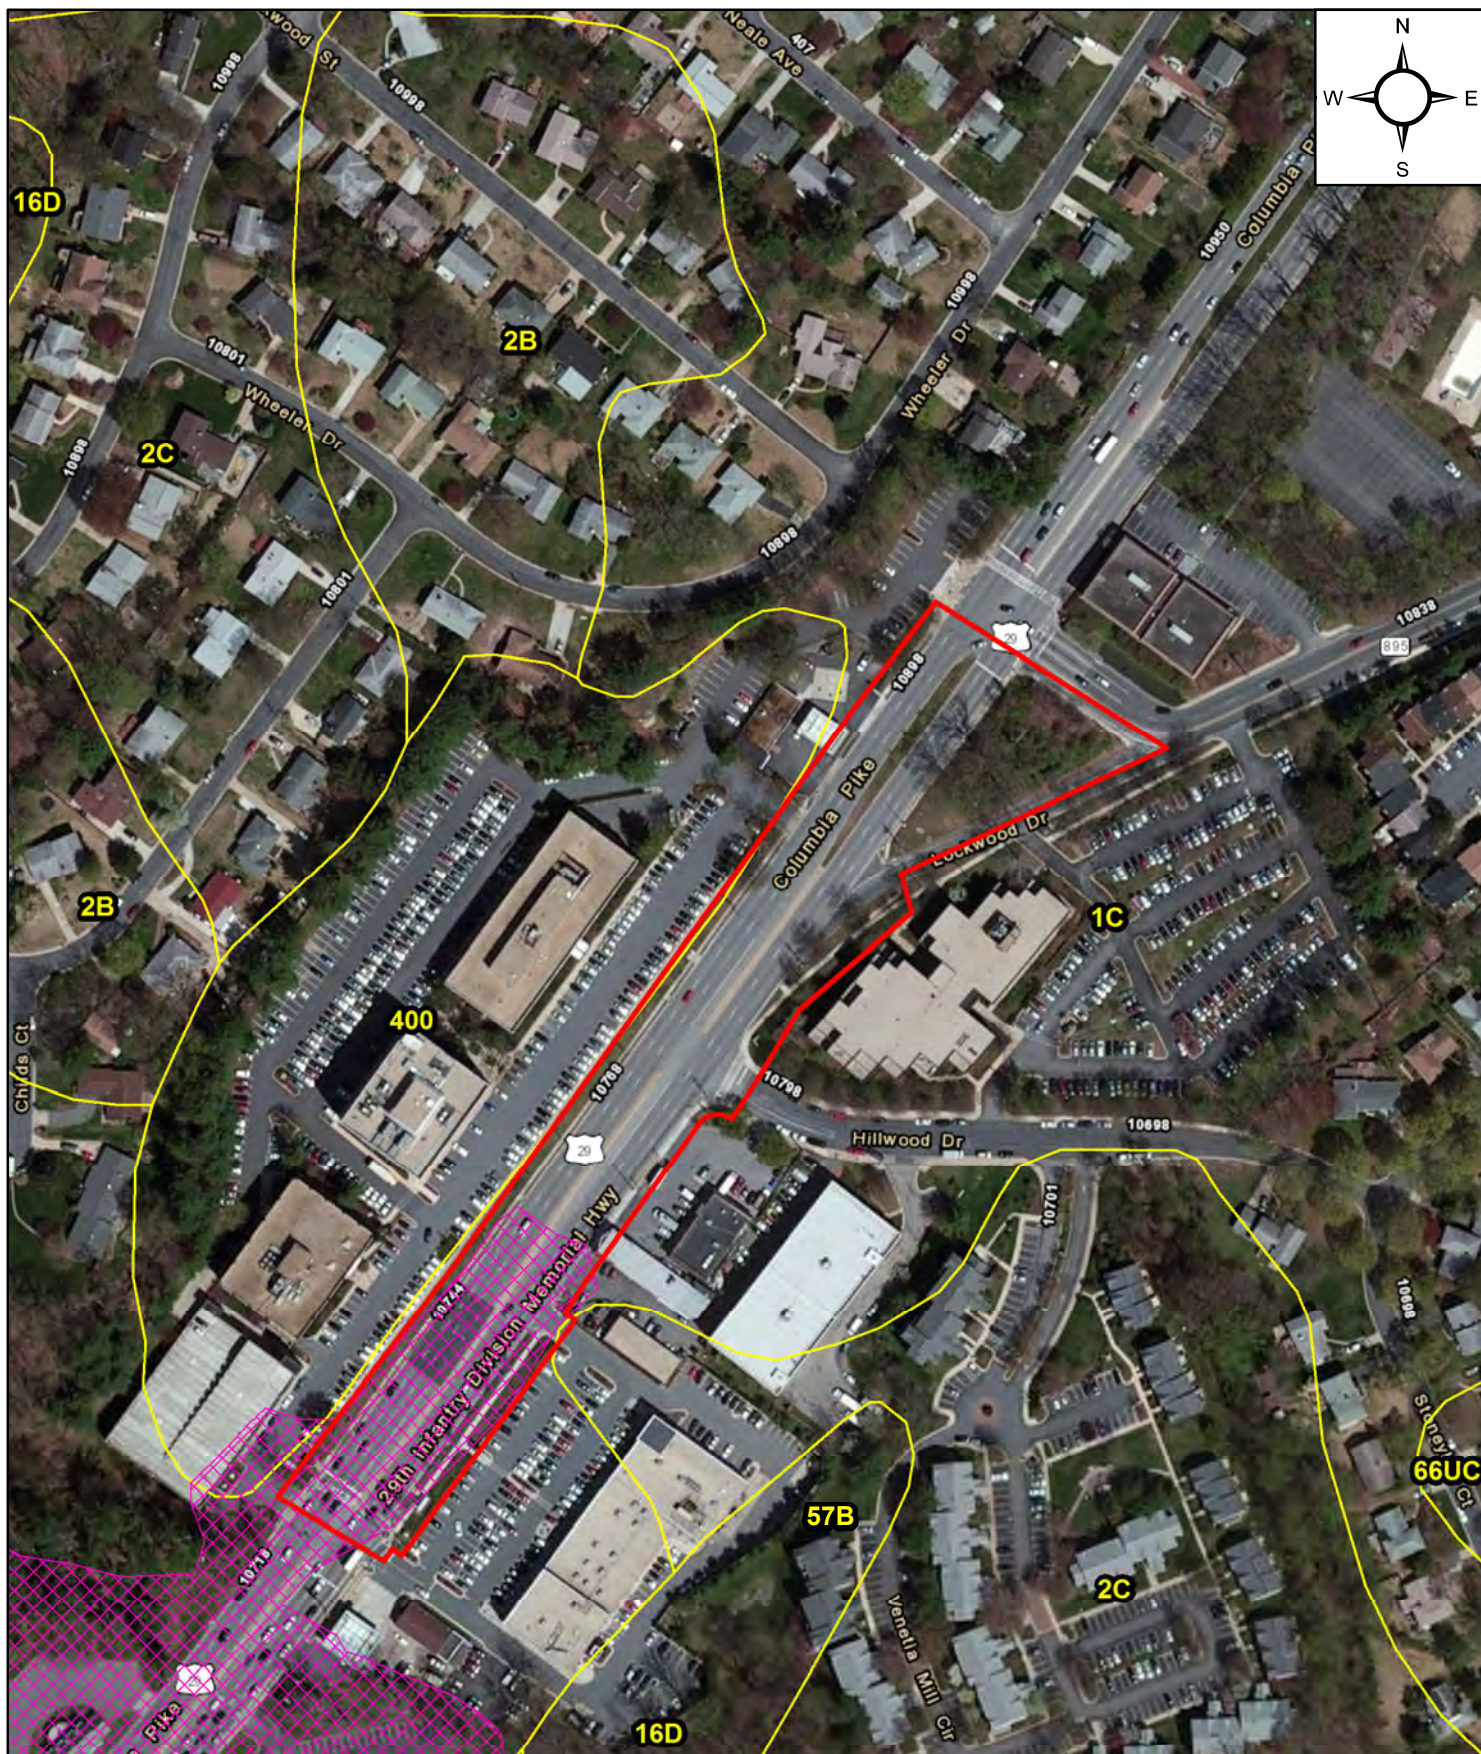
Figure 3d

Station 4 - Burnt Mills

Approximately 45,911 square feet (SF) of Federal Emergency Management Agency (FEMA) 100-year floodplains fall within the project study areas at Station Stop 4 – Burnt Mills, according to Montgomery County FEMA GIS data (**Appendix A, Figures 3a-3k**).

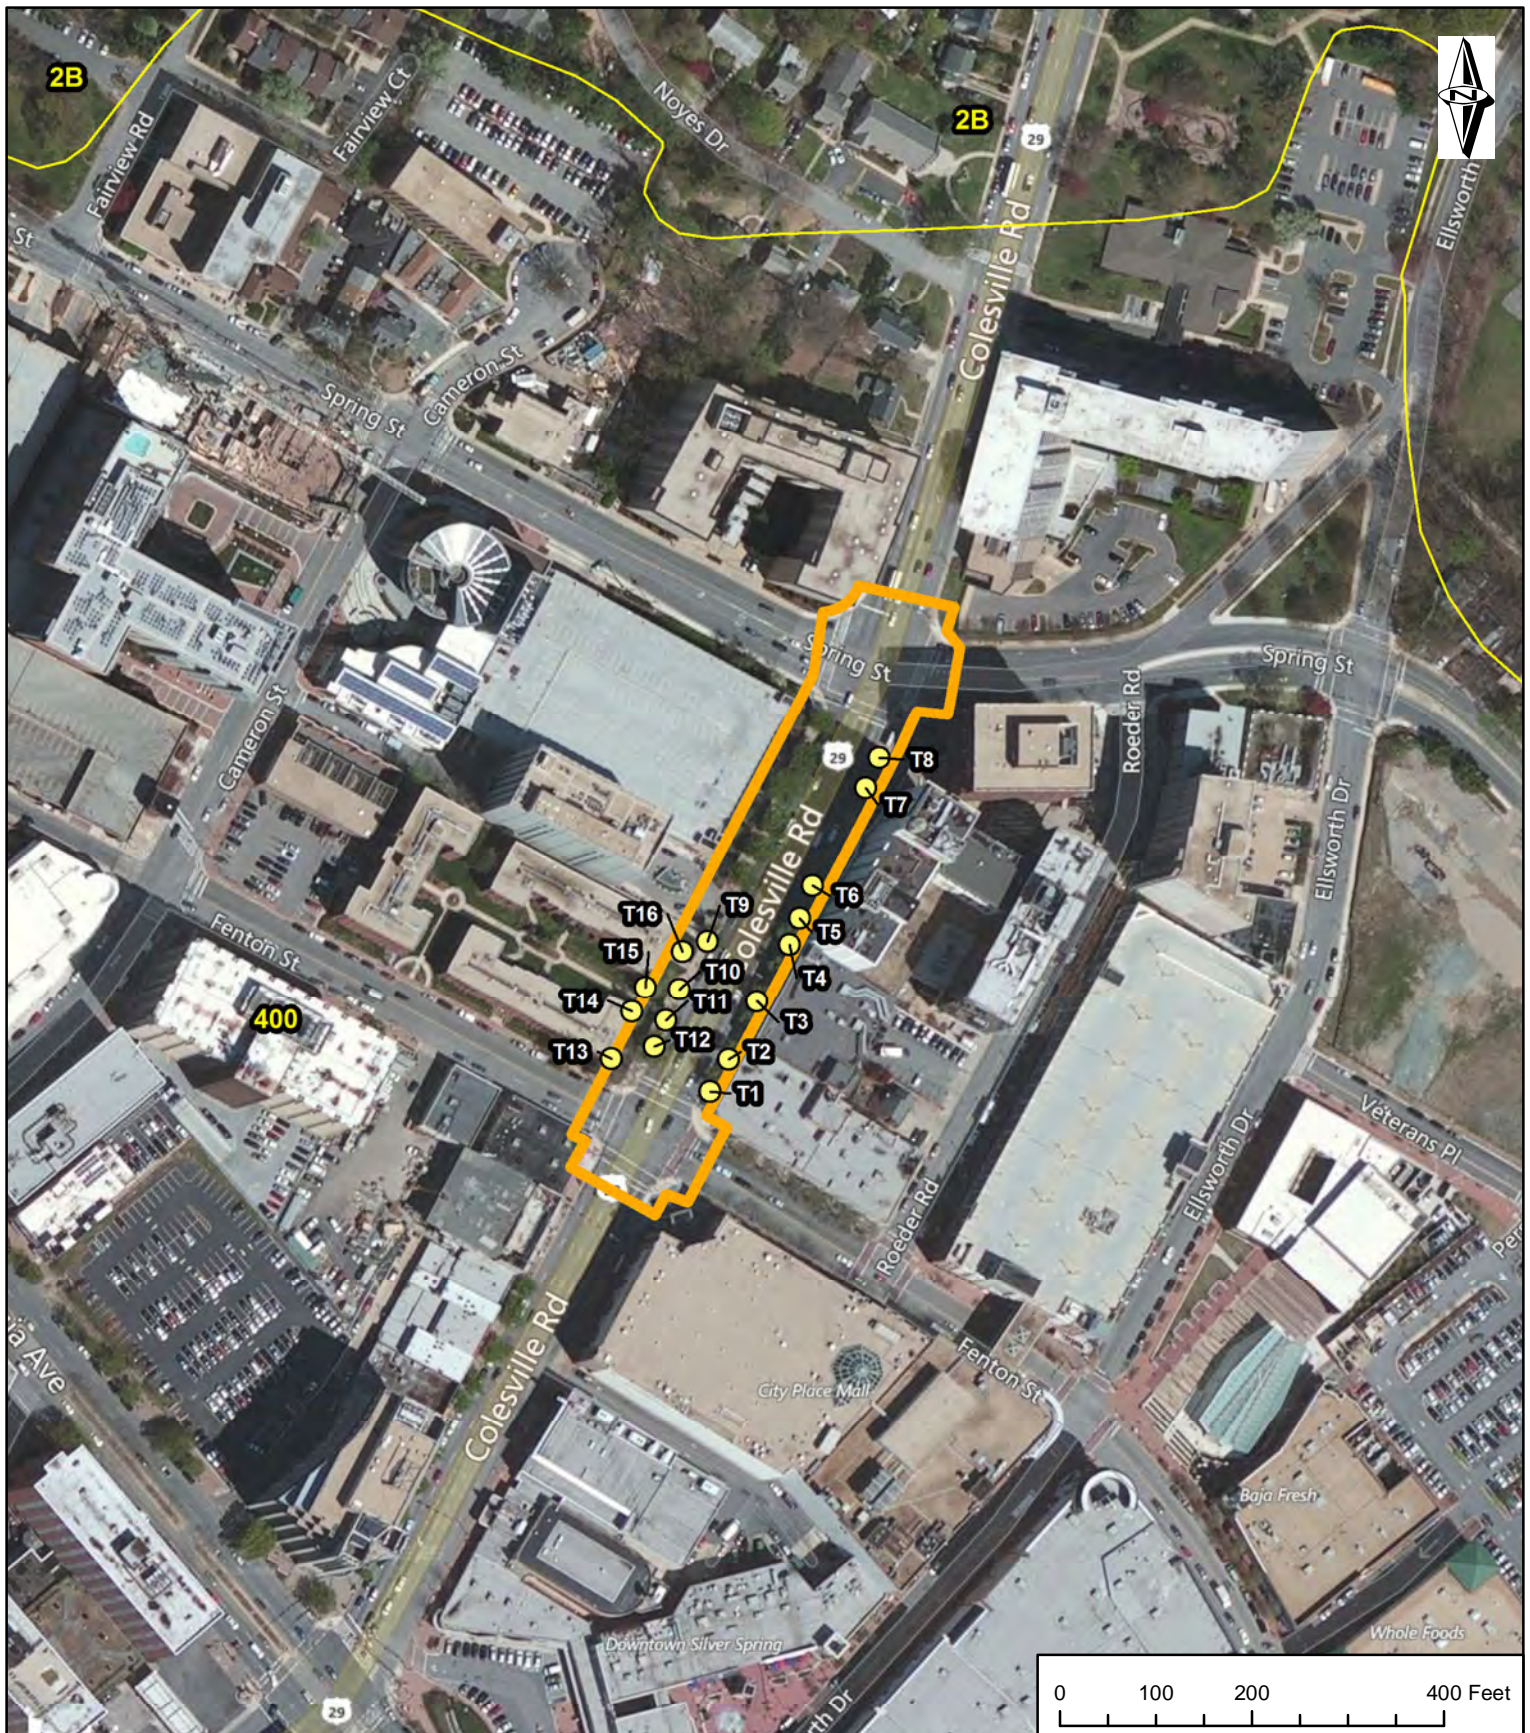
Page 1 of 10  
Fenton Street

- Significant/Specimen Trees
- Inventoried Trees <24" DBH
- Critical Root Zone
- Study Area
- DNR Waters
- DNR Wetlands
- NWI Wetlands
- FEMA 100-Year Floodplain
- SSURGO Soils

RK&K inventoried 222 trees, including six significant trees ( $\geq 24$  inches DBH) (**Table 2**) and six specimen trees ( $\geq 30''$  DBH) (**Table 3**) within the project study areas. Photographs of the project study areas are located in **Appendix B**, information regarding inventoried trees is summarized in the Tree Inventory Table in **Appendix C**, and the locations of the trees are displayed on the Natural Resources Figures in **Appendix E**.

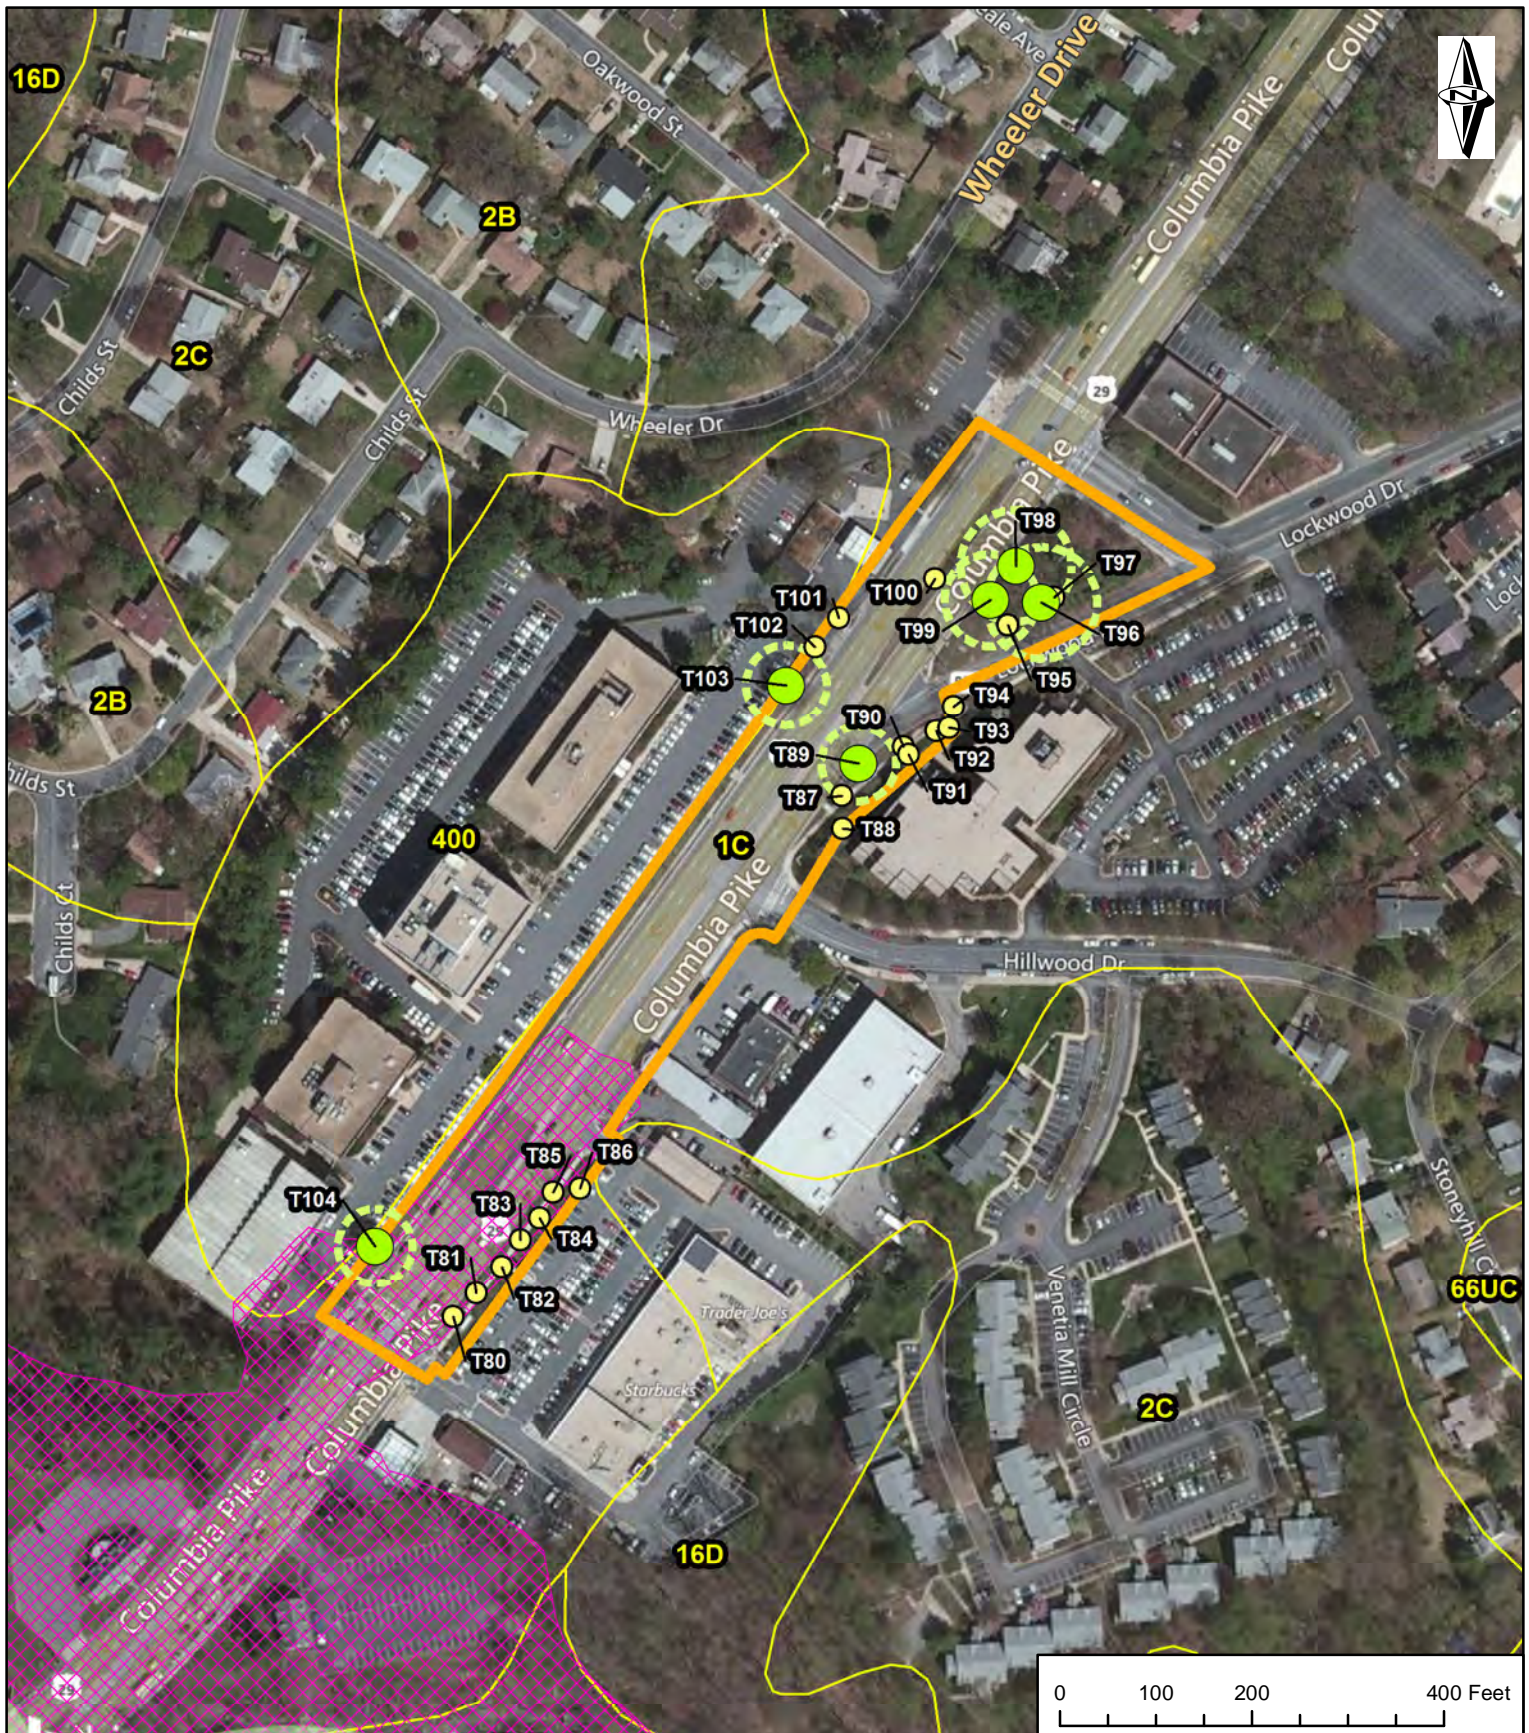
<b>US 29</b> <b>Bus Rapid Transit</b>
<b>Natural Resources</b> Page 3 of 10 Burnt Mills April 2017

Significant/Specimen Trees		DNR Wetlands
	Inventoried Trees <24" DBH		NWI Wetlands
	Critical Root Zone		FEMA 100-Year Floodplain
	Study Area		SSURGO Soils
	DNR Waters
