# Twinbrook / Rockcrest Watershed September 1st, 2021 Flood Study at Rock Creek Woods Apartments

Summary Report: March 31, 2022

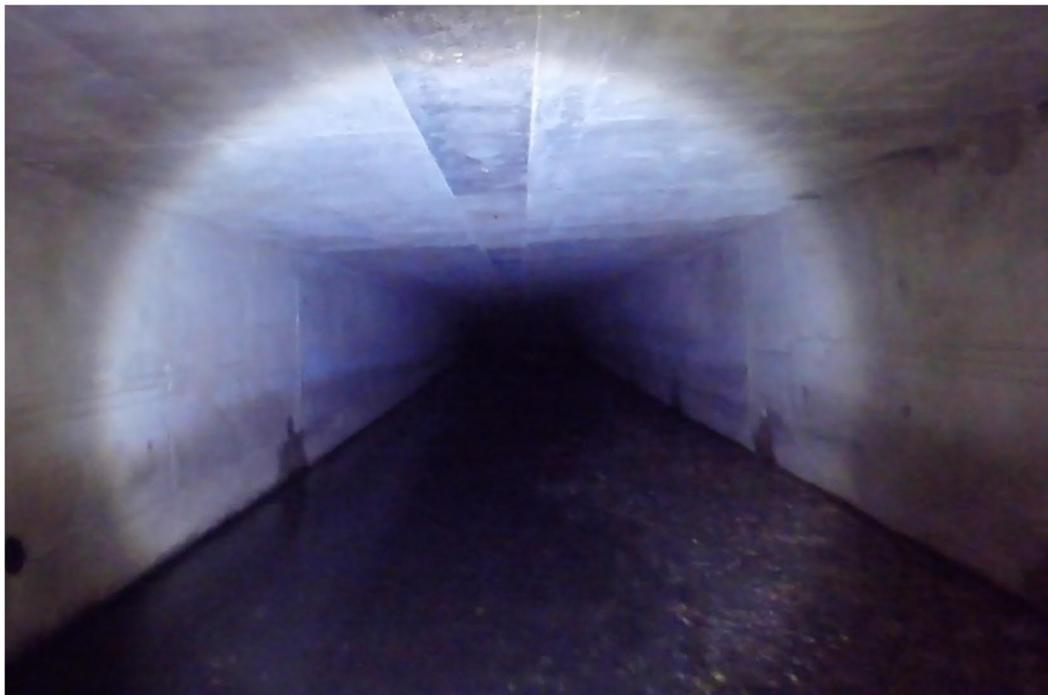
Hands on inspection of the structures revealed that the openings were clear with very little siltation and no signs of large blockages, such as tree limbs or boulders, that would have restricted flow during the rain event (see Figure 21). In several locations, there were block-outs in the side walls where storm drains could have been placed during construction. These block-outs had exposed, corroded reinforcing steel with exposed fill and voids up to 2 feet deep beyond the box culvert wall (see Figure 22). It appears these block-outs were never filled with concrete after construction was completed. Overall, the concrete box culverts were found to be in sound condition with only minor areas of concrete spalling or exposed reinforcing steel (see Figure 23). The inspection was filmed by Mercado Consultants' staff.

Figure 21 - Typical View inside of Box Culverts.

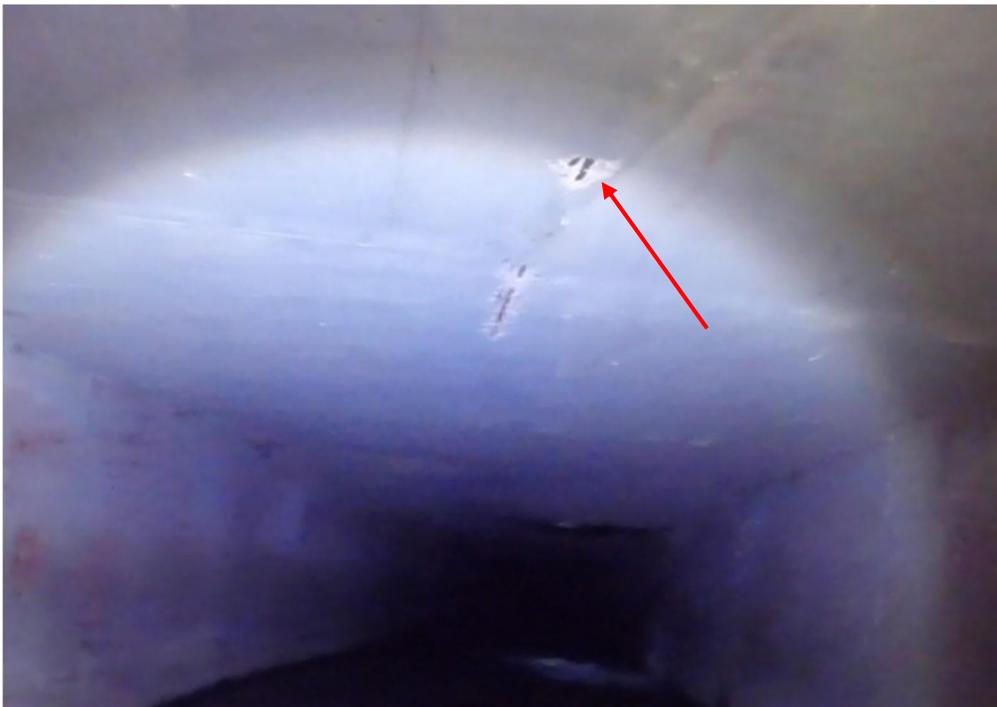
Figure 23 - Typical Minor Spall with Exposed Reinforcing Steel on Top Slab of Box Culvert

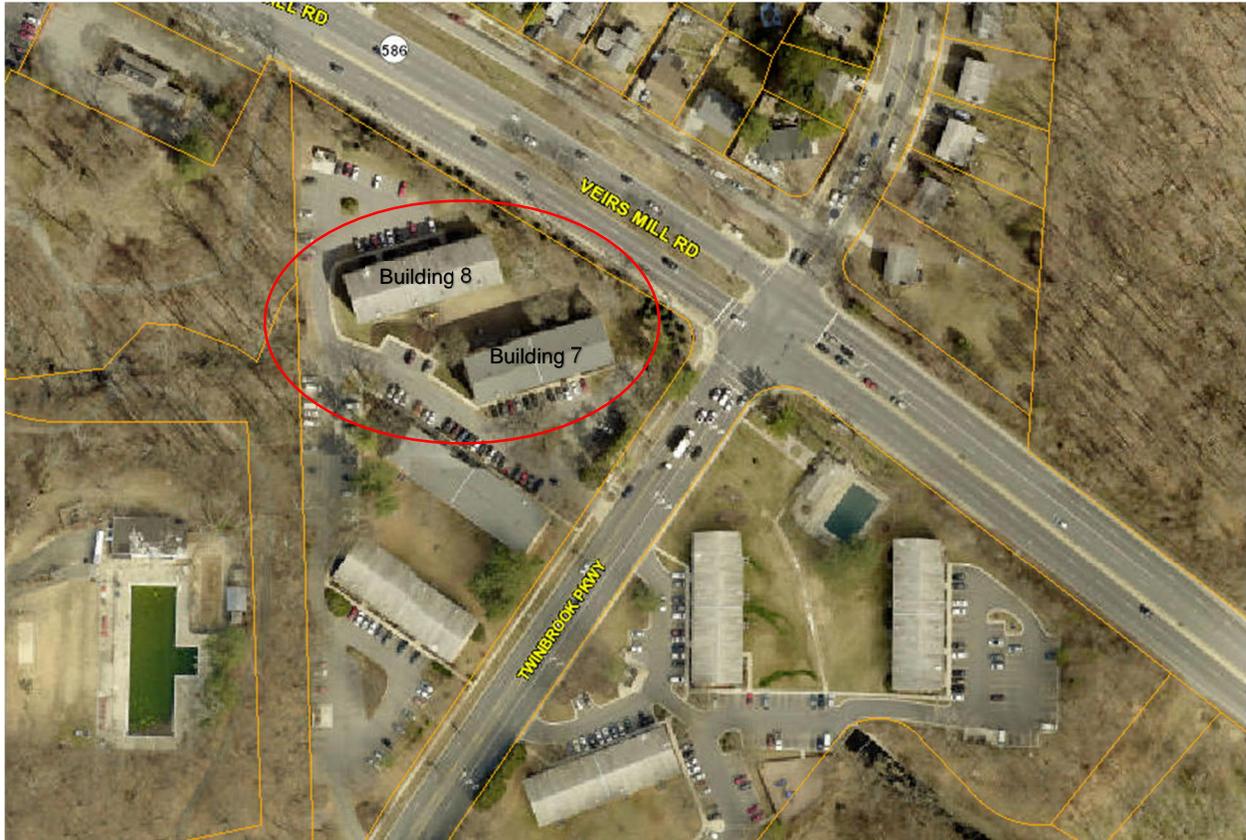
Bill Mercado, P.E. and Michael Mercado, P.E. conducted an inspection of the area of flooding at the Rock Creek Woods Apartments on September 7, 2021. The area that flooded was designated as Buildings Numbers 7 and 8 on the WSSC permitted plan set from May 23, 1966, and are located on the Northwest corner of the property near the Northern concrete box culvert (see Figure 33).

Figure 33 - Approximate Area of Flooding at Rock Creek Woods Apartments (Shown by Red Circle)

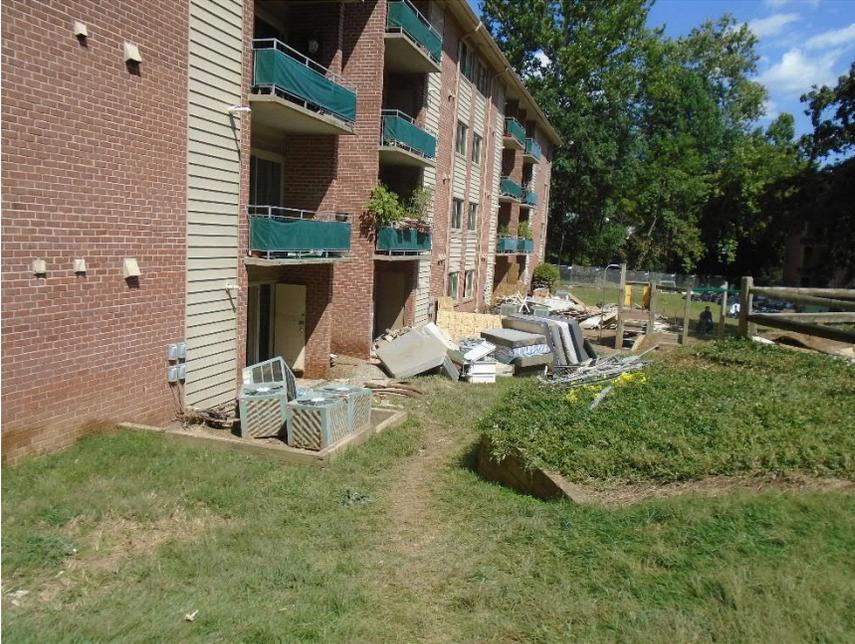
The inspection was performed while clean-up efforts were underway to remove flood damage for the basement level apartments for both of the flooded buildings (see Figure 34). The watermarks from the flood were evident on both buildings. Building No. 8 (Western building that flooded) had a high water mark of approximately 5.0' +/- from the concrete patio in front of the apartments which was evident on the drywall (see Figure 35 and Figure 36). Building No. 7 (Eastern building that flooded) had a high water mark of approximately 7.9' +/- from the concrete patio in front of the apartments which was evident on the siding outside the apartments (see Figure 37 and Figure 38). Building 7 is lower in elevation compared to Building 8.

Figure 34 - Area of Flooding and Debris Clean Up

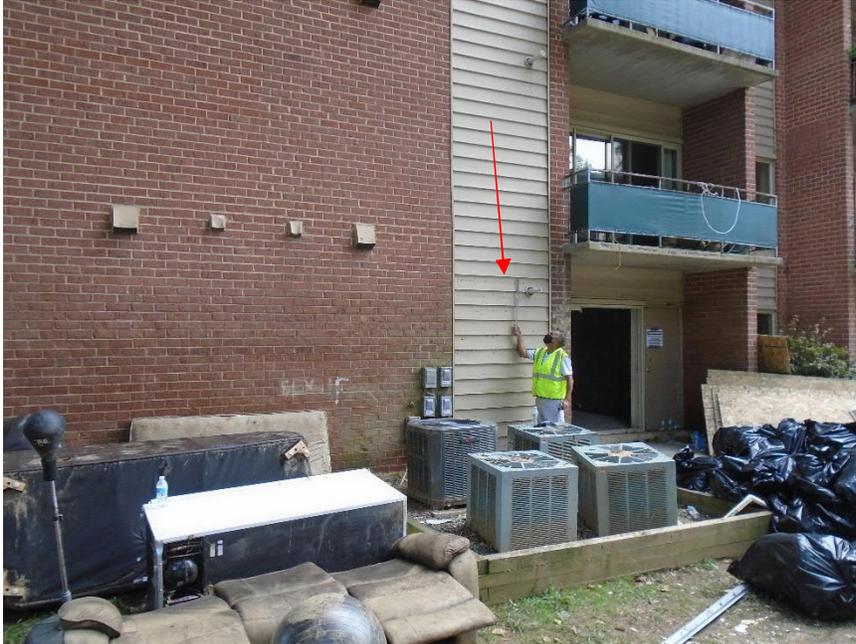
Figure 38 - High Water Mark Building 7

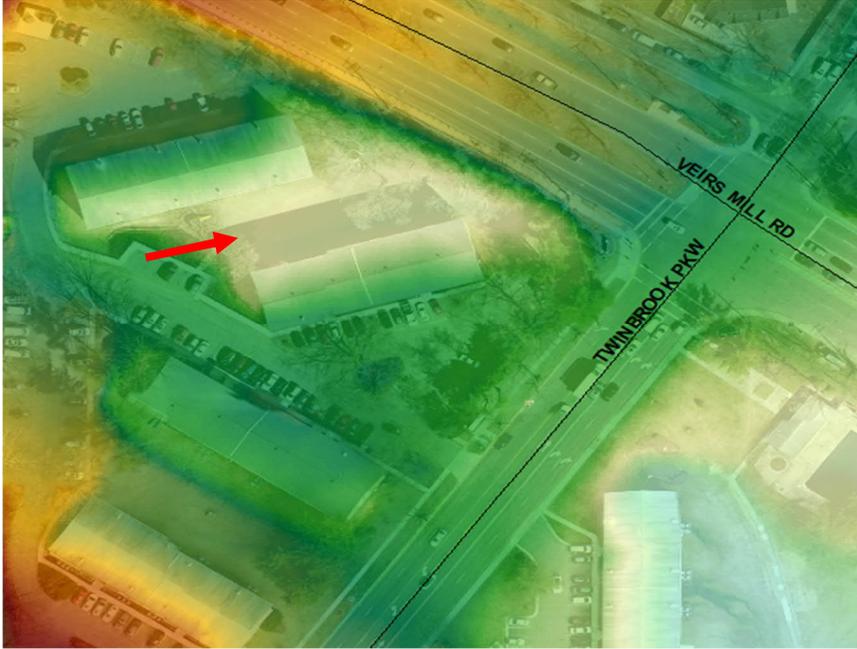
The area of flooding between Buildings 7 and 8 was observed to be in a depression in the shape of a bowl. A review of aerial lidar confirmed the shape of the topography (see Figure 39). Within the depression, there is no way for stormwater to naturally exit by gravity except through the storm drain system. Six inlets were connected by a series of 4" to 6" PVC drain pipes and ultimately discharged into an 18" reinforced concrete pipe (RCP) and 15" RCP at the Northern edge of the depression. Five of the inlets had green plastic grate coverings (see Figure 40), and one of the inlets had a metal grate covering (see Figure 41). All inlets were clear of debris during the inspection. The configuration of the inlets did not match the WSSC approved permitted plan set from 1966, (see Section 5.2 Comparison of Storm Drain System to Permitted Plans). A final as-built plan for the apartments' storm drain system was not available in historical records and it is not known if any of the changes to the storm drain system were approved during construction.

Figure 39 - Lidar Showing Depression (Bowl) in Area of Flooding.  
Colors from High to Low: Brown, Red, Yellow, Green, White, Light Blue

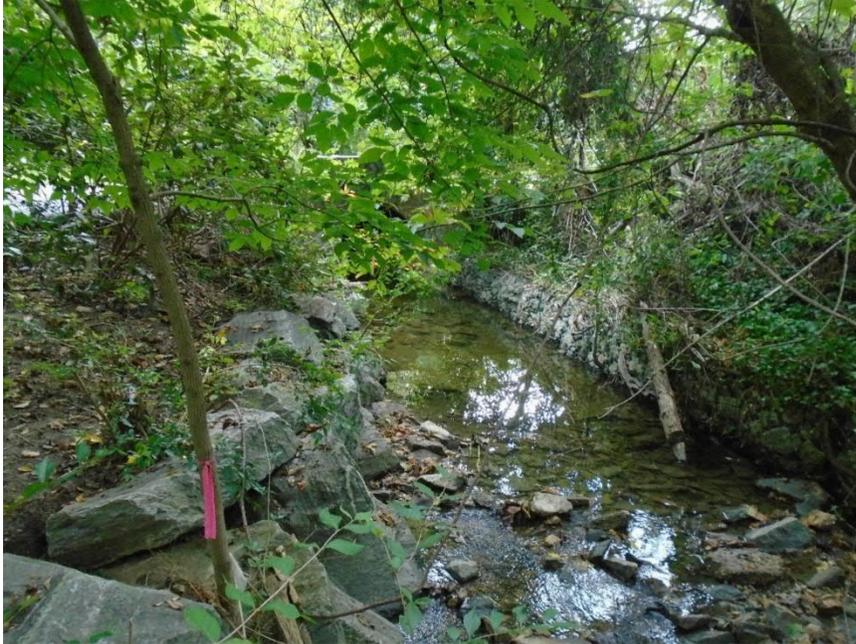
Bill Mercado, P.E. and Michael Mercado, P.E. conducted a visual inspection of Tributary 1 from the most upstream storm drain outfall to the box culvert entrance on October 12, 2021. Throughout the length of the tributary, there was low flow of several inches of water. Stone riprap, trees, and vegetation line its banks (see Figure 42).

Figure 42 - Typical stream and bank conditions of Tributary 1.

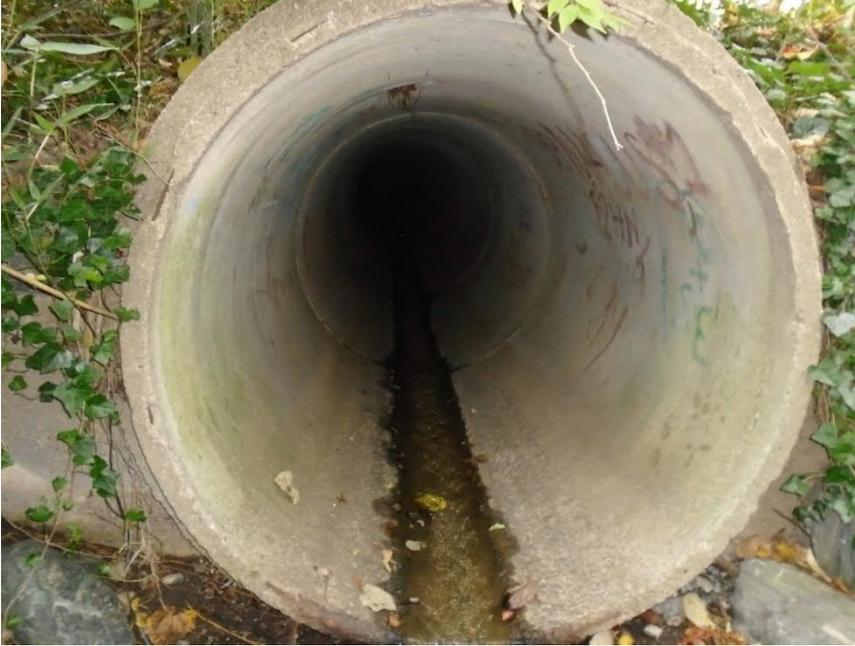
At the upstream end of Tributary 1, there are two outfalls: a 60-inch reinforced concrete pipe (RCP) outfall by Ardennes Avenue and a three-cell, 3'-0" high by 5'-0" wide corrugated metal pipe arch (CMPA) outfall near Halpine Road (see Figure 43 and Figure 44). The streams from these two outfalls connect approximately 400' +/- downstream and form Tributary 1. A pedestrian bridge crosses the tributary at Vandergrift Avenue (see Figure 45). The tributary flows through a 5'-8" high by 6'-0" wide corrugated metal pipe arch (CMPA) below the access driveway between Atlantic Avenue and the Twinbrook Community Recreation Center (see Figure 46). Another pedestrian bridge crosses the tributary before the culvert entrance (see Figure 47). Debris was observed at an elevation that was below the top of the headwall (see Figure 48). No signs of water overtopping the head wall were found on Twinbrook Parkway.

Figure 43 - 60-inch RCP Outfall to Tributary 1.

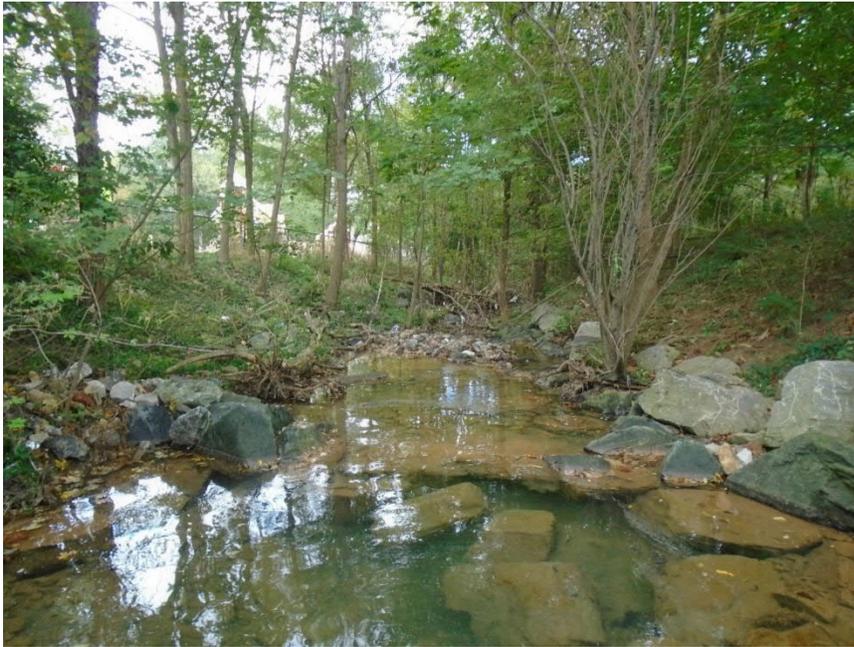
Bill Mercado, P.E. and Michael Mercado, P.E. conducted a visual inspection of Tributary 2 from the most upstream storm drain outfall to the box culvert entrance on October 12, 2021. Throughout the length of the tributary, there was low flow of several inches of water. Stone riprap, trees, and vegetation line its banks (see Figure 49).

Figure 49 - Tributary 2 Typical Stream and Bank Conditions.

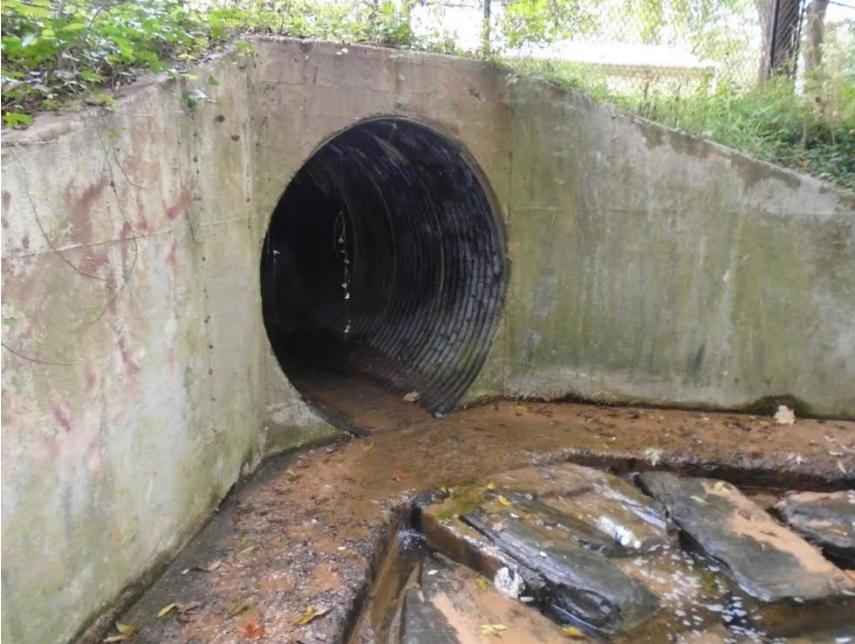
The open-channel tributary begins at a 66-inch corrugated metal pipe (CMP) outfall at its most upstream end (see Figure 50). A pedestrian bridge crosses above the tributary approximately halfway between the outfall and Ardennes Avenue (see Figure 51). The tributary then flows through two 60-inch reinforced concrete pipes (RCP) beneath Ardennes Avenue and a rectangular box culvert (4'-9" high by 8'-0" wide) beneath Atlantic Avenue (see Figure 52 and Figure 53). Debris and erosion found along the bank and the broken fence were visual signs of flood water overtopping Atlantic Avenue (see Figure 54). Debris was also present in a fence adjacent to Tributary 2 parallel to Aleutian Avenue (see Figure 55). Another pedestrian bridge crosses the tributary between Atlantic Avenue and the culvert entrance (see Figure 56). Debris was observed within sections of the chain link fence above the top of the culvert entrance headwall (see Figure 57).

Figure 50 - 66-inch CMP Outfall to Tributary 2.

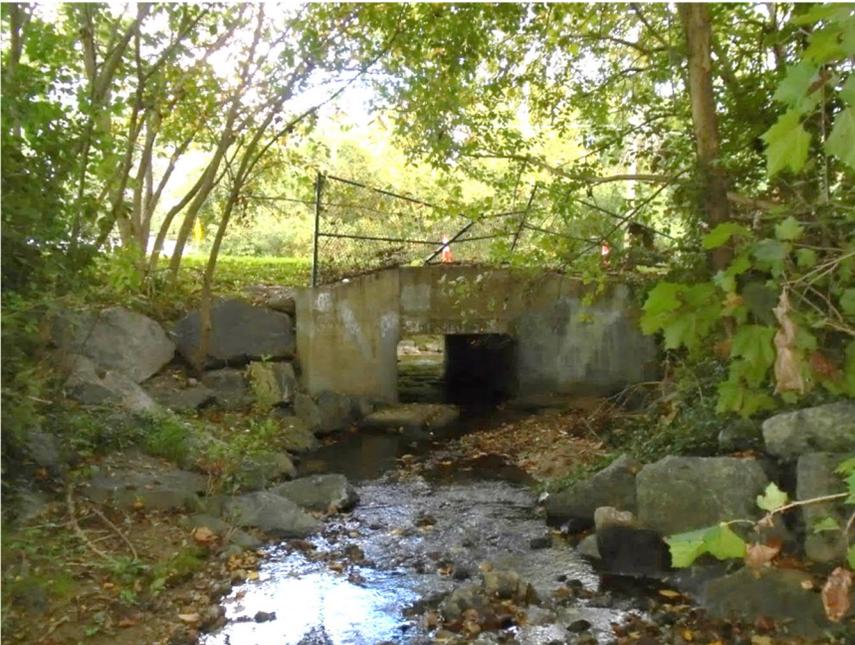
Figure 53 - Atlantic Avenue Crossing Tributary 2. Note: Damaged fence from flooding.

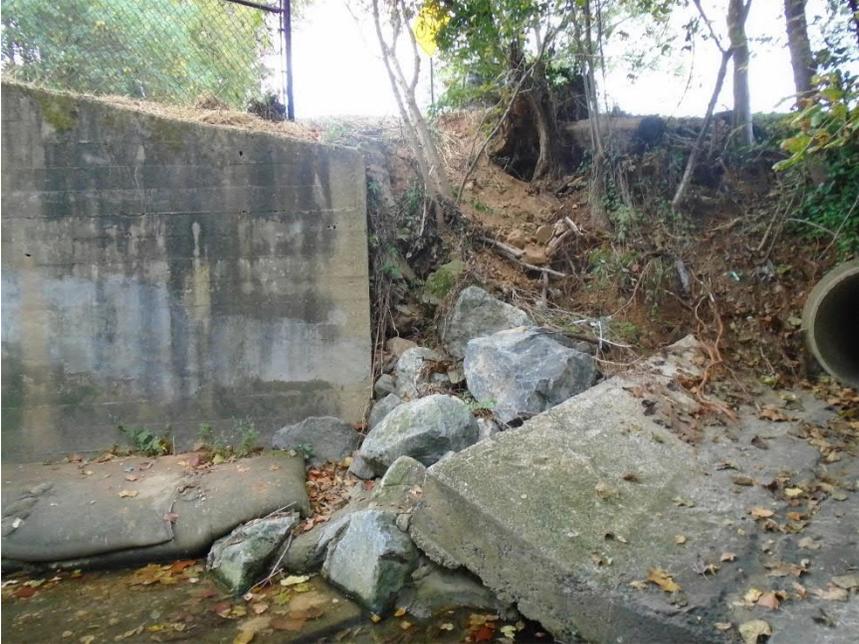
Figure 54 - Debris and Erosion at Atlantic Avenue Crossing.

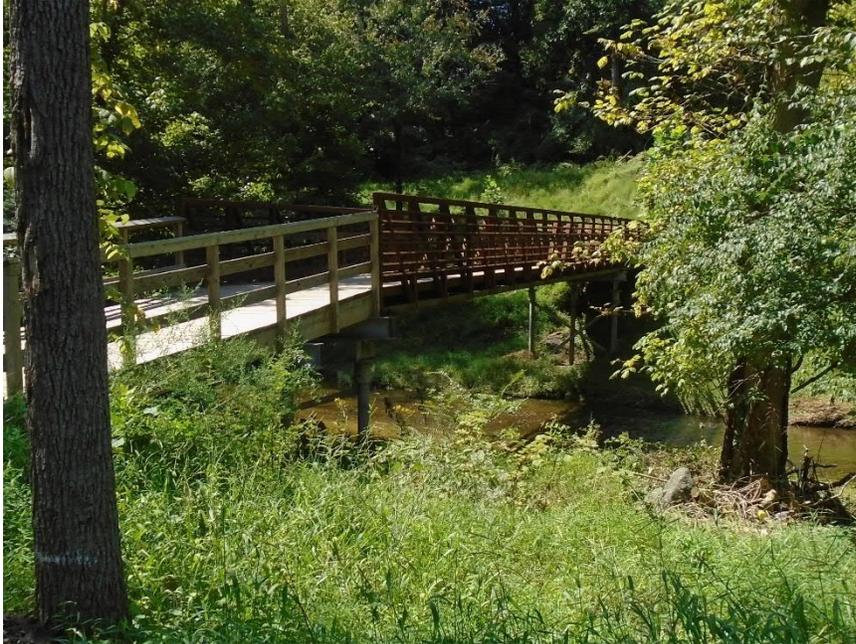
Figure 61 - Pedestrian Bridge Crossing Downstream of Viers Mill Road Bridge.

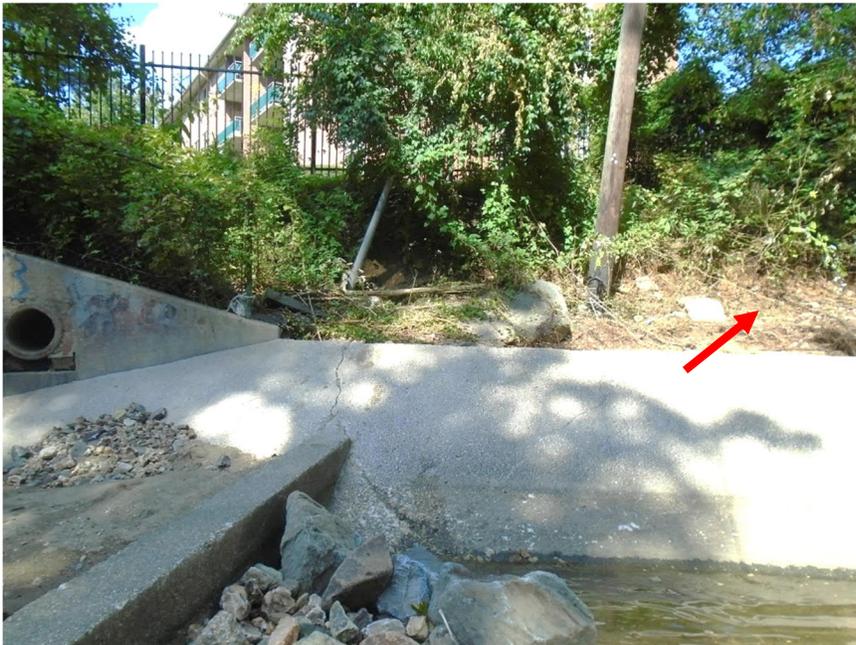
Debris was found along the entire bank of the tributary, with erosion present adjacent to the concrete apron at the box culvert outfall (see Figure 62). There was no evidence along Veirs Mill Road that the street had flooded during the storm. At the confluence with Rock Creek, there was evidence of high flood water based on bent grass through the downstream area beyond the Viers Mill Road Bridge (see Figure 63). There was no evidence of water overtopping the Veirs Mill Road Bridge crossing at Rock Creek.

Figure 62 - Typical Erosion Along Bank Above Concrete Apron.

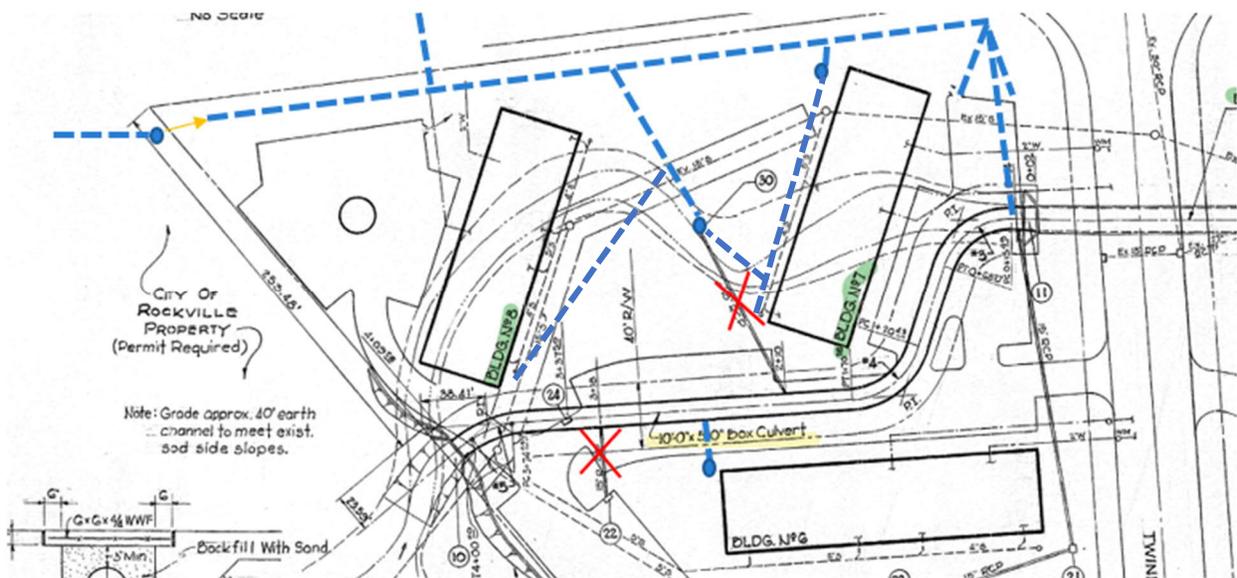
Figure 64 - Excerpt of 1966 Permit Plans showing inlets (blue circles), storm drain pipes (blue dashed lines), concrete flume (yellow arrow) and pipes that do not match the actual surveyed conditions (red X's).

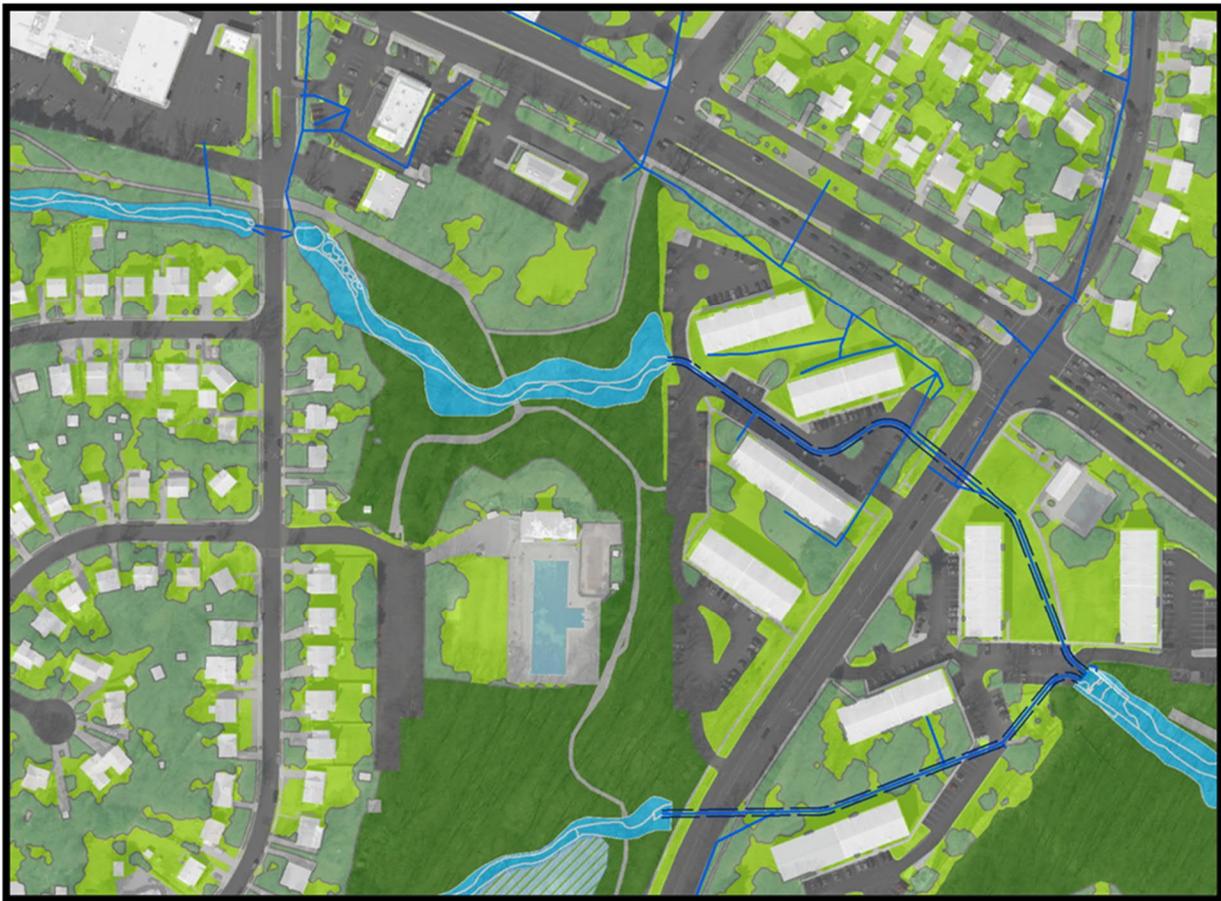
Figure 124 - Landcover dataset developed for H&H Model
