Natural Resource Inventory Report

Wapakoneta Roadway Improvements

GPI Project Number: 2008037.00 task 121
April 2013

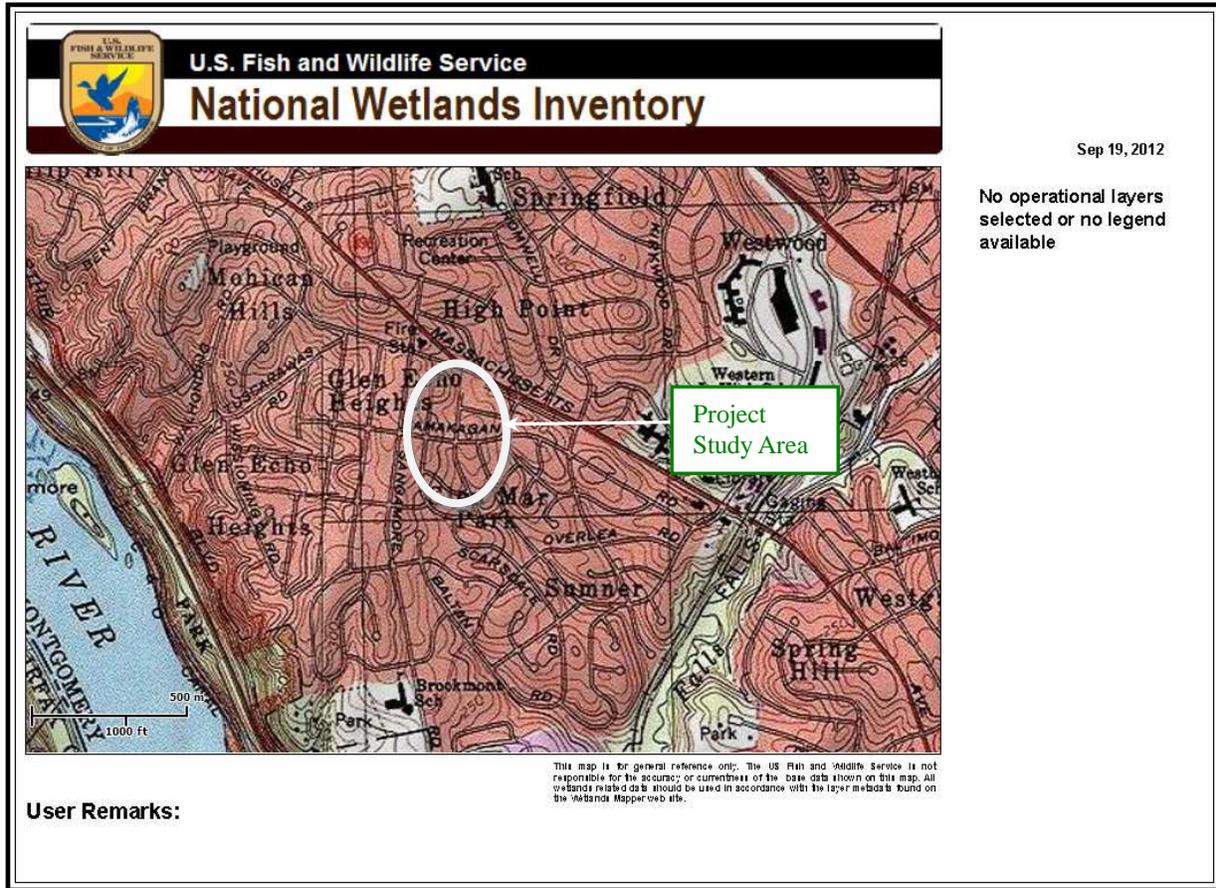
Figure 2: USGS and NWI Mapping

Geological Survey (USGS) Washington West Topographic Map (Figure 2), United States Department of Agriculture, Natural Resource Conservation Service, Montgomery County, Maryland, (Figure 3) the list of Hydric Soils of Montgomery County, aerial photography, FEMA mapping, and National Wetland Inventory Mapping. The results of the off-site investigation did not identify the presence of any wetland or waterway mapped within the study area.

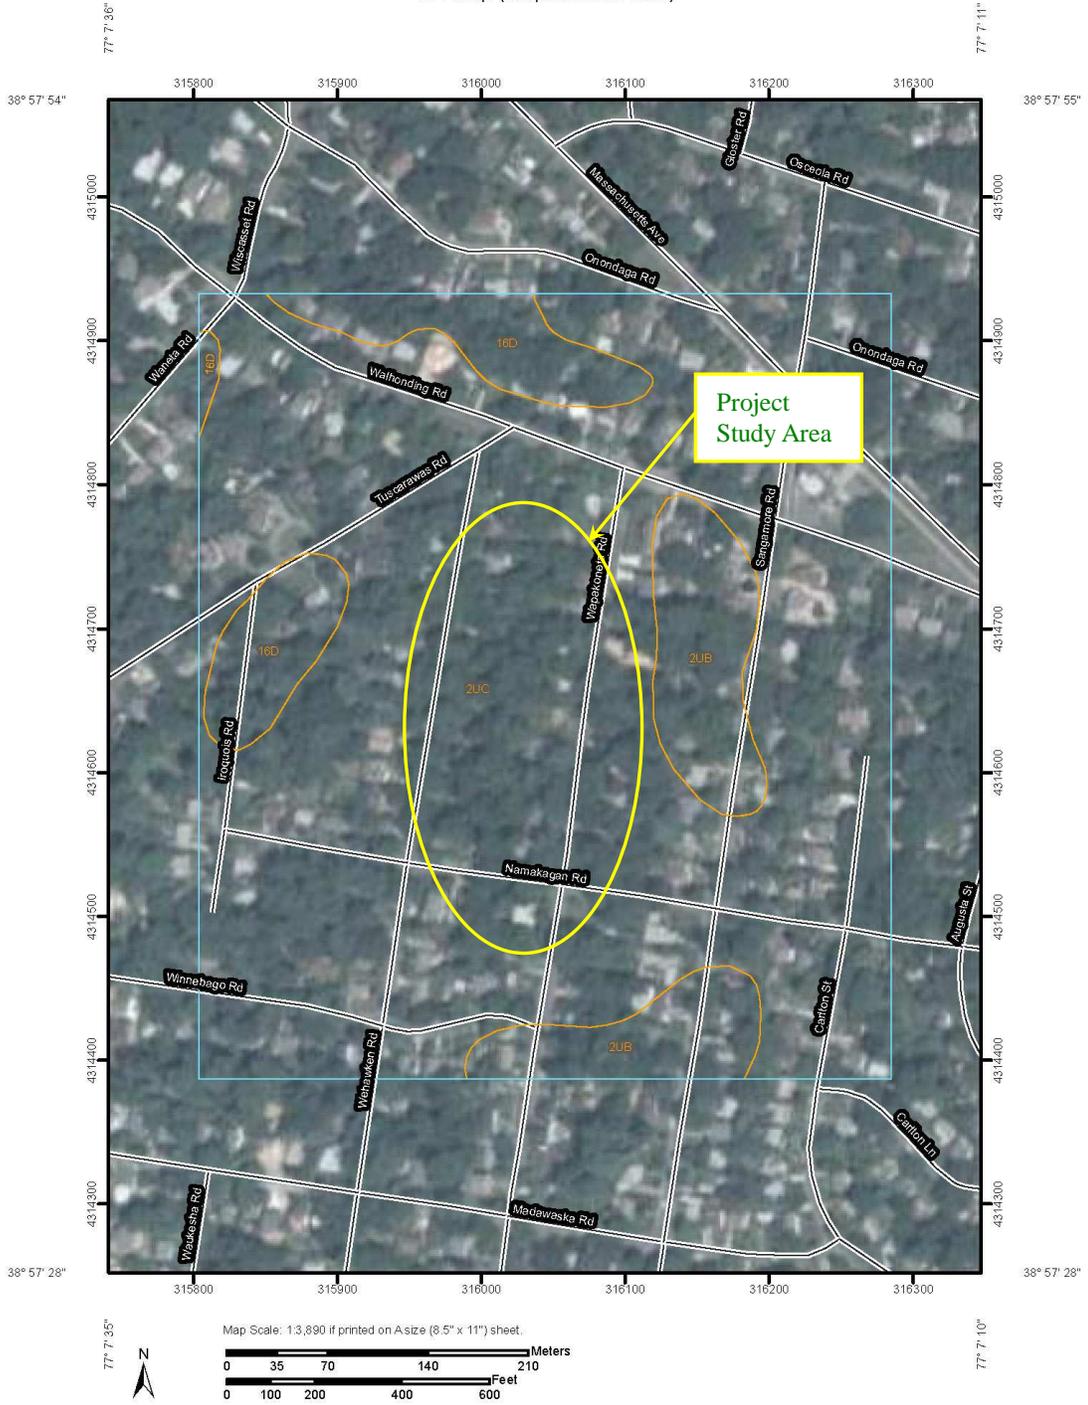
Figure 3: Soils Map

A review of the United States Department of Agriculture Web Soil Survey (USDA WSS) of Montgomery County (accessed 09/19/2012) revealed the presence of Glenelg silt loam within the project study area. Table 1 identifies the soils and their characteristics.

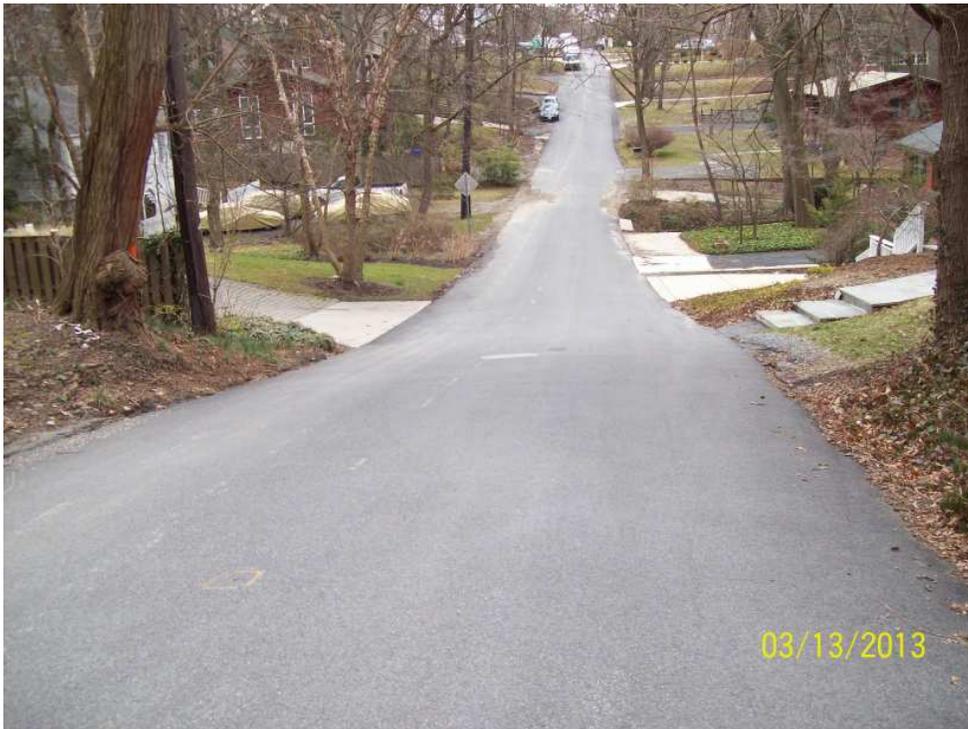
Photograph #1 View of Wapakoneta Road

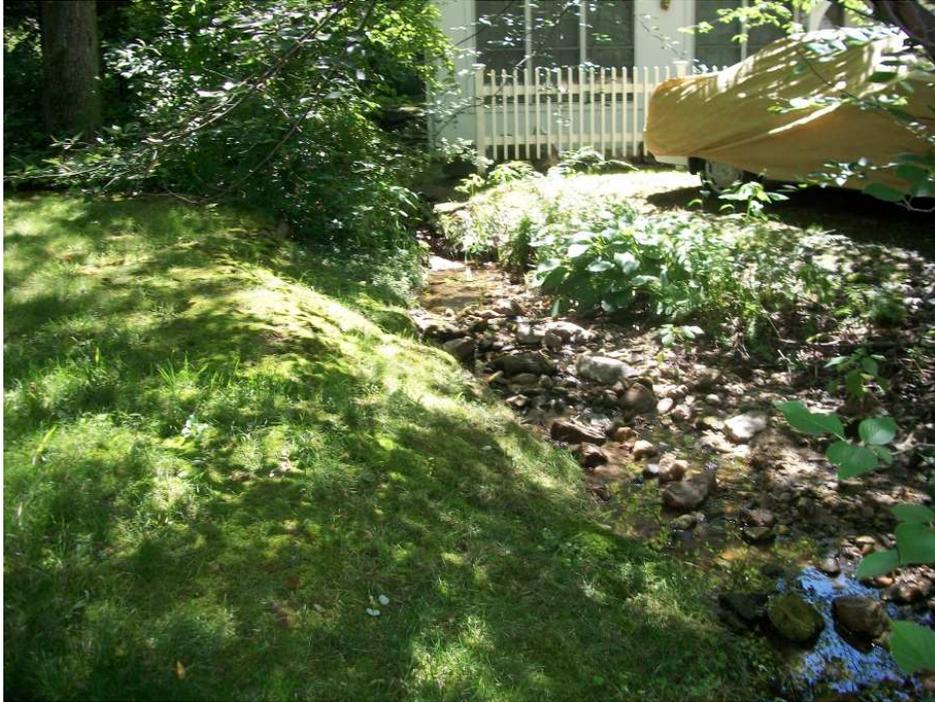
portions of the stream channel. The stream originates from a groundwater seep in the backyard of 6022 Walhonding Road and continues through the backyards of 5332 Wapakoneta Drive, 5413 Wehawken Road, 5409 Wehawking Road, passes through a culvert under Wekawken Road and daylights across the street at 5409 Wehawken Road. The ordinary high water mark was delineated and surveyed as “Waters of the US” and confirmed with the Maryland Department of Environment on January 23, 2013.

Photograph #2 View of the stream at 5409 Wekawken Avenue

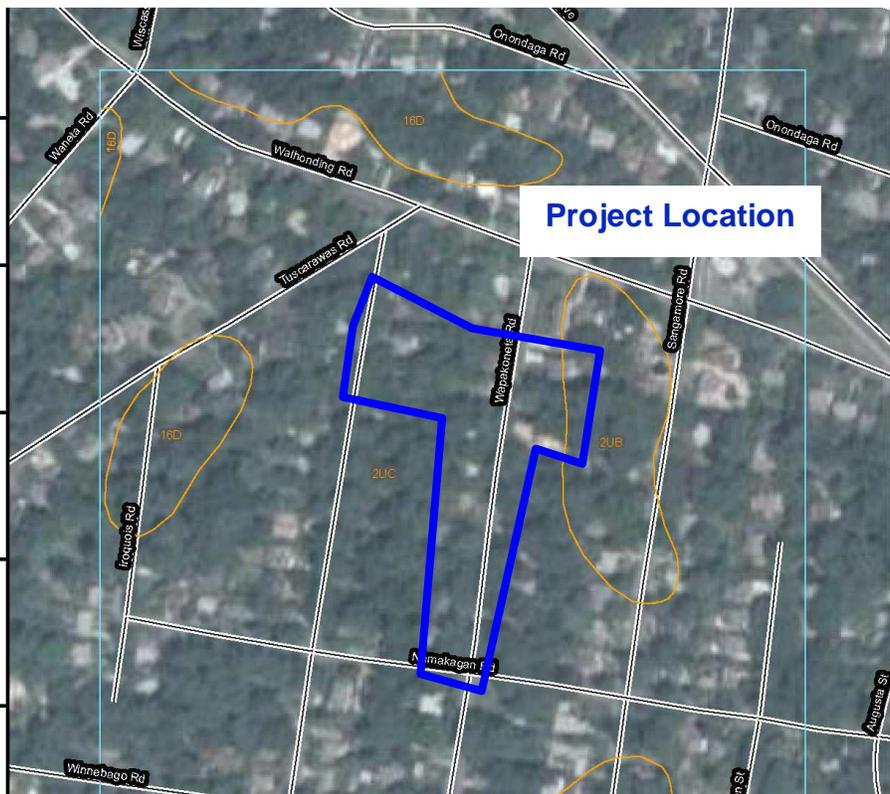
Figure 3: Soils Map

An off-site wetland and waterways investigation was performed using the United States Geological Survey (USGS) Topographic Map (Figure 2), United States Department of Agriculture, Natural Resource Conservation Service, Montgomery County, Maryland, (Figure 3)

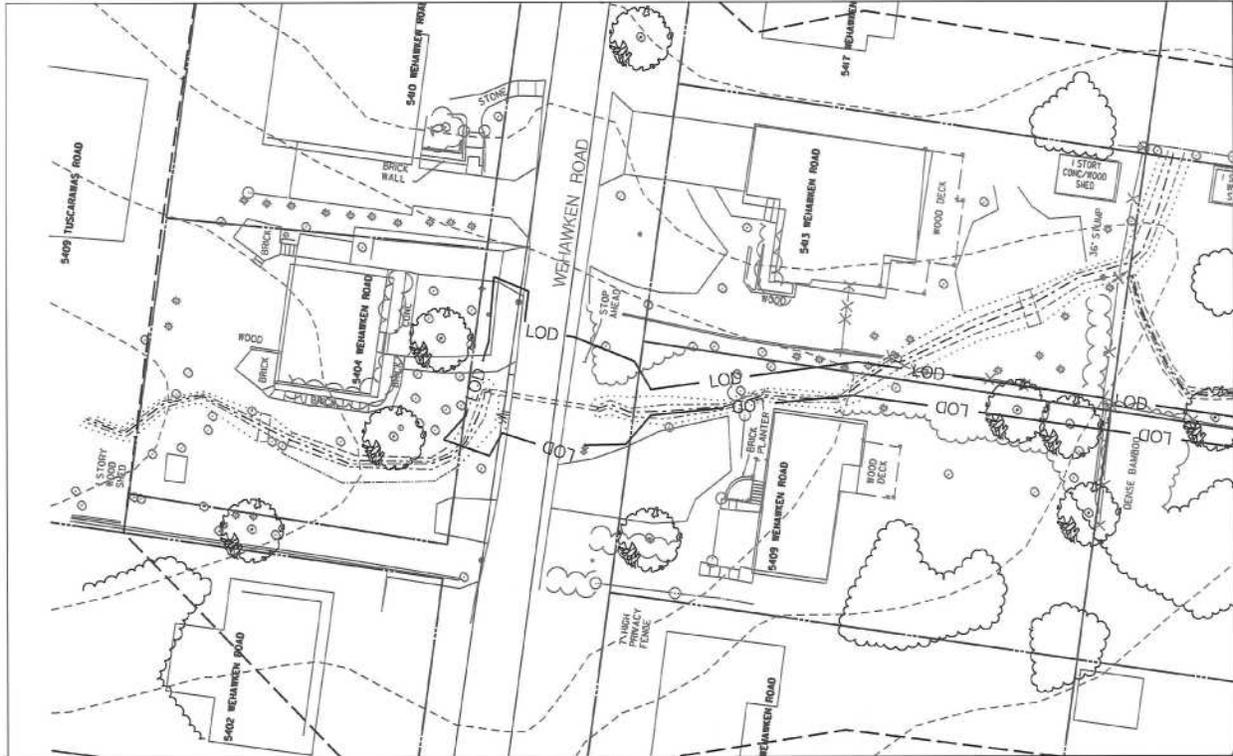
A routine on-site wetland and waterways investigation was performed to verify the existing secondary data information. The entire project area has been disturbed in the past by residential development. No wetlands were identified during the on-site investigation. Although no waterways were identified during the off-site investigation, one waterway was identified during the on-site investigation. This waterway consisted of a shallow defined channel edged with landscape stone. Sediments consisted of sand and gravel; vegetation was also present with portions of the stream channel. The stream originates from a groundwater seep in the backyard of 6022 Walhonding Road and continues through the backyards of 5332 Wapakoneta Drive, 5413 Wehawken Road, 5409 Wehawking Road, passes through a culvert under Wekawken Road and daylights across the street at 5409 Wehawken Road. The ordinary high water mark was delineated and surveyed as "Waters of the US" and confirmed with the Maryland Department of Environment on January 23, 2013. The location of the delineated stream is shown in Figure 4. Photographs 1 and 2 illustrate the character of the stream in the upstream and downstream portions of the project.

Figure 4: Surveyed boundary of Stream Channel

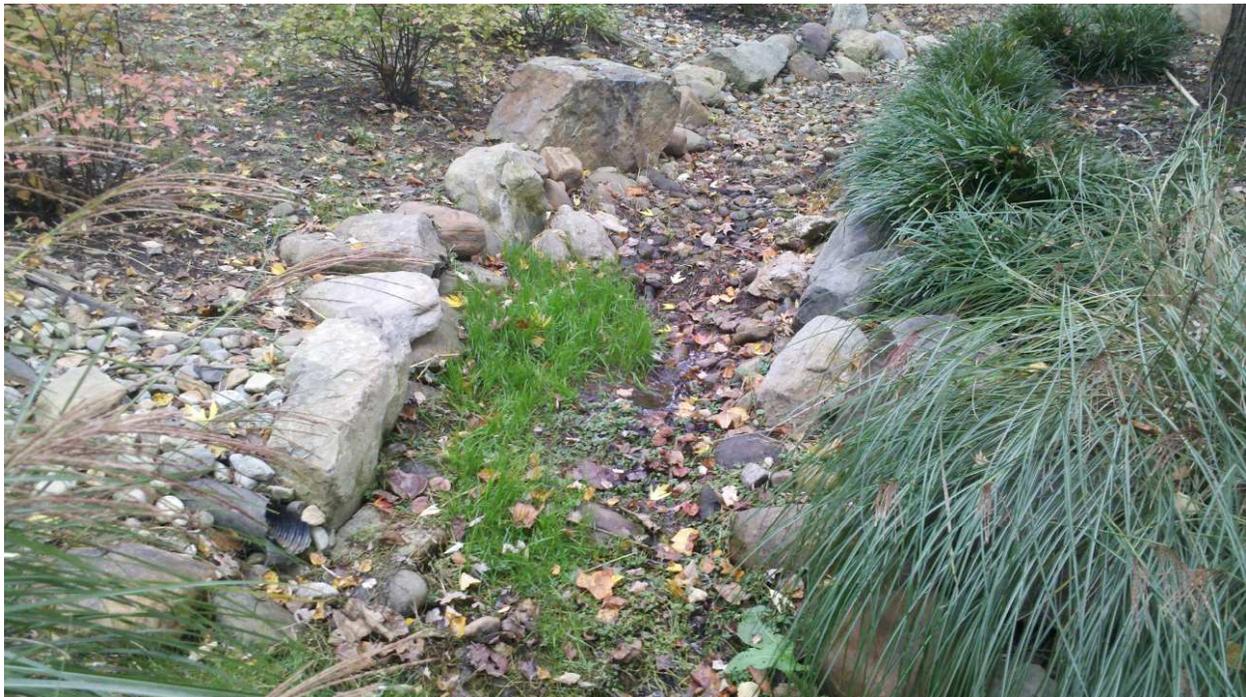
Photograph #1: View of headwater/seep portion of the stream channel

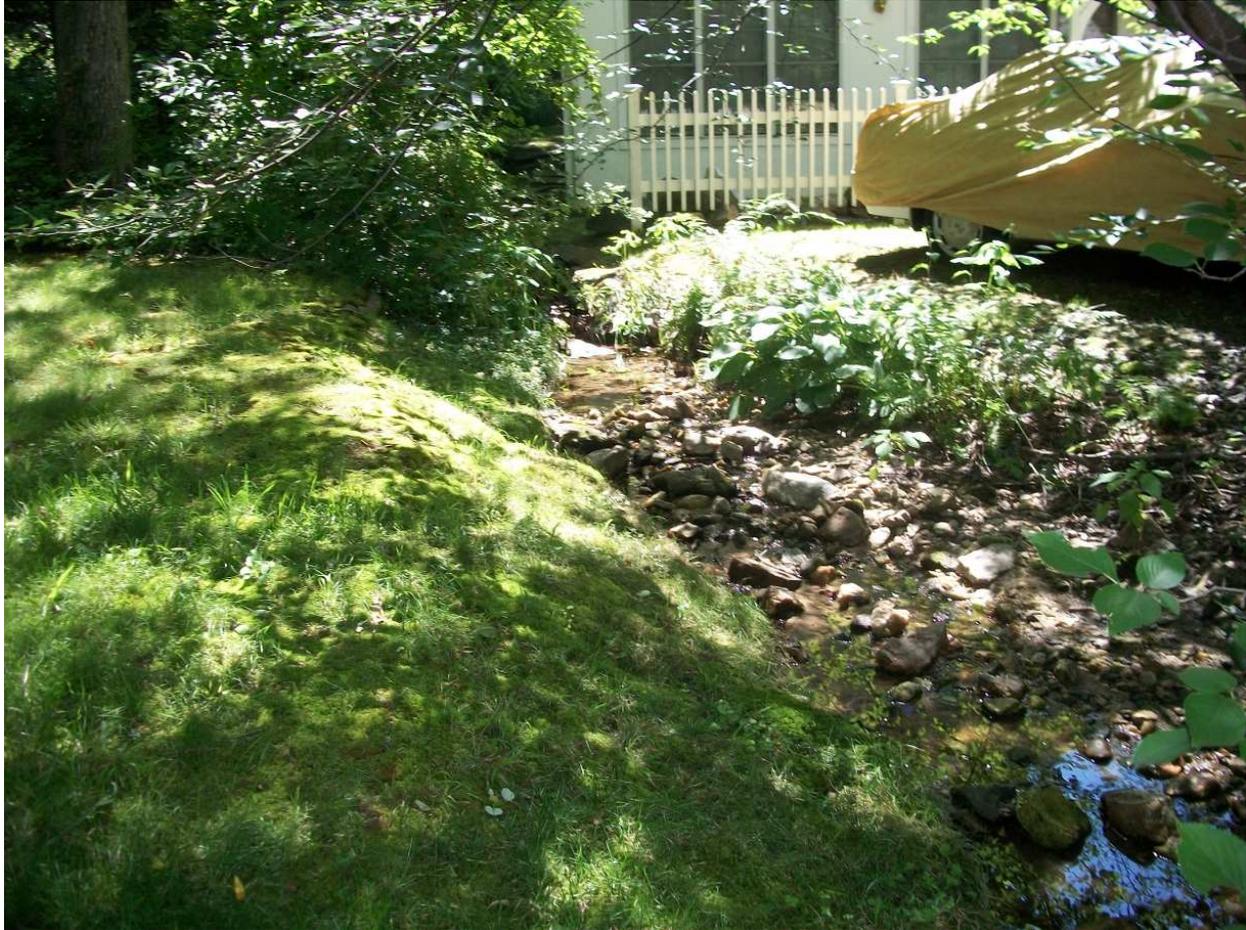
Photograph #2: View of the stream at 5409 Wekawken Avenue.
