Northwest Branch

3.4 Dumont Oaks Stream Restoration

3.4.1 Introduction

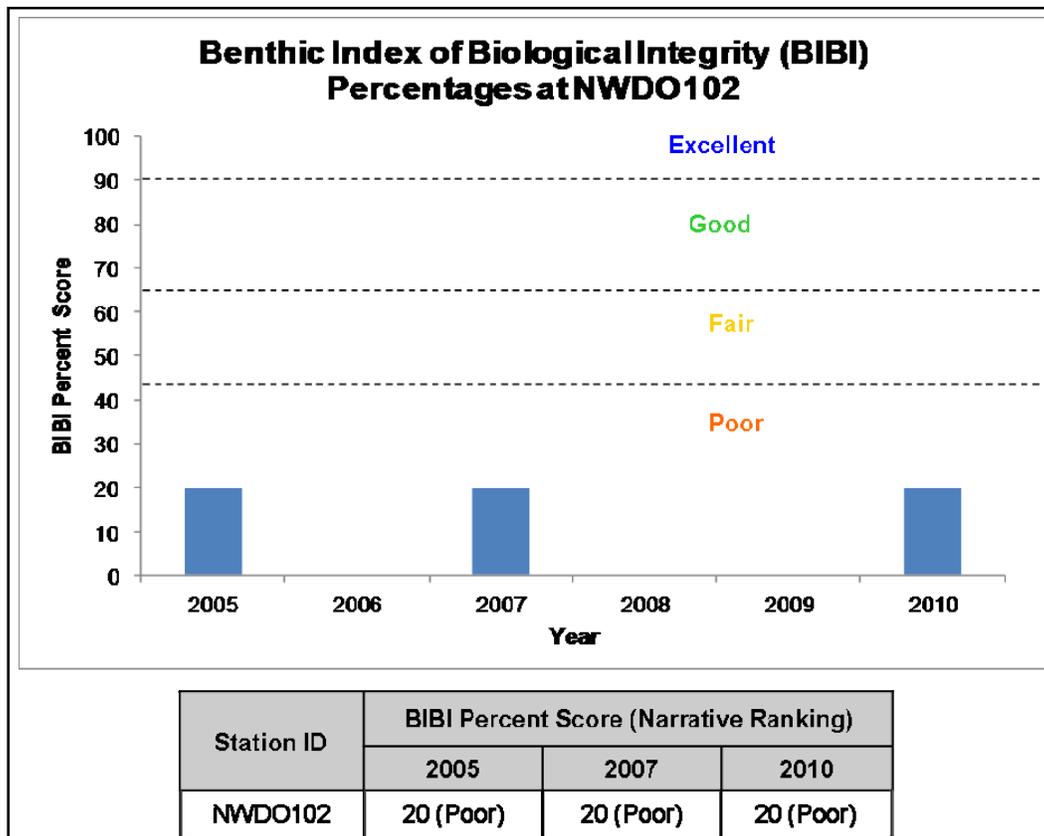
Figure 3.4.8 –Post-Restoration Benthic Index of Biological Integrity (BIBI) Percentages at NWDO102

The benthic macroinvertebrate community at NWDO102, as assessed using the MCDEP Benthic Index of Biological Integrity (BIBI), was rated as Poor, scoring the lowest possible BIBI percentage (20) during each monitoring year in the post-restoration period (*Figure 3.4.8*). In 2005, too few benthic macroinvertebrate individuals were collected to calculate an accurate BIBI, the site was therefore given the lowest possible score for that year. In both 2007 and 2010, NWDO102 was heavily dominated by the family Chironomidae (midges), specifically from the subfamily Orthocladiinae, with nearly 75 percent and 84 percent of the community represented by this subfamily, respectively. Field data sheets from 2010 benthic macroinvertebrate monitoring are included in *Appendix D*.

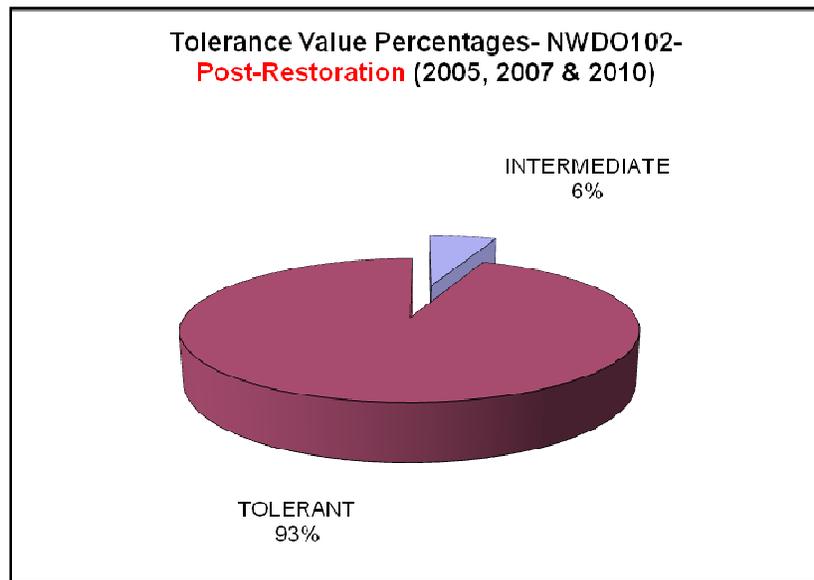
Figure 3.4.9– Benthic Macroinvertebrate Tolerance Composition at NWDO102 After Restoration

Site NWDO102 was dominated by (93 percent) tolerant taxa following restoration, with 6 percent of the community represented by taxa intermediate in sensitivity (**Figure 3.4.9**). The tolerant taxa were represented by midges and several families of aquatic worms in the Subclass Oligochaeta. Intermediate taxa were represented by net spinning caddisflies, *Simulium* sp. (blackflies), *Tipula* sp. (craneflies), and *Bezzia* sp. (biting midges).

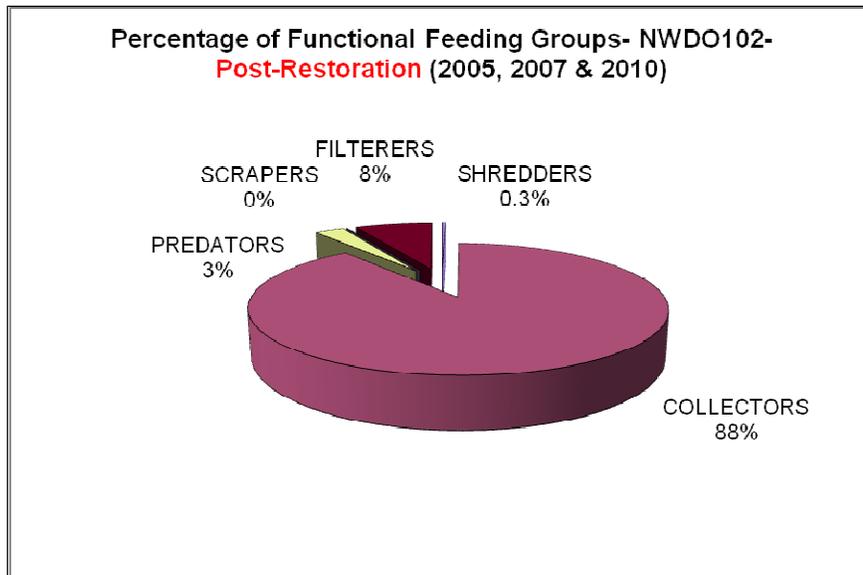
Figure 3.4.10 – Benthic Macroinvertebrate Functional Feeding Group Composition at NWDO102 After Restoration

Collectors were the most dominant functional feeding group at NWDO102 after restoration, representing 88 percent of the community. The remainder of the community consisted of filterers, predators, and shredders, which comprised eight percent, three percent, and 0.3 percent of the community, respectively. Specialized feeders, including scrapers and shredders that require less degraded stream conditions or specific habitat features, were present in only minor amounts (less than one percent) after restoration (**Figure 3.4.10**).

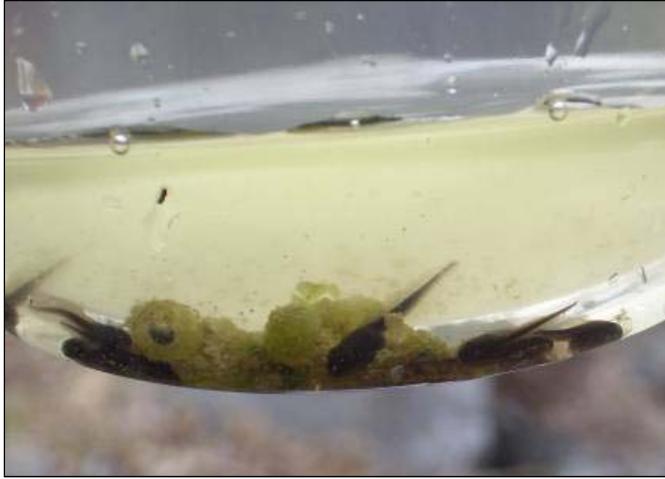
Figure 3.4.12 – Wood Frog Tadpoles and Eggs Found at NWDO102 in 2007

2009. In 2005, three spotted salamander egg masses and 23 wood frog egg masses were observed during the site visit. Herpetofauna were documented again in 2007, including 12 spotted salamander egg masses and over 50 wood frog tadpoles (**Figure 3.4.12**). One adult spotted salamander was also found in the periphery of the pool (**Figure 3.4.13**).

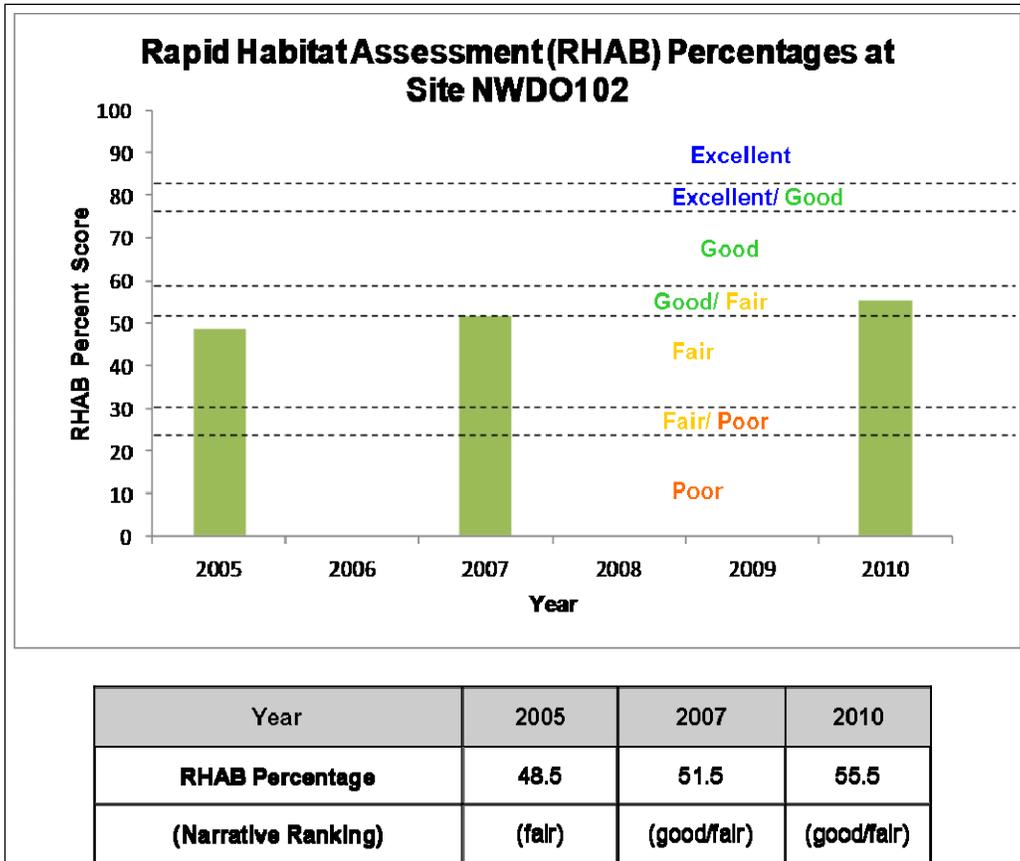
Figure 3.4.15 –Post-Restoration Rapid Habitat Assessment (RHAB) Percentages at NWDO102

Post-restoration aquatic habitat was evaluated at NWDO102 in the spring of 2005, 2007, and 2010. RHAB percentages were in the Fair range in 2005 (48.5), but improved slightly to the Good/Fair range in 2007 (51.5) and 2009 (55.5). **Figure 3.4.15** shows aquatic habitat scores after restoration occurred at NWDO102.

Following restoration, aquatic habitat conditions were mostly within the Good/Fair range. Habitat conditions were generally suboptimal, with 50 percent or greater of the stream substrate surrounded by fine sediment, and only marginal protection of streambanks by riparian vegetation. The benthic macroinvertebrate community was rated as Poor, having the lowest possible percentage in all years, which likely indicates that improvements were not translated to the community with the restoration activities. The benthic macroinvertebrate community may be limited by the stream water quality at this site since the watershed in which the Dumont Oaks tributary flows is highly urbanized. In its current state, the basin is likely not able to assimilate impacts from impervious surface runoff or treat all of the contaminated stormwater without implementation of watershed-wide stormwater management improvements. Another possible explanation for the consistently poor condition of the benthic community is that re-colonization potential is limited. Benthic macroinvertebrates are more sedentary than fish, and predominantly recolonize from short distances upstream or via flying adults laying their eggs. Artificial introduction of healthy communities of benthic macroinvertebrates may be considered an option for this stormwater wetland and stream in the future.

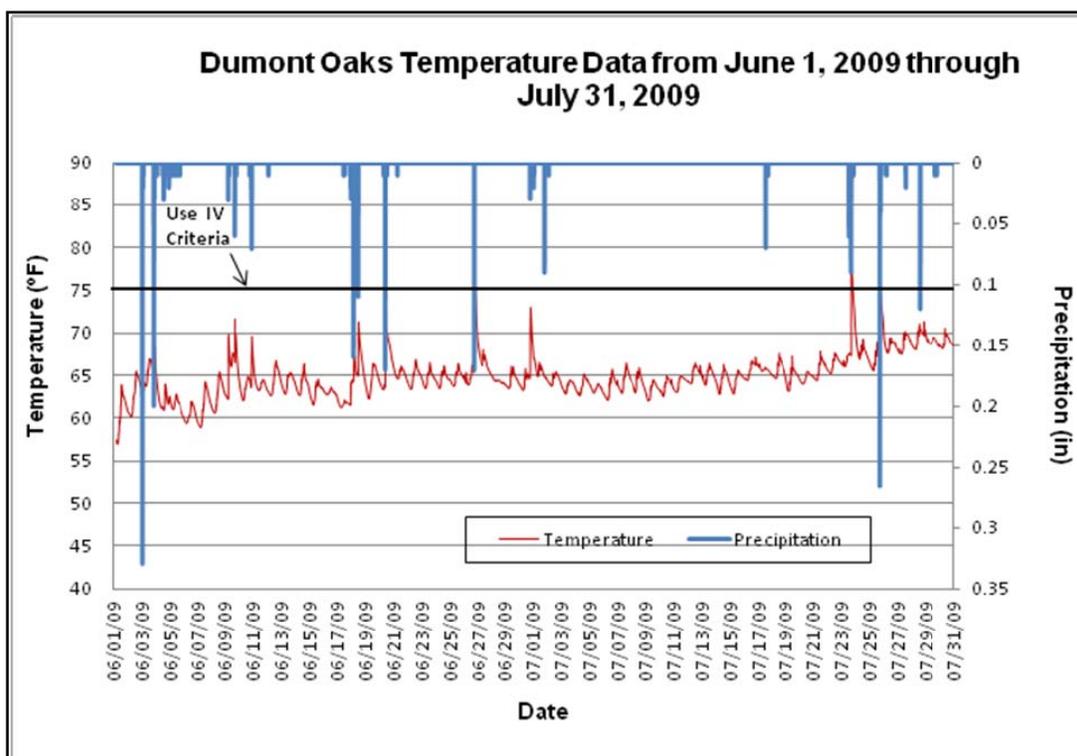
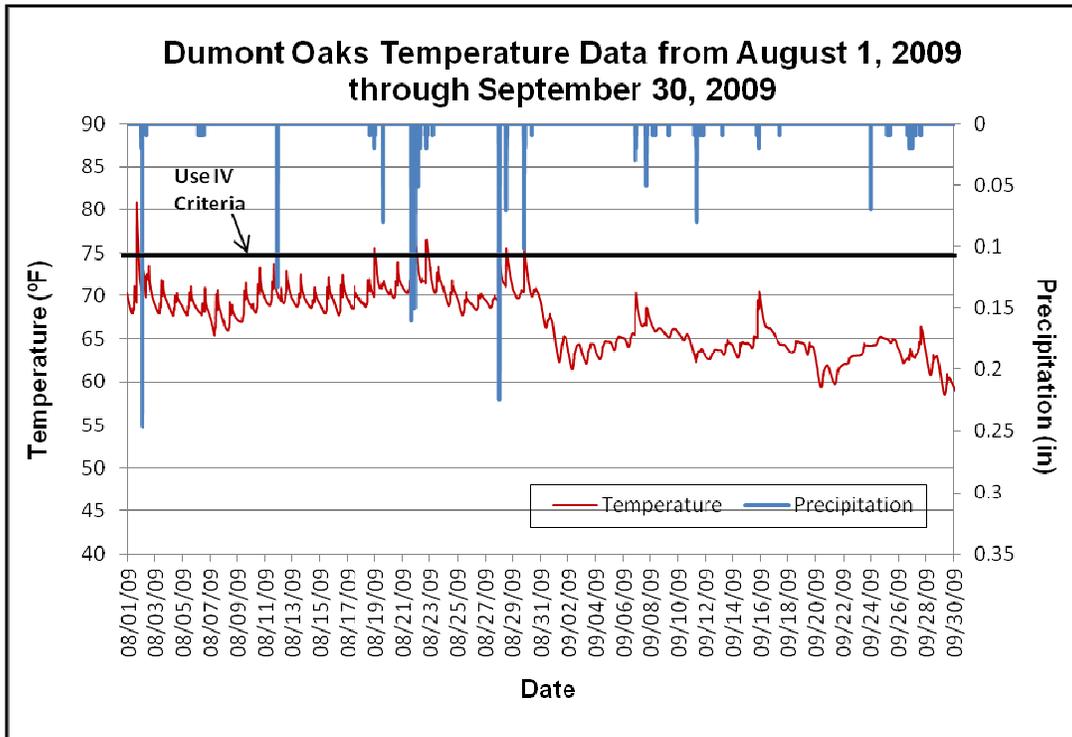
Figure 3.4.18 – Stream Temperature at NWDO102 from June 1, 2009 through July 31, 2009

Date	2005	2007	2009
Average (°F)	69.3	67.3	65.8
Min (°F)	54.3	53.4	57.0
Max (°F)	81.7	77.9	80.8
Percentage of readings exceeding Use IV standard (75 °F)	6.0	0.5	3.0

The goal of avoiding introduction of new thermal impacts into the tributary cannot be determined at this time. No temperature data is available upstream of the stormwater pond to compare the stream temperature flowing into the pond with the temperature flowing out of the pond, and baseline temperature data were not collected to compare pre- and post-restoration thermal regimes. However, during each monitoring year, the average temperature below the pond was below the Use IV temperature standard. It is recommended that one additional logger be placed upstream of the pond in the future and the logger station downstream of the pond be re-established to determine whether the pond is causing thermal impacts to its receiving stream. If temperature is significantly higher below the pond, then remediation measures may be advisable. It is also recommended that mowing and trimming around the pond be minimized to allow trees, shrubs, and pond-side vegetation to grow uninhibited to provide better pond shading. Without greater shading, it is unlikely that potential thermal impacts can be easily remediated.

It is recommended that a temperature monitoring site be established upstream of the pond and this site, as well as the downstream site, be monitored for another year to determine whether the pond is causing thermal impacts to its receiving stream. It is also recommended that mowing and trimming be minimized around the pond to allow trees, shrubs, and pond-side vegetation to grow uninhibited to provide better pond shading. Without greater shading, it is unlikely that any thermal impacts detected can be easily remediated.
