## 3.21 Sycamore Creek Stream Restoration

### 3.21.1 Introduction

#### *Subwatershed facts*

#### *Project Facts*

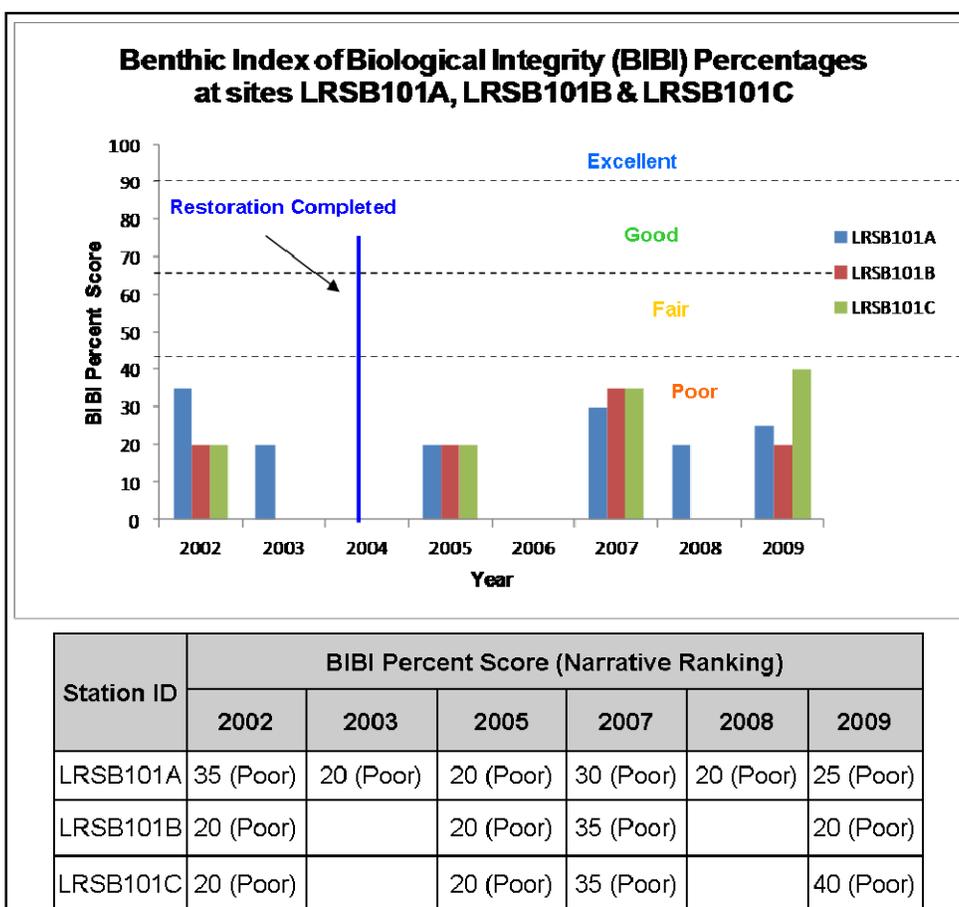
**Figure 3.21.8 - Pre- and Post-Restoration Benthic Index of Biological Integrity (BIBI) Percentages at LRSB101A, LRSB101B, and LRSB101C**

All benthic macroinvertebrate percent scores remained in the Poor range at the three Sycamore Creek sites after restoration. Each site showed an increase in BIBI percent score in 2007 but both LRSB101A and LRSB101B decreased in 2009, while the BIBI percent score at LRSB101C increased. Site LRSB101C showed a gradual improvement in BIBI percentage from 2005 to 2009. The increase in BIBI percentages in 2007 was due to the presence of one EPT taxon at

each site; no EPT taxa were collected in the project area in 2005 and only one was collected in 2009, at LRSB101C. All sites also had an increase in the ratio of scrapers to scrapers plus filter feeding collectors in 2007, contributing to the increase in BIBI scores in that year. Scrapers need periphyton to feed and are considered a more specialized functional feeding group than collectors and are therefore more sensitive to disturbance. Generally, these sites were comprised of macroinvertebrates that reflect a disturbed condition. An improvement in overall benthic community composition after restoration activities was only apparent at the downstream site, LRSB101C through 2009.

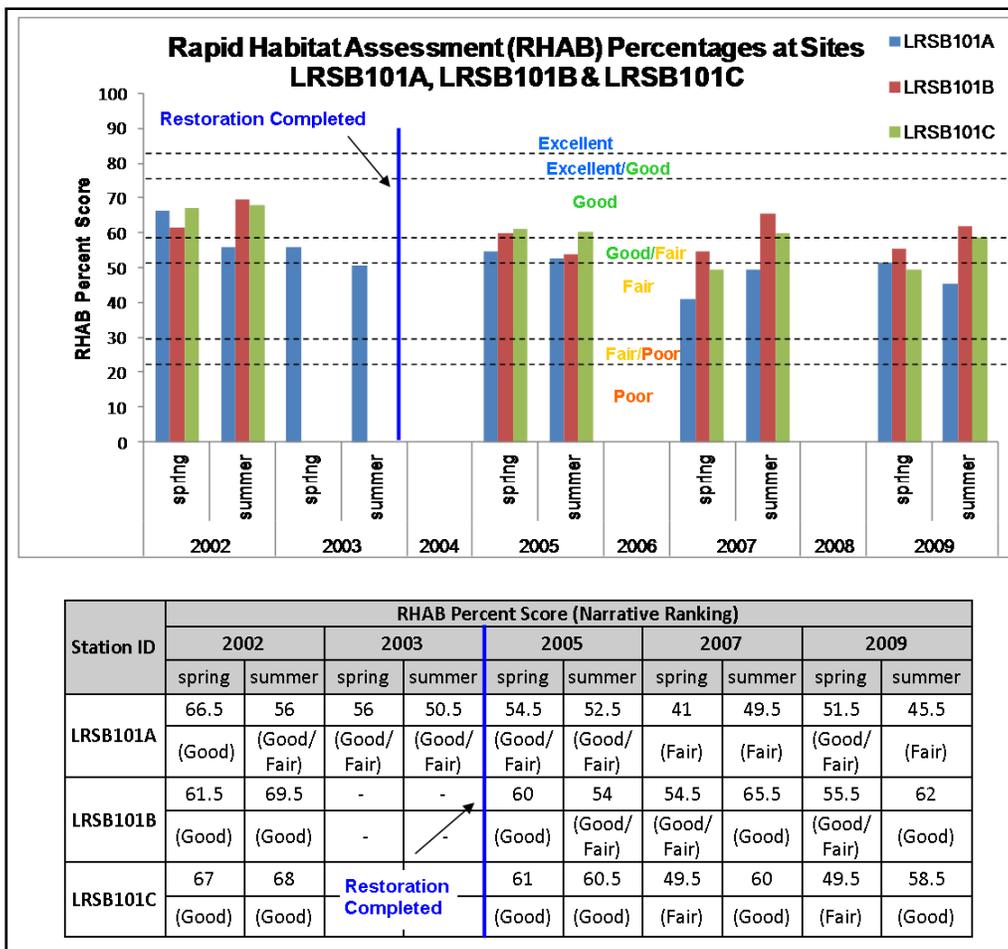
Pre-restoration qualitative habitat was evaluated at LRB101A, LRSB101B, and LRSB101C in the spring and summer of 2002, and also at LRSB101C in the spring and summer of 2003. Scores prior to restoration were mostly in the Good range at all Sycamore Creek sites, with LRSB101A scoring a little lower than others during the summer of 2002 (**Figure 3.21.36**). In-stream cover, the habitat category associated with fish habitat, was generally assessed as having “adequate habitat for maintenance of populations”. Benthic macroinvertebrate habitat was generally rated as suboptimal, with the two sites lower in the watershed, LRSB101B and LRSB101C scoring slightly higher. Riffles occurred fairly frequently at all sites, and sediment deposition was rated as minor to moderate, with LRSB101B being less affected by sediment deposition. The streambanks in the project area were moderately stable to moderately unstable and the vegetated buffer at LRSB101A and LRSB101B were moderately impacted by human activities.

**Figure 3.21.36 – Pre- and Post-Restoration Rapid Habitat Assessment (RHAB) Percentages at LRSB101A, LRSB101B, and LRSB101C**

Post-construction qualitative habitat scores declined slightly from pre-restoration conditions and were generally in the Good, Good/Fair, and Fair ranges at the three Sycamore Creek sites. In-stream cover and epifaunal substrate rankings for fish and benthic macroinvertebrate habitat were mostly in the lower suboptimal and upper marginal ranges at LRSB101A, a decline from the pre-construction period. At LRSB101B epifaunal substrate scores were also in the lower suboptimal and upper marginal ranges, also declining from the pre-restoration period. However, in-stream cover scores were slightly higher at LRSB101B than they were in the pre-restoration period. LRSB101C had higher epifaunal substrate and in-stream cover scores than the other two sites on Sycamore Creek, mostly in the suboptimal range; assessed as providing adequate habitat for fish and having riffles with an abundance of cobble. Occurrence of riffles declined from the pre-construction period at all sites after construction, while sediment deposition increased with moderate to heavy sediment deposition noted at LRSB101A and LRSB101C. Site LRSB101B had slightly better sediment deposition scores but was still assessed as having moderate deposition and more than was assessed prior to restoration. Channel flow status was fairly consistent among sites with approximately 75 percent of the channel being filled with water. Streambanks at all three Sycamore Creek sites were moderately stable. Vegetation covered approximately 50 to 70 percent of the banks at all sites and patches of bare soil were apparent. Overall, post-restoration qualitative habitat scores were slightly lower than pre-restoration

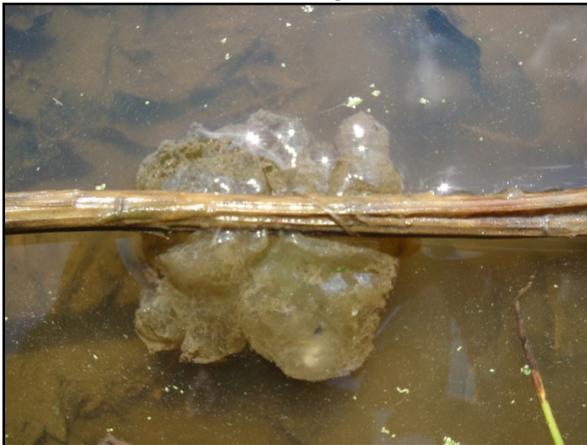
**Figure 3.21.39 – Vernal Pool 2 at LRSB101B showing spotted salamander egg mass**

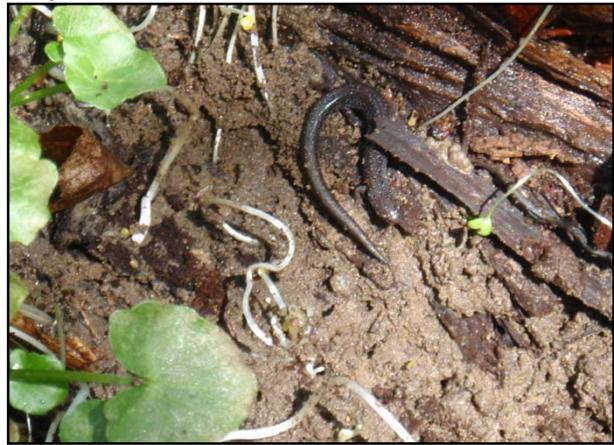
65 feet long by 26 feet wide. Emergent, herbaceous vegetation was found growing, primarily at the downstream end of the vernal pool and included softstem bulrush, and water lily or *Sagittaria sp.* (arrowhead) (**Figure 3.21.38**). Common rush and lesser celandine were found growing on the banks. Logs and a few smaller tree limbs were also observed in the vernal pool and were noted as potential attachment sites for egg masses. Three *Ambystoma maculatum* (spotted salamander) egg masses were found within the pool (**Figure 3.21.39**). *Pseudacris crucifer crucifer* (spring peepers) were heard calling from the pool and one adult was observed outside the pool. Two *Plethodon cinereus* (Eastern red-backed salamanders), in the leadback phase, were found under logs during the search around the perimeter of the vernal pool (**Figure 3.21.40**).

**Figure 3.21.40 – Perimeter of Vernal Pool 2 at LRSB101B, showing Eastern red-backed salamander in lead-back phase**
