# Pedestrian Road Safety Audit

## University Boulevard (MD 193) and Colesville Road (US 29)

Montgomery County, Maryland

**July 2011**

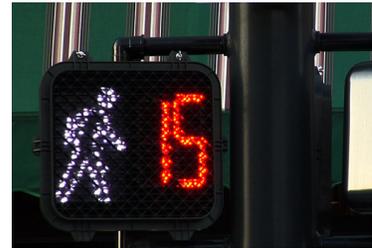
- *Countdown pedestrian signals:* Pedestrian signals with countdown indicators are used at the intersections of Colesville Road at University Boulevard eastbound (EB) and westbound (WB). Countdown signals have also been installed at the University Boulevard crossover at Lexington Avenue (to the east of Colesville Road), but not at the University Boulevard crossover to the west of Colesville Road. Countdown pedestrian signals have been found to reduce pedestrian injury crashes and improve pedestrian compliance to traffic controls in several national studies.

Photo of a countdown signal

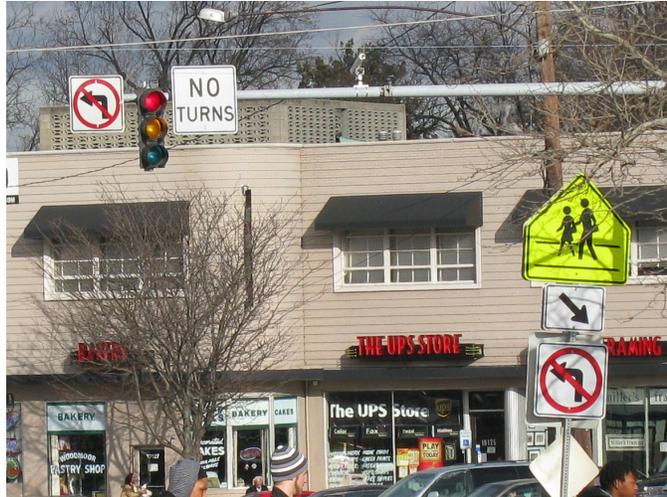
Figure 8: Left-turn Restrictions

- *Lane Configuration:* The separated east-west lane configuration of University Boulevard at Colesville Road reduces the number of turning movement conflicts between vehicles at these intersections. Additionally, left-turns from Colesville Road onto University Boulevard are prohibited, effectively eliminating all left-turn conflicts between vehicles on Colesville Road and University Boulevard. The lane configuration reduces the number of turning-movement conflict points between vehicles, pedestrians, and bicyclists at each intersection.

Left-turn restrictions at Colesville Road and University Boulevard WB

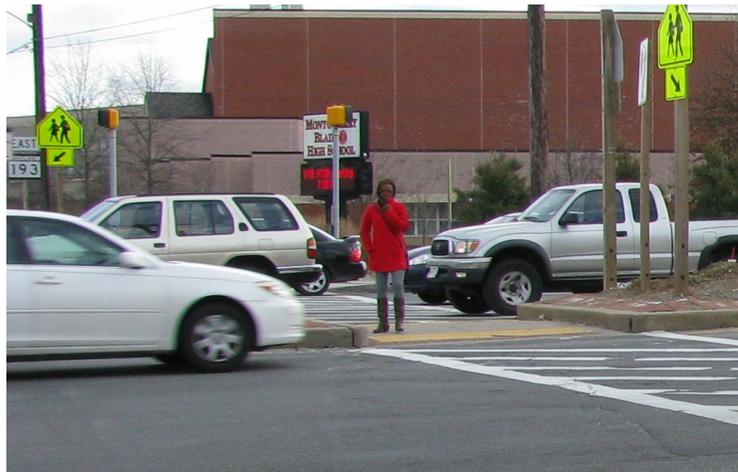
Figure 9: Colesville Road Median Refuge

- *Raised Median:* A raised median, approximately 8 feet wide, is provided along Colesville Road through the study area. Although the county's pedestrian signals are timed to allow pedestrians to cross the entire the width of the roadway, this median provides a refuge for pedestrians that may disregard the pedestrian signal and begin crossing at a time other than during the WALK phase of the pedestrian signal. At the Colesville Road intersections with both University Boulevard eastbound and westbound, the ends of the median are capped by diverter islands that provide a physical separation between vehicles in the intersections and pedestrians in the marked crosswalks.

Pedestrian in median refuge on Colesville Road
