Piney Branch Road (MD 320) Pedestrian Road Safety Audit

Montgomery County, Maryland

April 2011

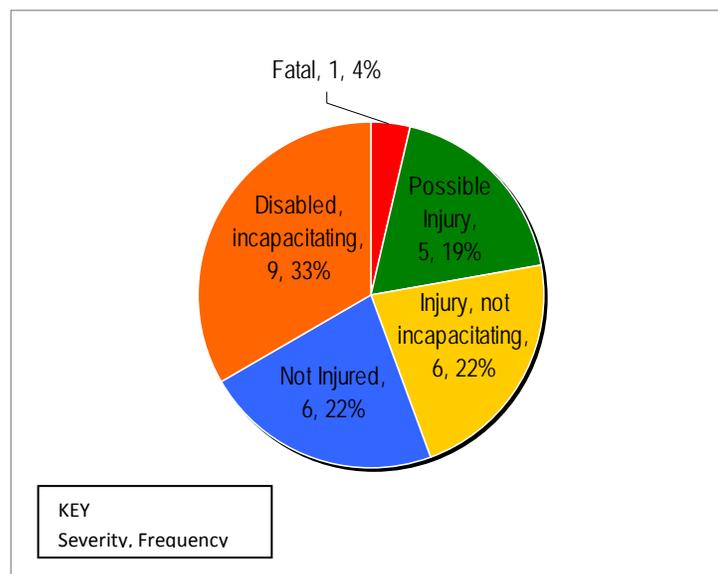
Figure 2: Pedestrian/Bicyclist Crashes by Severity

Crash data indicate that all of the pedestrian/bicyclist crashes resulted in injuries. One crash resulted in a fatality. As indicated in Figure 2, five of the 27 crashes resulted in possible injuries, 6 of 27 resulted in non-incapacitating injuries, 6 of 27 resulted in unknown degrees of injury, and 9 of 27 resulted in serious/disabling injuries. The consistent propensity for injuries associated with pedestrian crashes on this corridor supports the pursuit of additional pedestrian safety measures along the corridor.

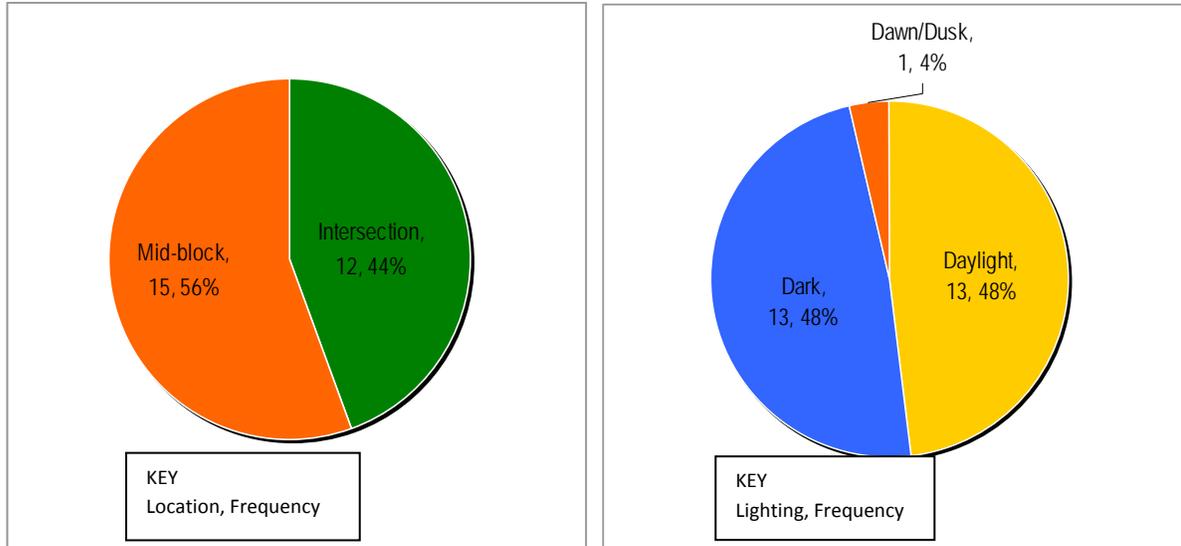
Figure 3: Pedestrian/Bicyclist Crashes by Corridor Location and Lighting Condition

Pedestrian/bicyclist crashes were equally distributed during the daylight and dark hours (13 crashes each), and one crash occurred during the dawn/dusk hours. The fact that there is an equal number of daylight and dark hour crashes is of notable concern, given that the volume of all traffic and the potential for conflicts is typically lower in the evening. This implies that there may be an overrepresentation of pedestrian-related crashes at night. Charts summarizing location and lighting are included in Figure 3. The majority of the pedestrian/bicyclist crashes (19 of 27) also occurred under dry road surface conditions. Totals of 7 of 27 and 1 of 27 crashes were reported under wet road surface conditions and unknown road surface conditions, respectively.
