# West Howard Avenue

Urban Design Study  
Kensington, Maryland  
Montgomery County  
Department of Housing and  
Community Affairs

October 2009

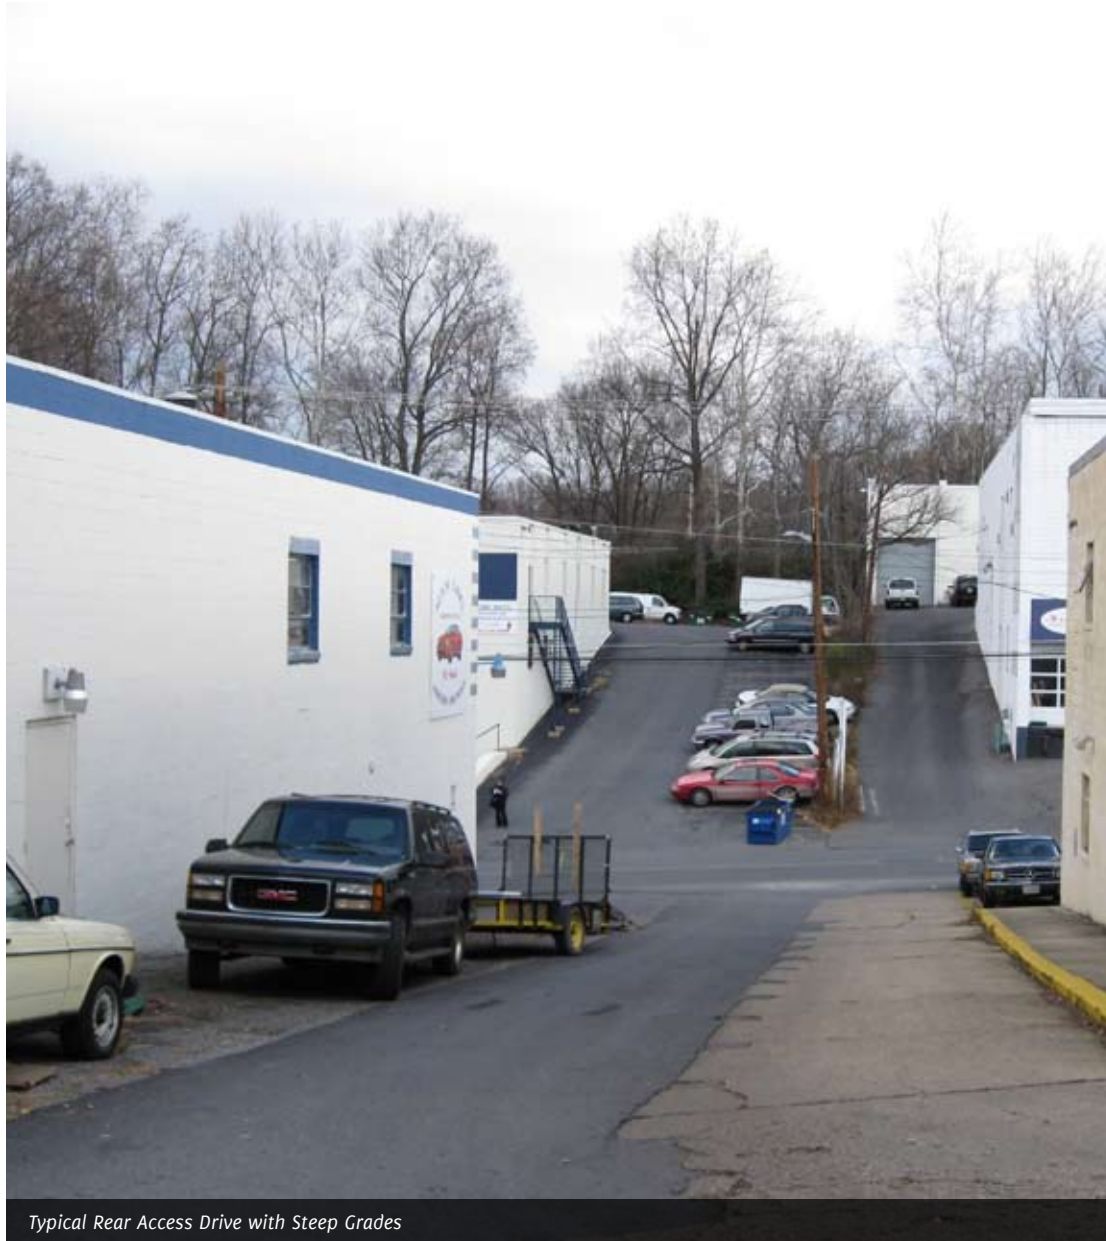
Typical Rear Access Drive with Steep Grades

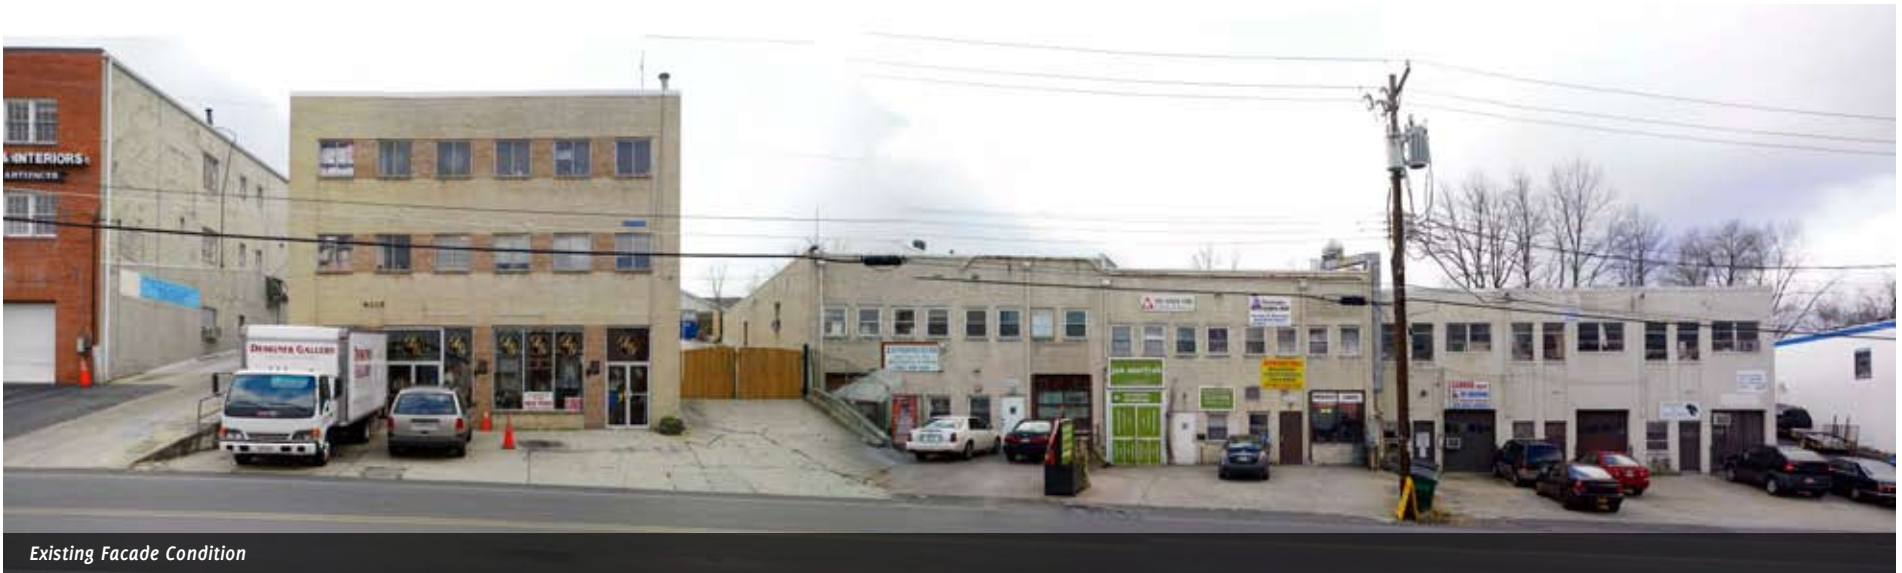
Existing Facade Condition

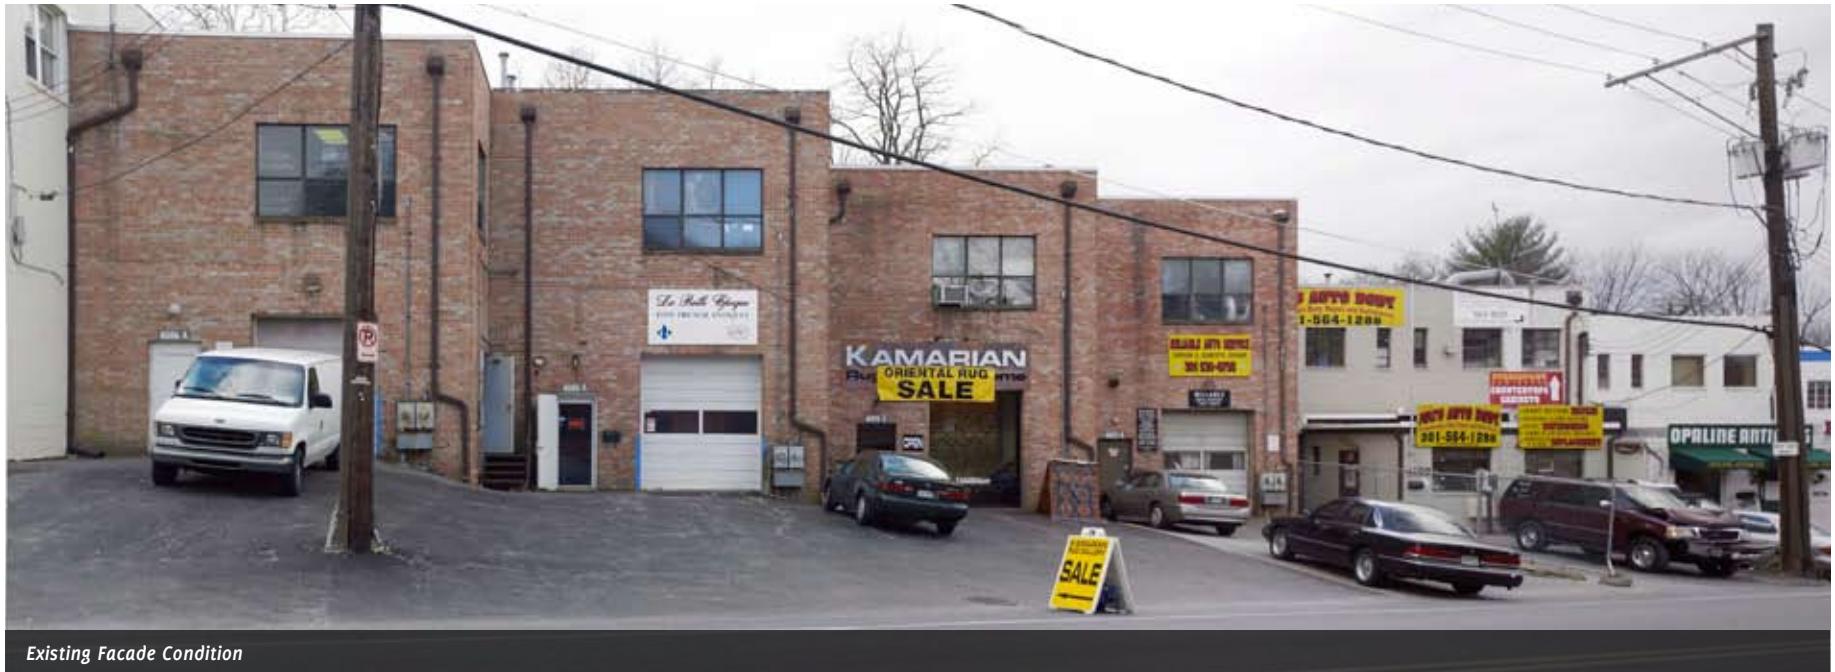
Existing Facade Condition

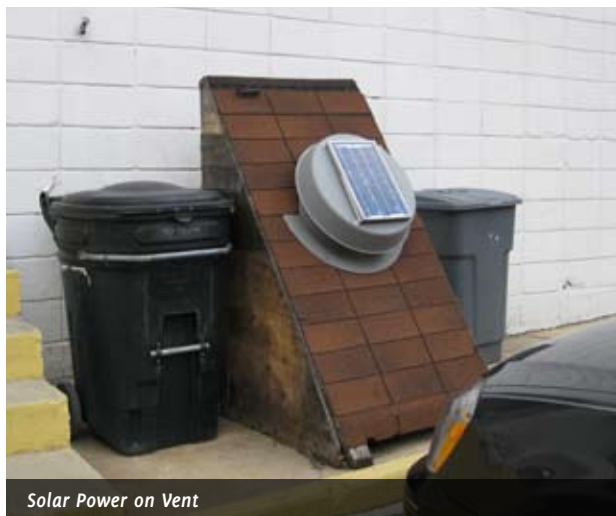
Solar Power on Vent

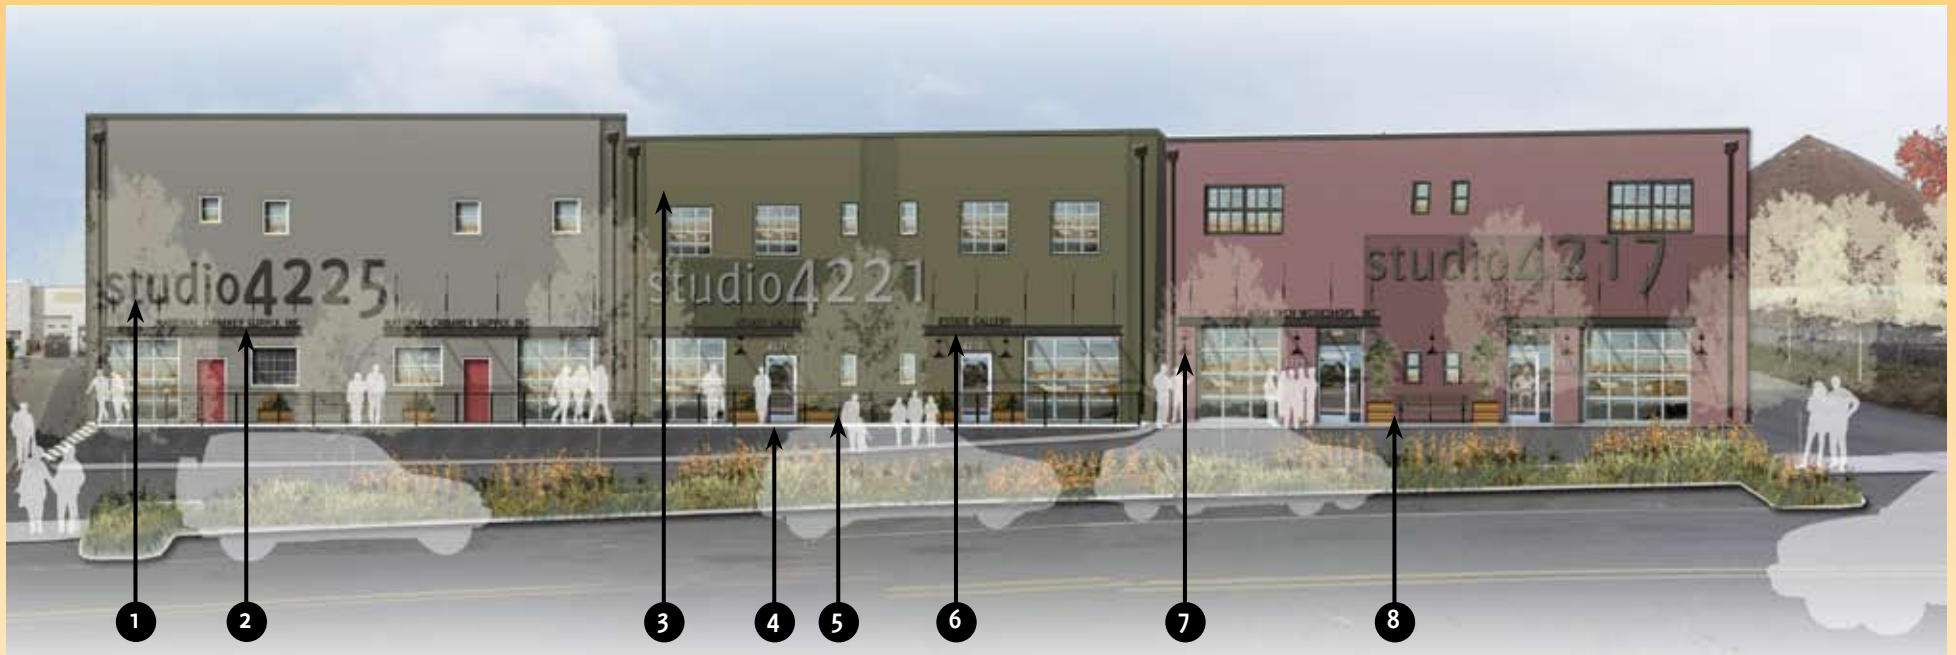
1. **Superscript Address Signage-** Bold and large lettering painted on the building's surface to provide clear indication of the building's location, and echo industrial era traditions.

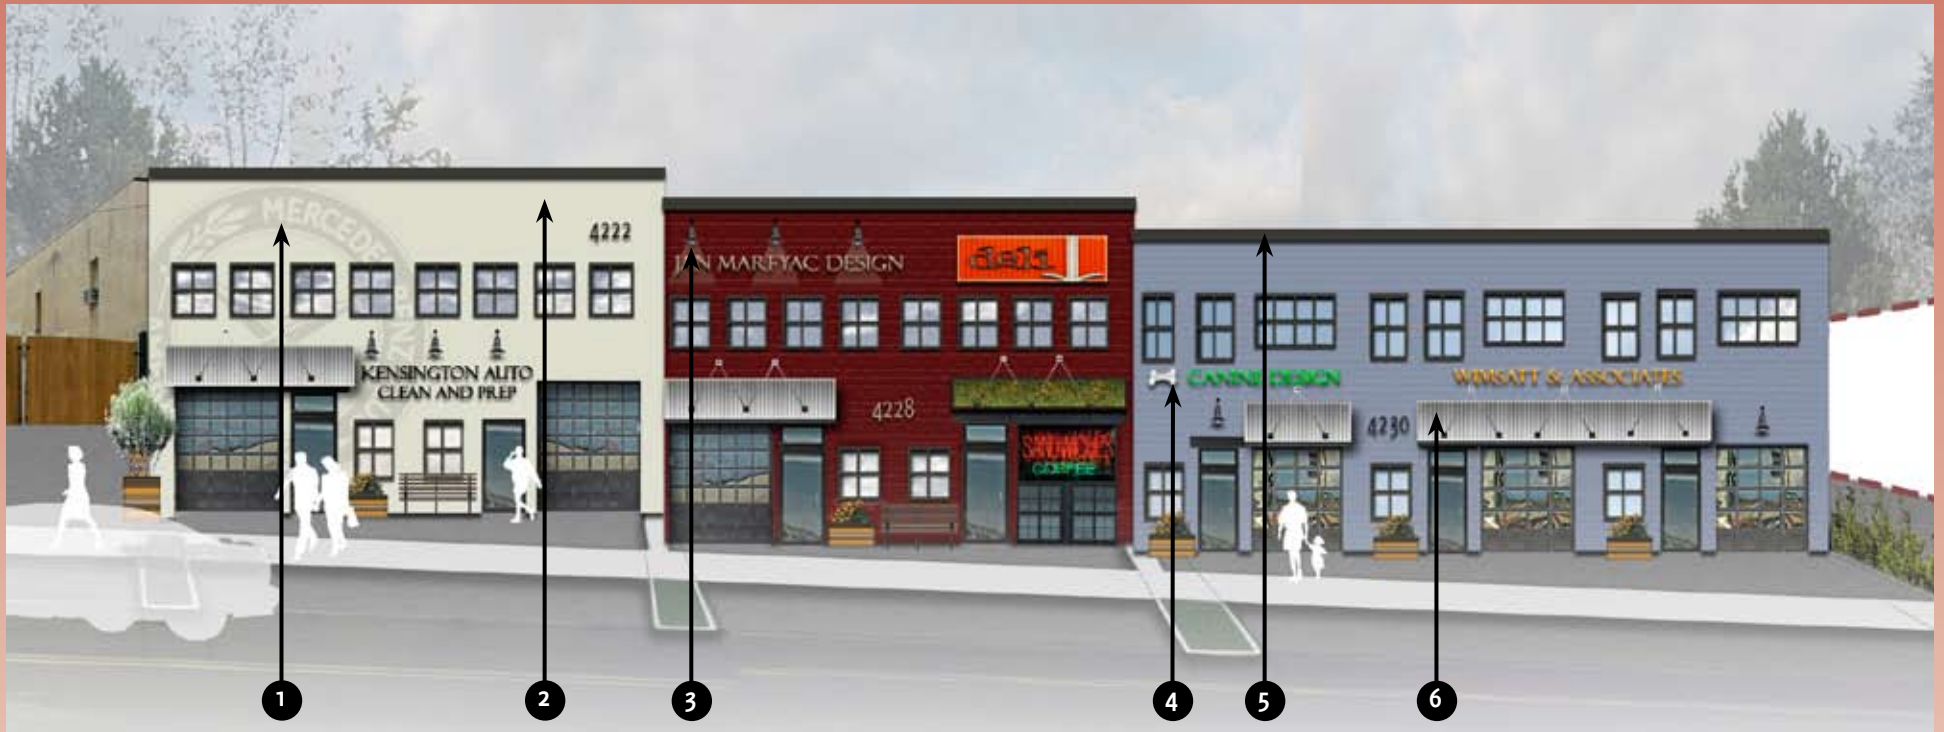
1. Painted Logos: Paint business logos onto facades.
2. Color : Paint facades using cool and bright colors.
3. Accent Lighting: Enhance the visibility of business signage by using backlighting, neon lighting or direct lighting.
4. Signage: Apply signage to the facade to bring order and break down the scale of buildings. Signs can range from simple metallic letters to durable (metal, or high-quality fabrics and plastics) sign boards with graphic imagery and text.
5. Cornice Line: Apply a contrasting and darker color to the cap of the building, distinguishing the upper edge of the building from the sky.
6. Canopies: Place canopies over store fronts and doors to reinforce frontage and add order to the facade.

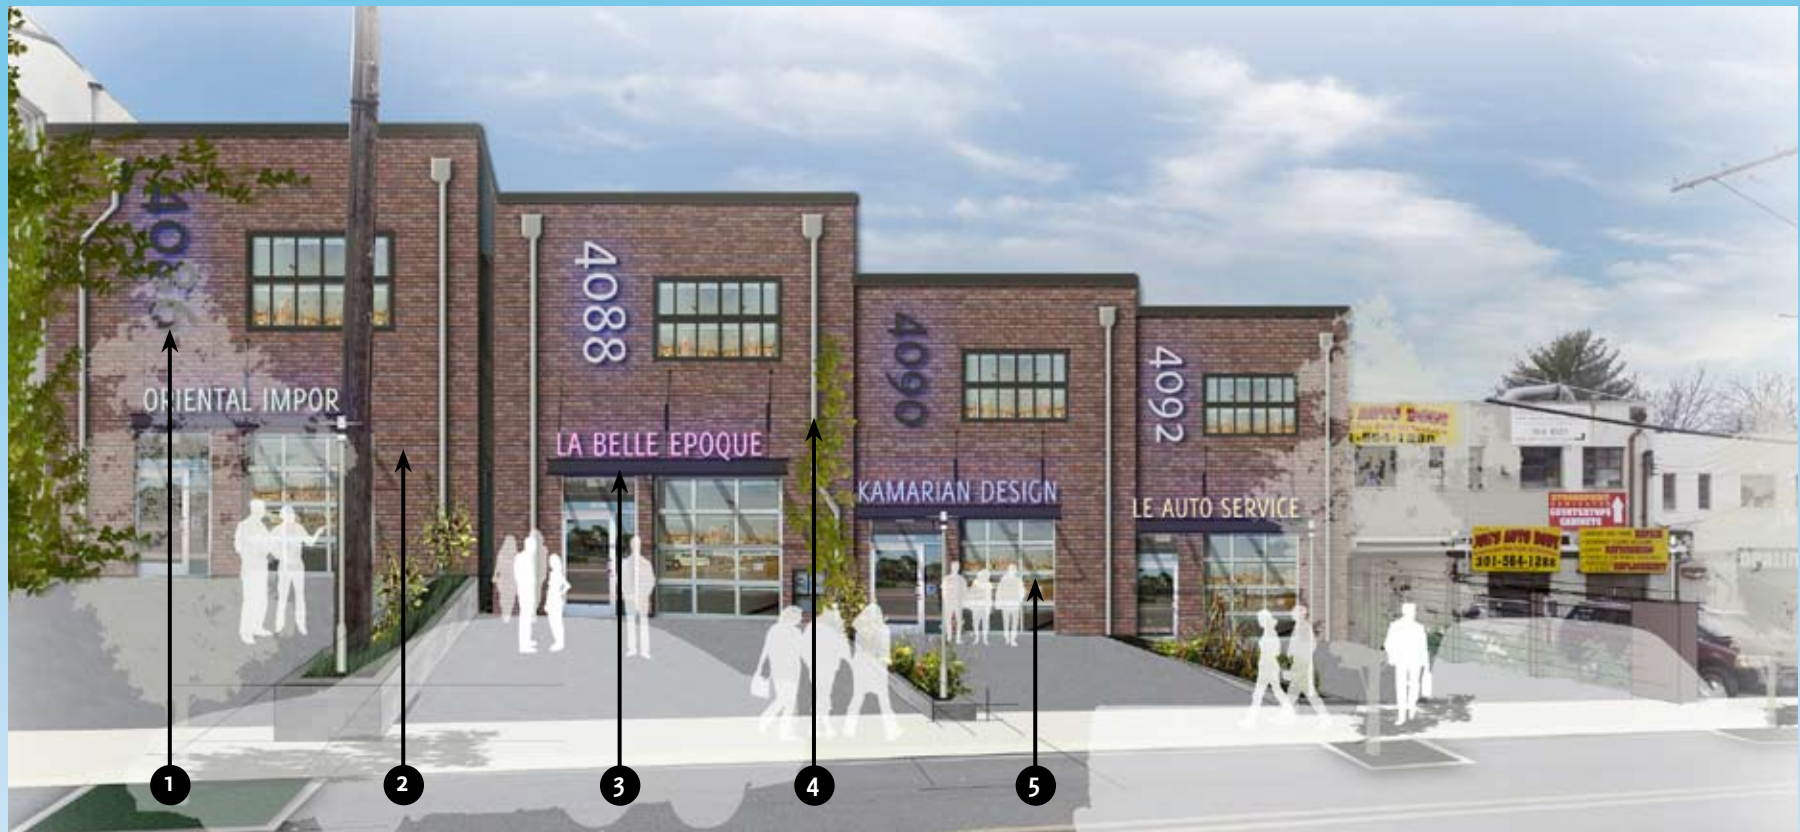
**1. Signage:** Apply superscript address numbers vertically on the building to contrast the horizontal nature of existing windows. Animate signs with vivid and bright colors and lighting to contrast the dark brick.

**2. Brick:** Repair and clean brick to express its natural color. This is most applicable to structures whose brick is in good condition and have an interesting color.

**5. Garage Doors:** Replace opaque doors with glazed doors to enlarge business transparency to the street. Where possible, replace garage doors with a storefront glazing system to provide better insulation.

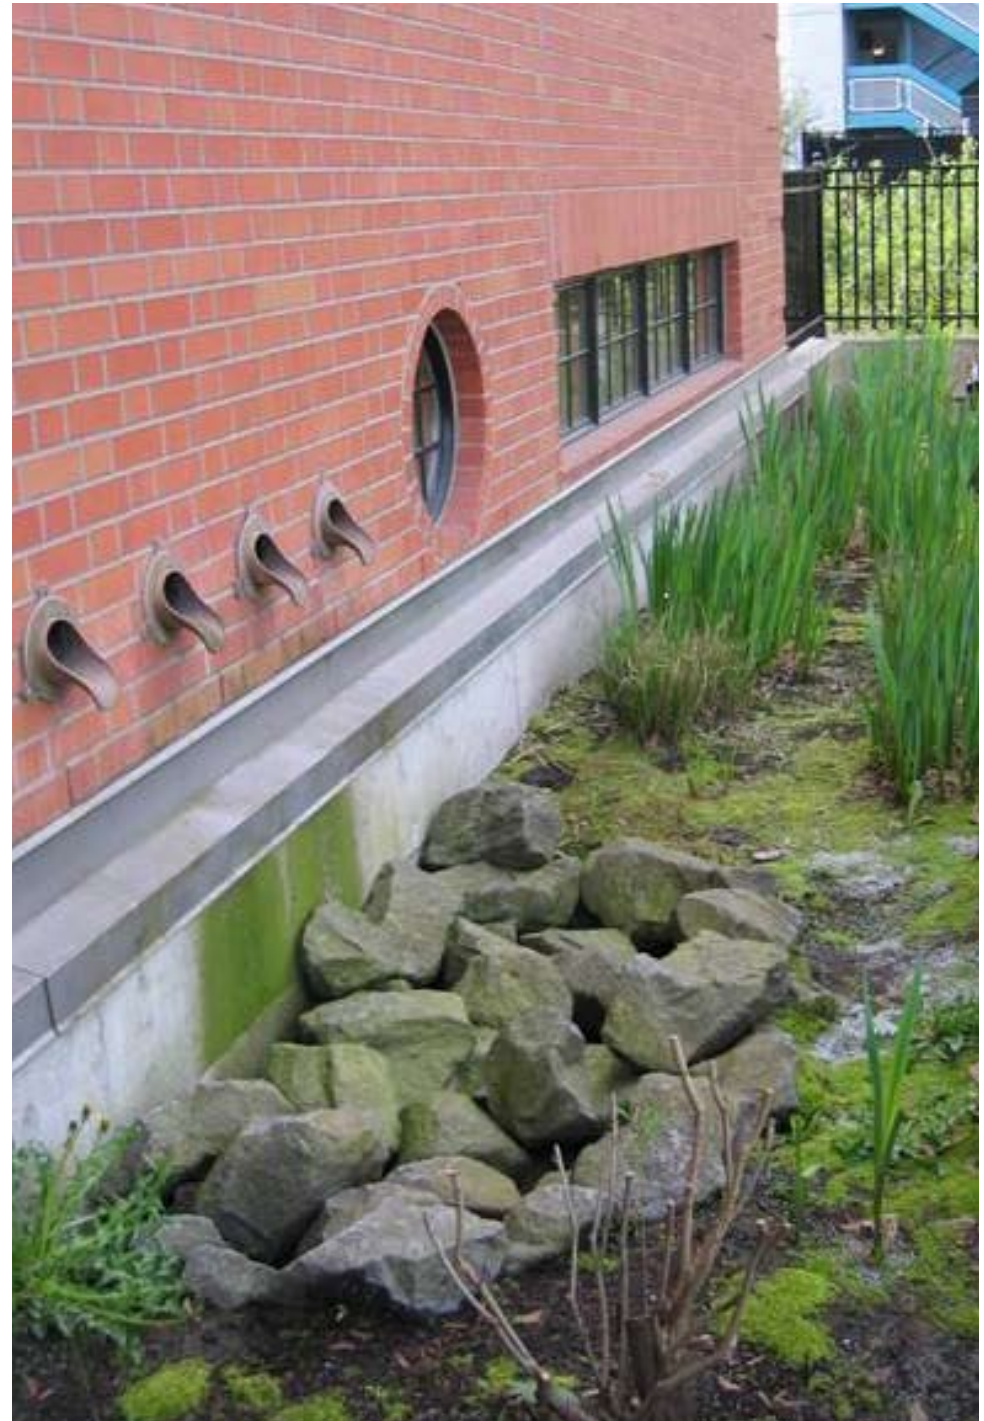
*Rain Garden*

1. Reduce surface imperviousness by introducing planting areas along West Howard Avenue and integrating planter boxes where removing the hardscape is not feasible.
2. Develop comprehensive stormwater management strategy within the street right-of-way with:
  - Sand Filter- locate beneath streets
  - Permeable Pavers- locate in areas of minimal impact, such as in areas for parking spaces
  - Biofiltration- locate along West Howard to serve both as a landscape and stormwater feature
  - Oversized pipes- locate beneath streets
3. Encourage off-site strategies to mitigate of stormwater runoff:
  - Rain gardens
  - Redirect downspouts to pervious areas
  - Green roof treatments

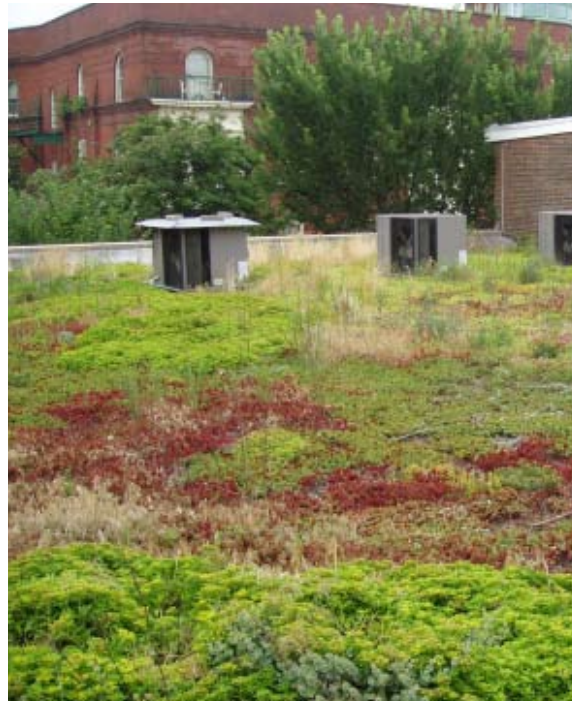
Green Roof

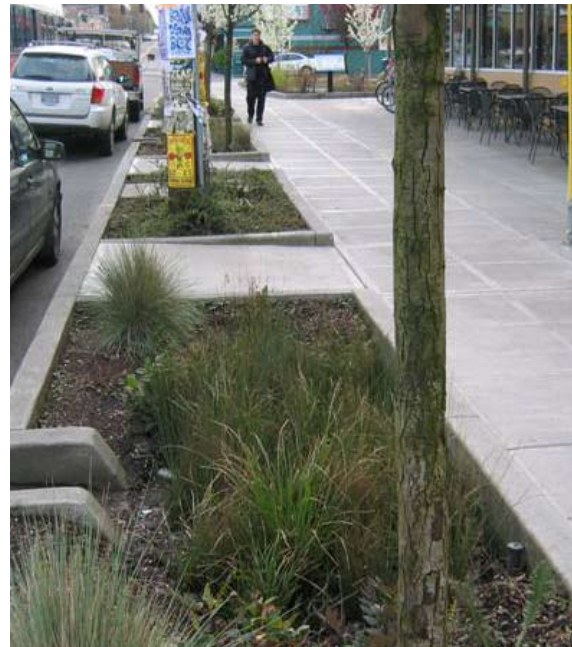
Bioinfiltration

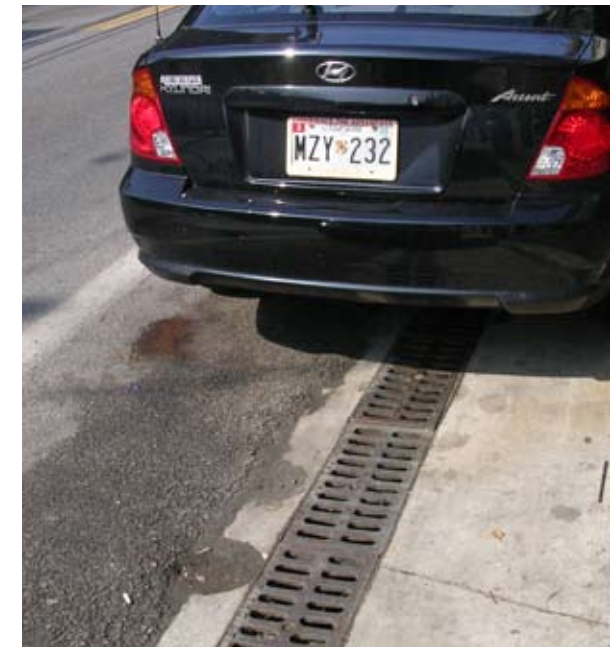
Drain to Underground Storage
