TO: Gude Landfill – Nature and Extent Study Report

SUBJECT: Post-Closure Care Monitoring and Maintenance

Topic: Landfill Gas Management - Chronology
Author: Stephen Lezinski, Engineer III, Montgomery County DEP/DSWS
Date: November 4, 2010

**Figure 3-4
EXISTING GUDE LANDFILL GAS EXTRACTION AND MONITORING SYSTEMS**

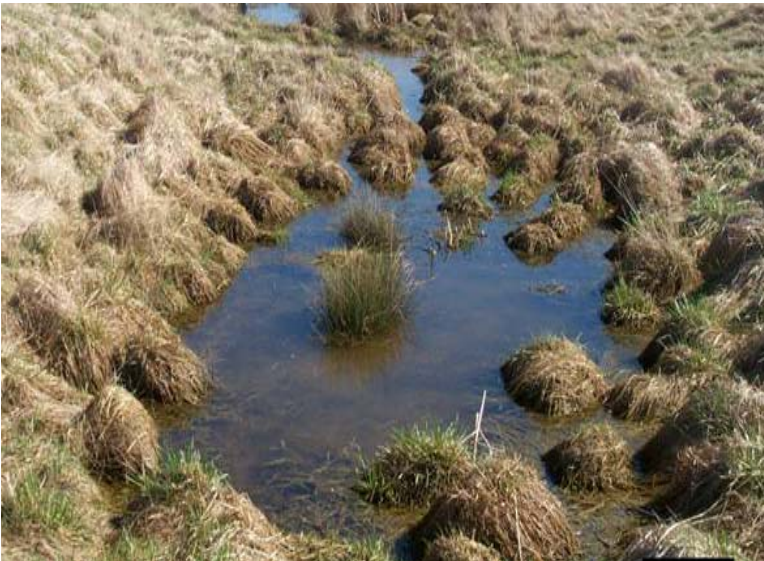
Photo 1 - Stormwater Ponding (before repairs)

erosion. Surface depressions on the Landfill are typically caused by differential settlement through natural decomposition of the waste mass. Surface depressions that contain ponding water or areas that exhibit erosion are regraded with soil to provide positive drainage, seeded and stabilized. These corrective measures help to reduce infiltration, prevent sediment dispersion and redirect runoff to existing swales and stormwater collection infrastructure. Other areas of the Landfill require additional maintenance measures that can include surface oriented infiltration trenches (filter fabric, stone and pvc pipe) to collect and redirect runoff. Refer to Photos 1-3 for documentation of typical cover system maintenances. Cover system maintenance occurred in: 2009 – January, February, March and July; 2010 – May and June.

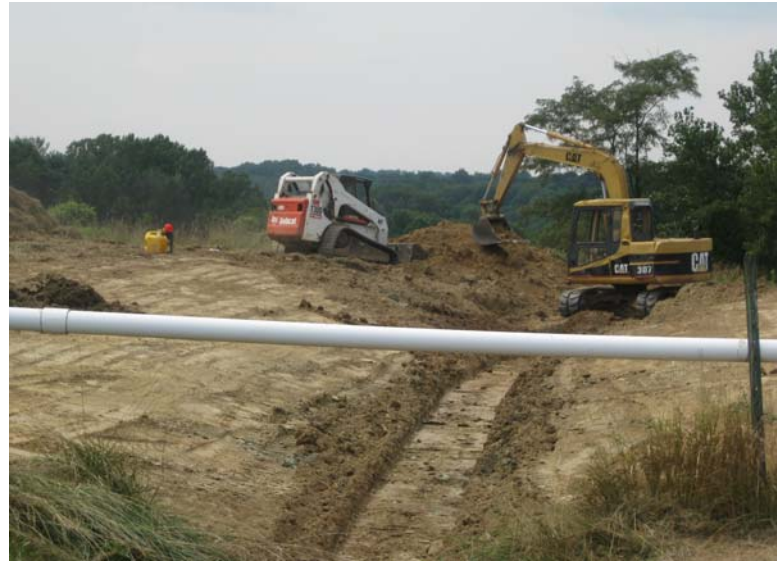
Photo 2 – Drainage Channel Installation (during repairs)

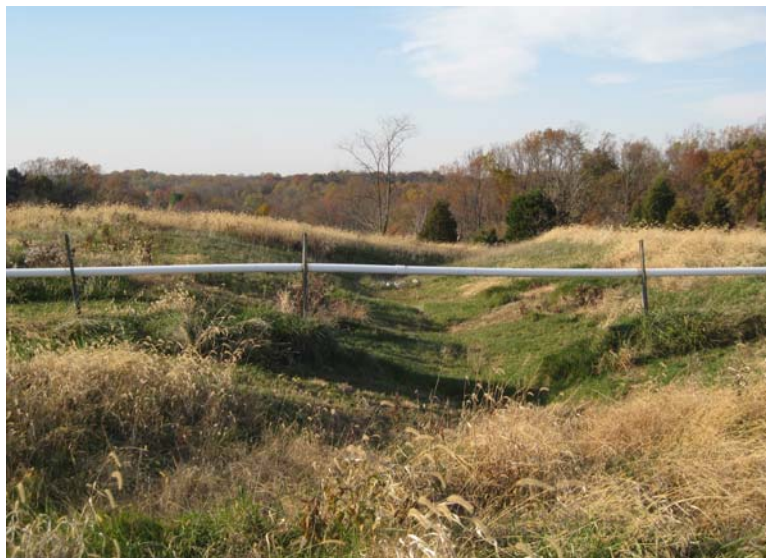
Photo 3 – Drainage Channel (after repairs)

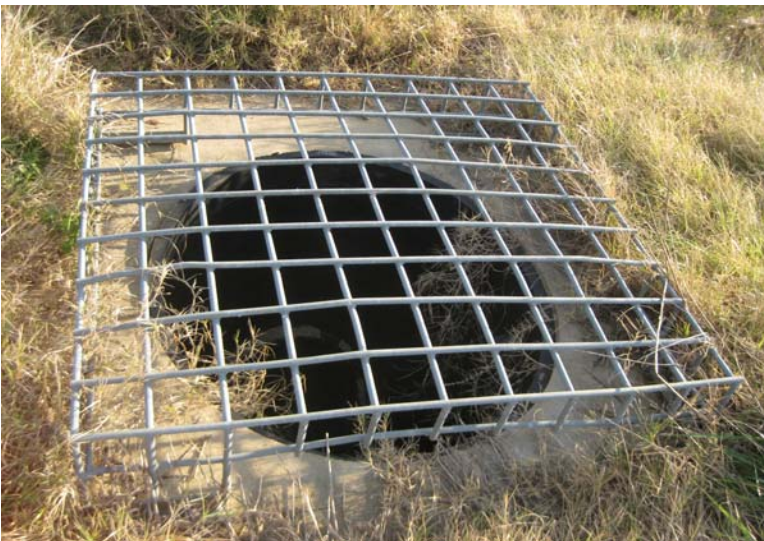
**Photo 4 – HDPE Manhole with upslope
Drainage Channel for Stormwater Collection**

In 1992-1993, Montgomery County in conjunction with SCS Engineers developed engineered plans and specifications for a series of stormwater infrastructure improvements at the Gude Landfill. The site improvements were implemented to collect and direct stormwater off of the landfill site in 1993-1994. The site improvement work included, but is not limited to the construction of: stormwater diversion berms; drainage swales channels with conveyance piping; stormwater collection manholes; sediment basin upgrades to accommodate increased stormwater volume; access road construction, etc. Refer to Photos 4-5 for documentation of typical stormwater infrastructure improvements. General stormwater management system maintenance occurred in: 2009 – January, February, March and July; 2010 – May and June.

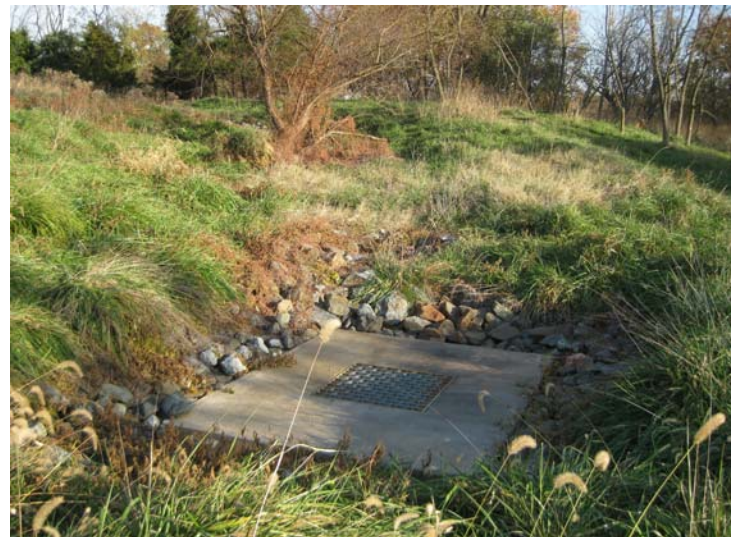
**Photo 5 – Concrete Inlet with upslope
Drainage Channel for Stormwater Collection**

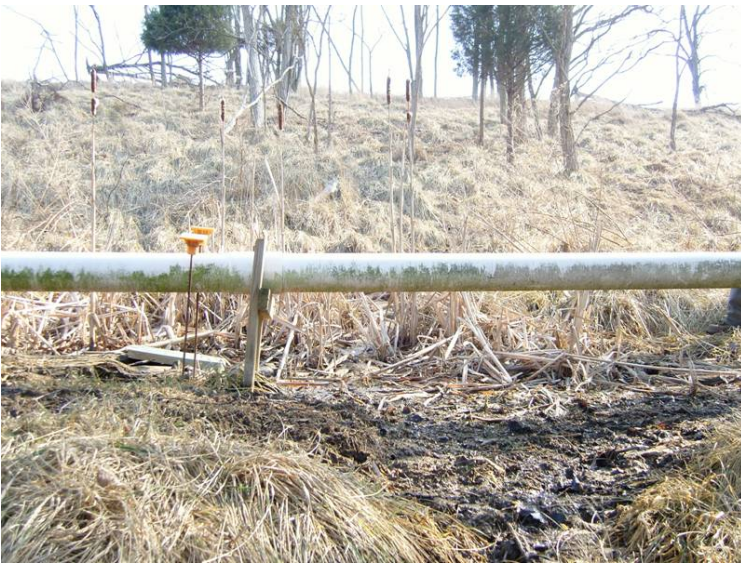
Photo 6 - Leachate Seep (before repairs)

Leachate seeps on pre-regulatory era landfills (Pre-RCRA) are typically repaired in a manner that redirects the surface expression of leachate back into the waste mass. This procedure allows for natural attenuation of the leachate since the Gude Landfill does not have a leachate collection system. Leachate seeps repair work involves the installation of a subsurface oriented infiltration trench, which includes: excavating the surface expression (soil and waste) to an adequate depth to contain the seep; lining the trench with filter fabric; placing stone in the trench as infiltration media; covering the trench with two feet minimum of soil to surface grade with seed and straw. Excavated soil and waste are transported to other areas of the Landfill site to be buried and covered with two feet minimum of soil with seed and straw. Refer to Photos 6-9 for documentation of typical leachate seep repairs. Leachate seep repair work occurred in: 2009 – January, February, March and July; 2010 – May and June.

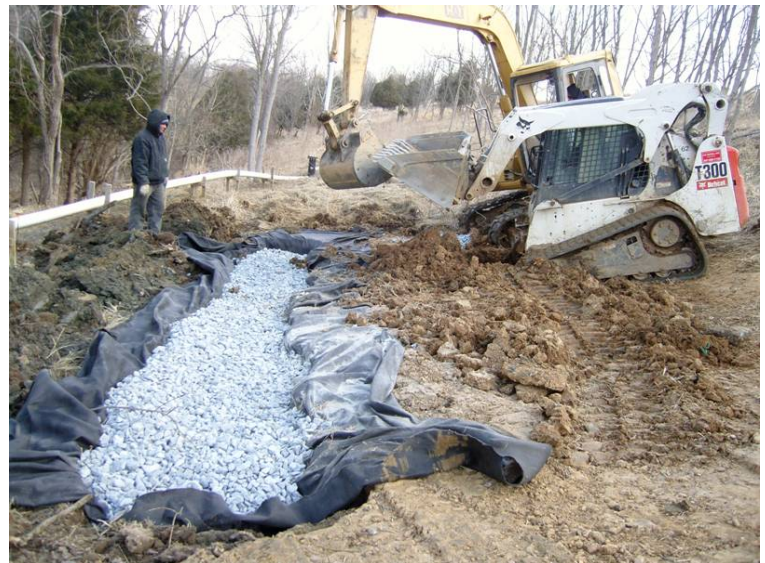
Photo 7 – Infiltration Trench Installation (during repairs)

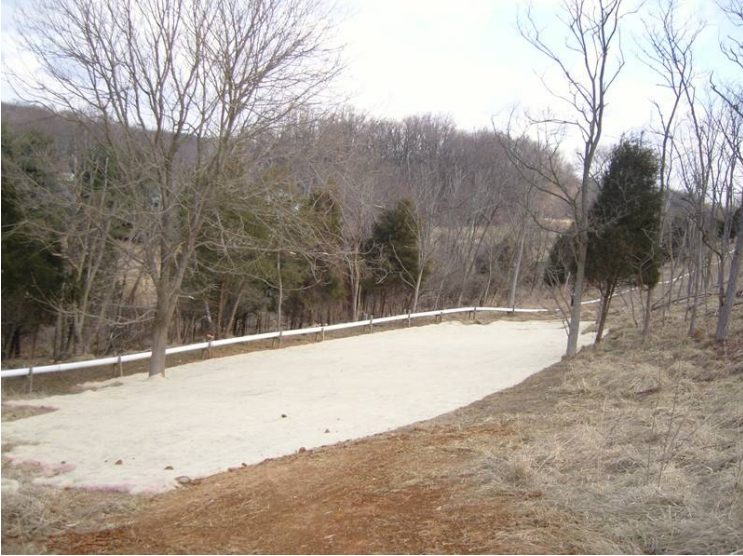
**Photo 8 – Disturbed Area of Leachate Seep
(during repairs)**

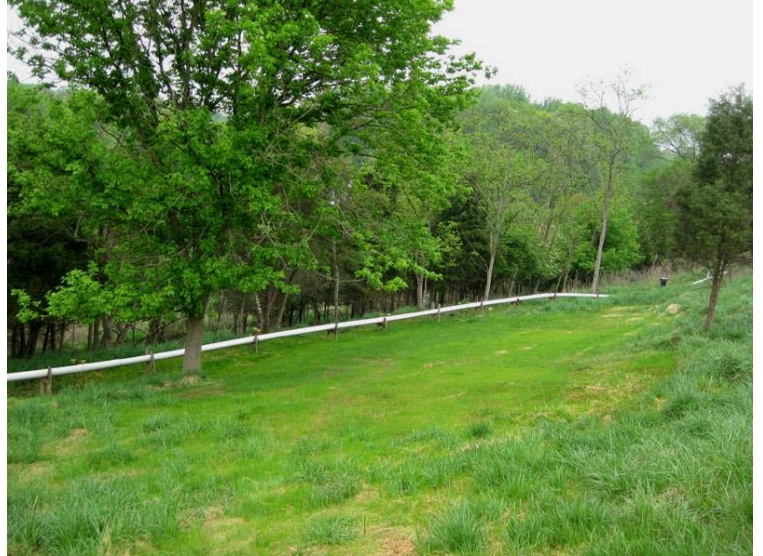
**Photo 9 – Area of Leachate Seep
(after repairs)**

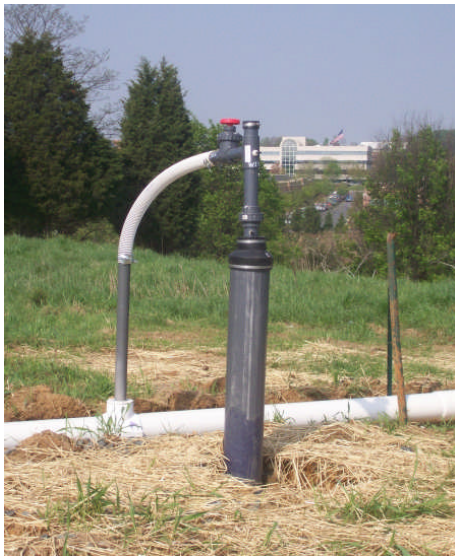
Photo 1 – Gas Extraction Well Head Assembly

- Landfill Gas Migration Evaluation – Concurrently with the Landfill Gas Flare Station procurement and installation, in June/July 2004, two consulting firms (SCS Engineers and Geosyntec Consultants) under contract with the County performed a landfill gas migration evaluation. Each evaluation confirmed methane gas concentrations exceeded the 5.00 percent threshold limit at and beyond the northwest property boundary of the Landfill. Photos 1 and 2 presents a gas extraction well head assembly and gas collection piping.

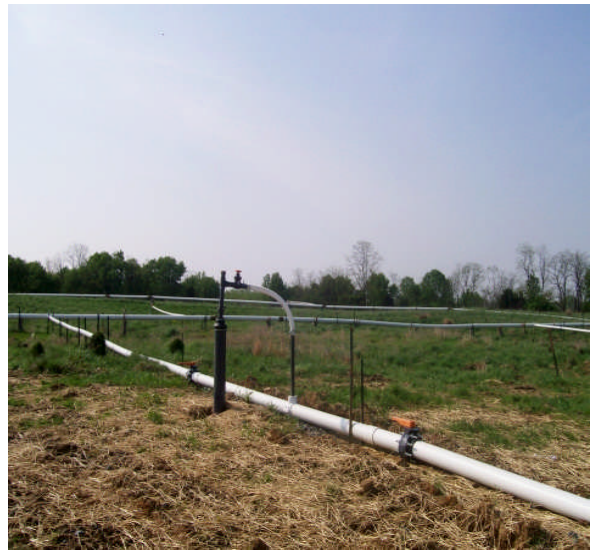
Photo 2 – Gas Collection Piping

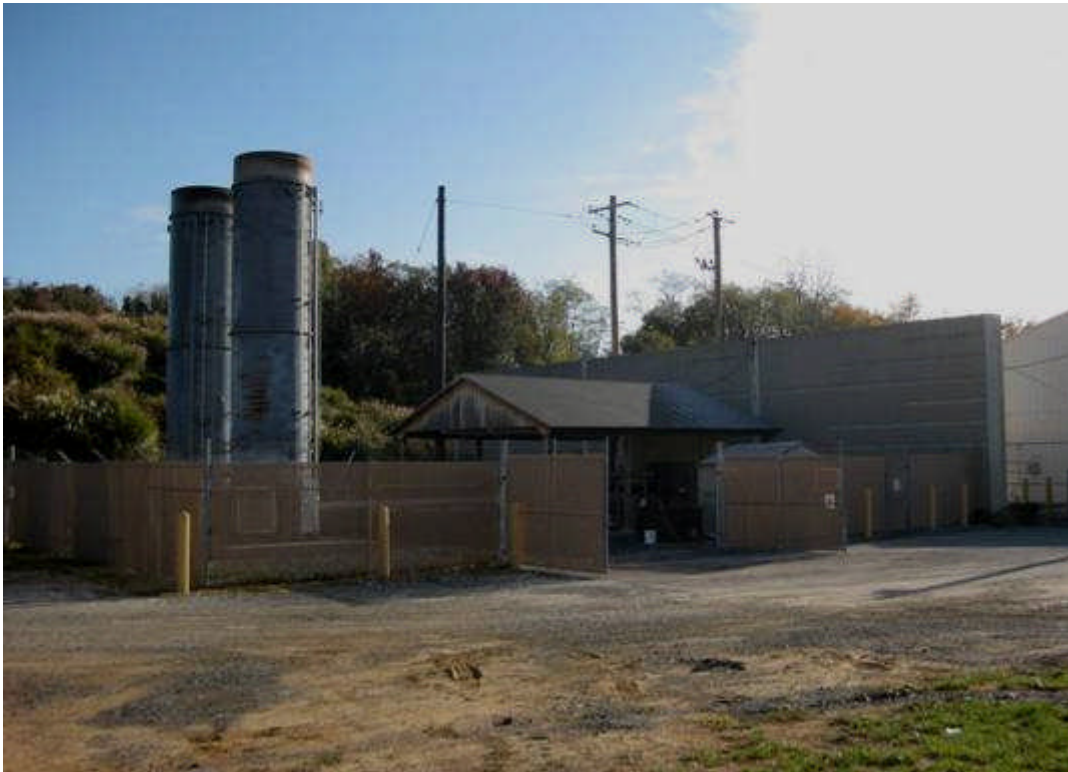
Photo 3 – Landfill Gas Flare Station

- Landfill Gas Flare Station Installation – The County received a permit to construct from MDE, Air and Radiation Management Administration (ARMA) to build and operate the Flare Station with two enclosed ground flares in June 2004, which were installed in May 2005. With the operation of the Flare Station, methane gas concentrations dropped

substantially from May-September 2005 along the northwest property boundary of the Landfill. Photo 3 presents the Flare Station.

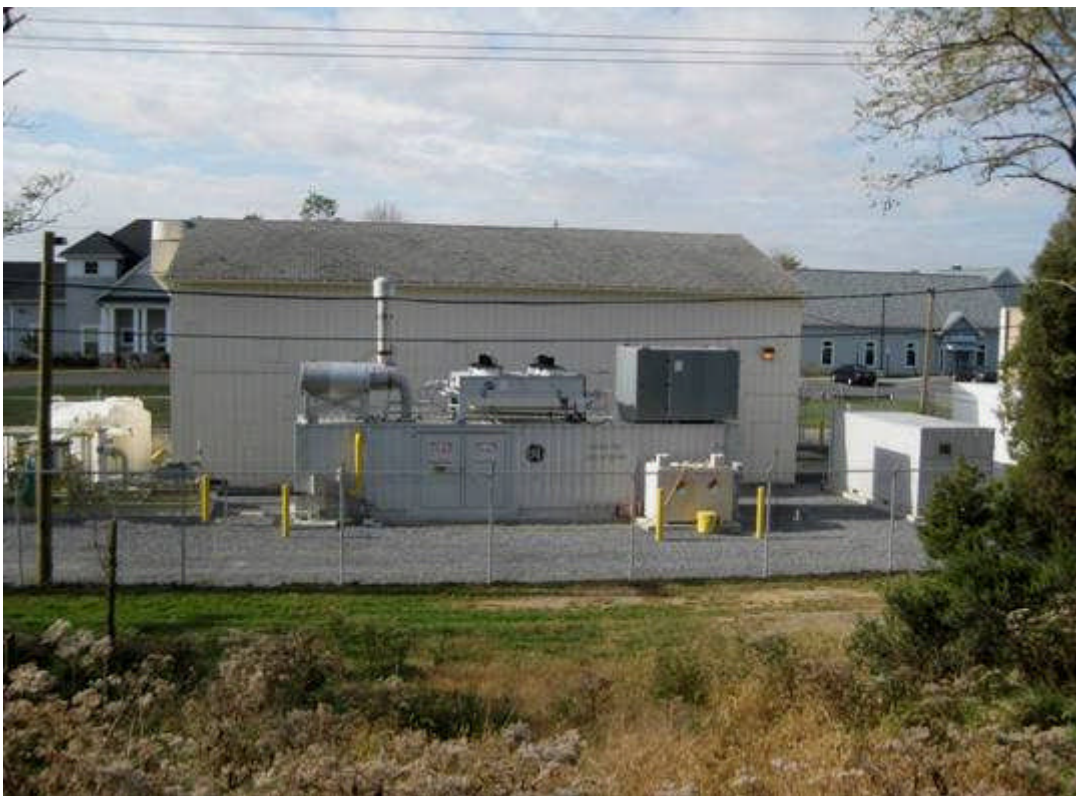
Photo 4 – Landfill Gas-to-Energy Facility

- New Landfill Gas-to-Energy Facility Installation – The County in conjunction with the Northeast Maryland Waste Disposal Authority developed a Request for Proposal (RFP) to design, construct, and operate a new landfill gas-to-energy (LFGE) facility at the Gude Landfill. In December 2007, the Authority signed a contract with SCS Engineers for the LFGE project. The LFGE Facility beneficially uses landfill gas in one (1) 0.8 MW Jenbacher GS 316 internal combustion engine to generate electricity in conjunction with Flare Station operations. The MDE/ARMA permit to construction was received in September 2008. Construction was initiated in December 2008 and start-up operations and power export to grid occurred in June 2009. Photo 4 presents the Gas-to-Energy Facility.

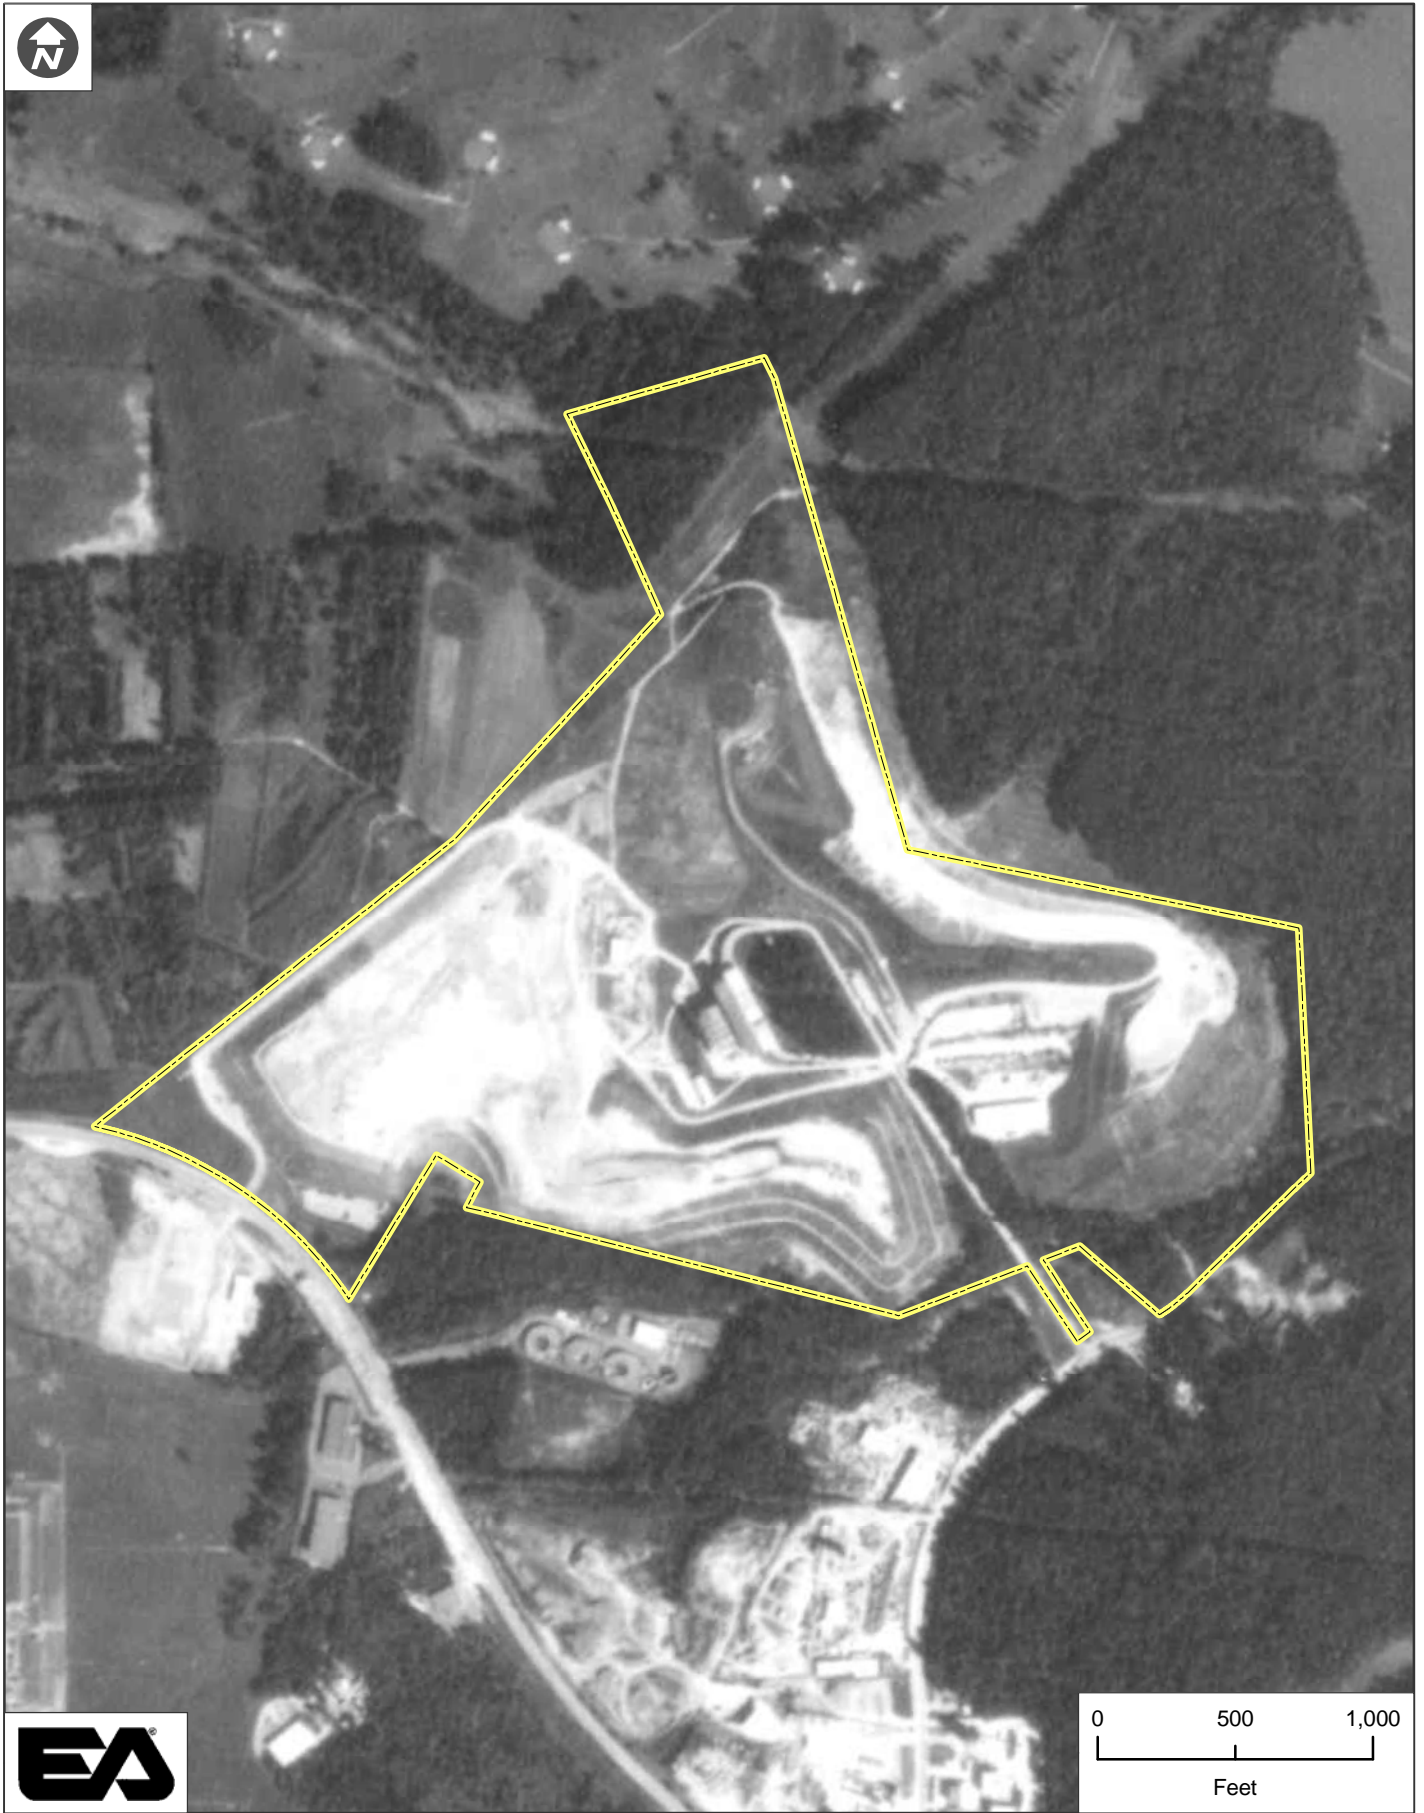
Waste Delineation Figure

Based on the investigation, it was determined that waste was generally placed within the Landfill property boundary in most locations, as shown on the attached figure. Waste was placed beyond the property boundary along the MNCPPC property boundary to the north and east of the Landfill, with the limit of waste approximately 200 to 250 ft from the Landfill property boundary. Surficial waste was found along the gas pipeline right of way and the Washington Suburban Sanitary Commission (WSSC) property boundary with the Landfill.

2009 Aerial Map
