SCHOOL-RELATED CRASH-INFRASTRUCTURE REVIEW

Location: Eternity Road at Hopkins Road

Crash Date: October 7, 2024

Local Case No.: 240047797

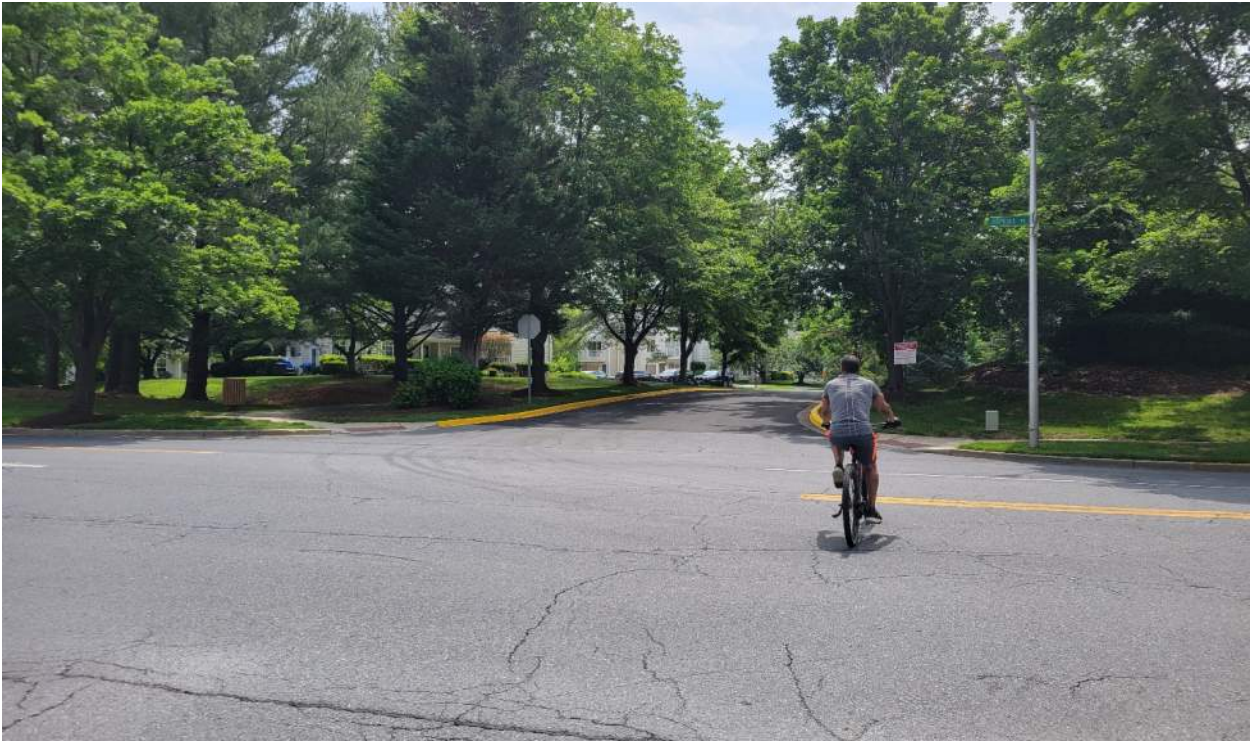
Photo 1. Taken from Eternity Road, looking south at Hopkins Road. Bicyclist traveling along unmarked crosswalk with no conflicting traffic.

1. Install stop lines for the Eternity Road and Amarillo Drive approaches.
2. Install continental crosswalk markings crossing Eternity Road at Hopkins Road.
3. Realign ramps at the subject intersection to guide pedestrians perpendicular to the roadway and away from the center of the intersection.
4. Replace the faded and damaged school ahead assembly in the eastbound direction approaching Steeple Road

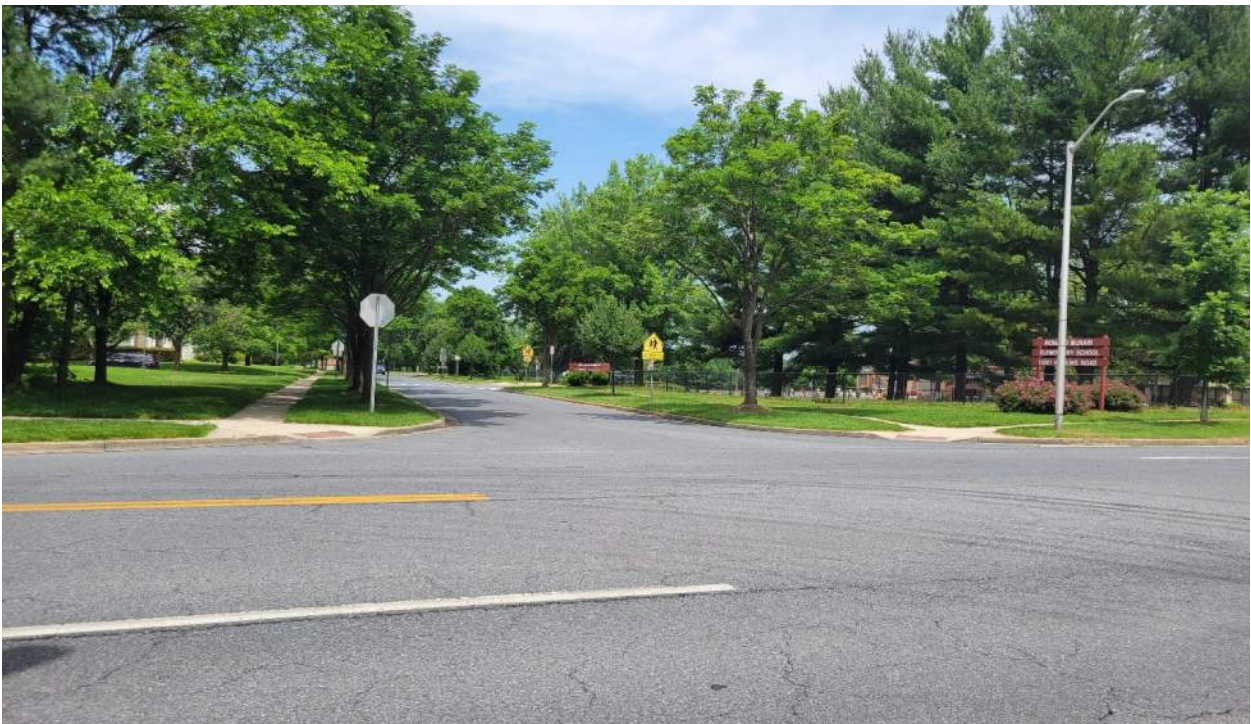
Photo 2. Taken from Amarillo Drive, looking north at Hopkins Road and Eternity Road. Ronald McNair Elementary School in northeast quadrant.

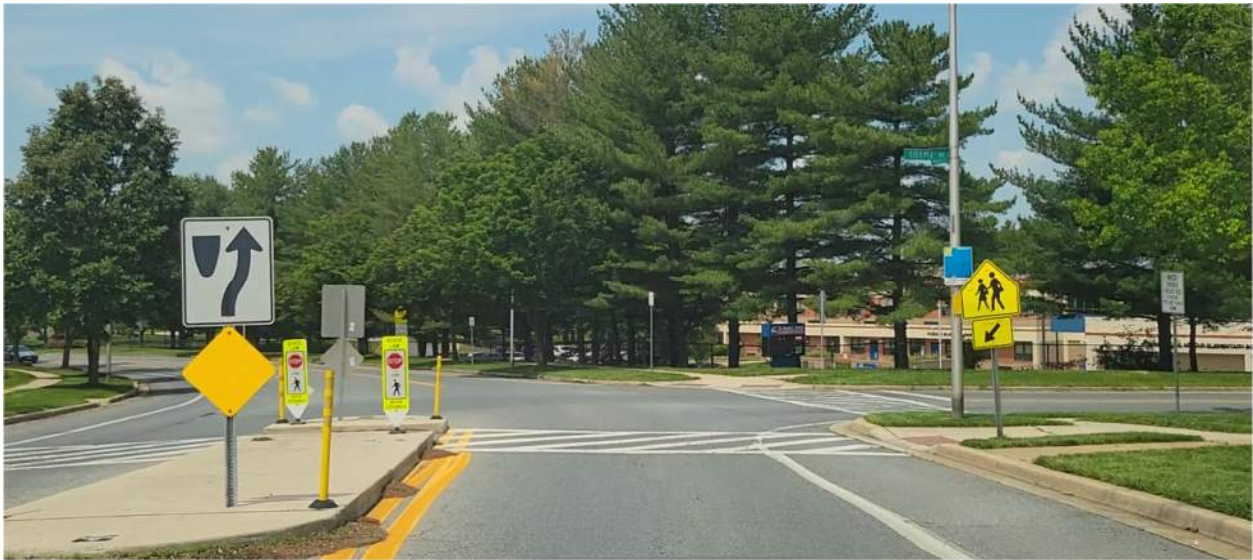
Photo 3. West/northbound Hopkins Road at Steeple Road.

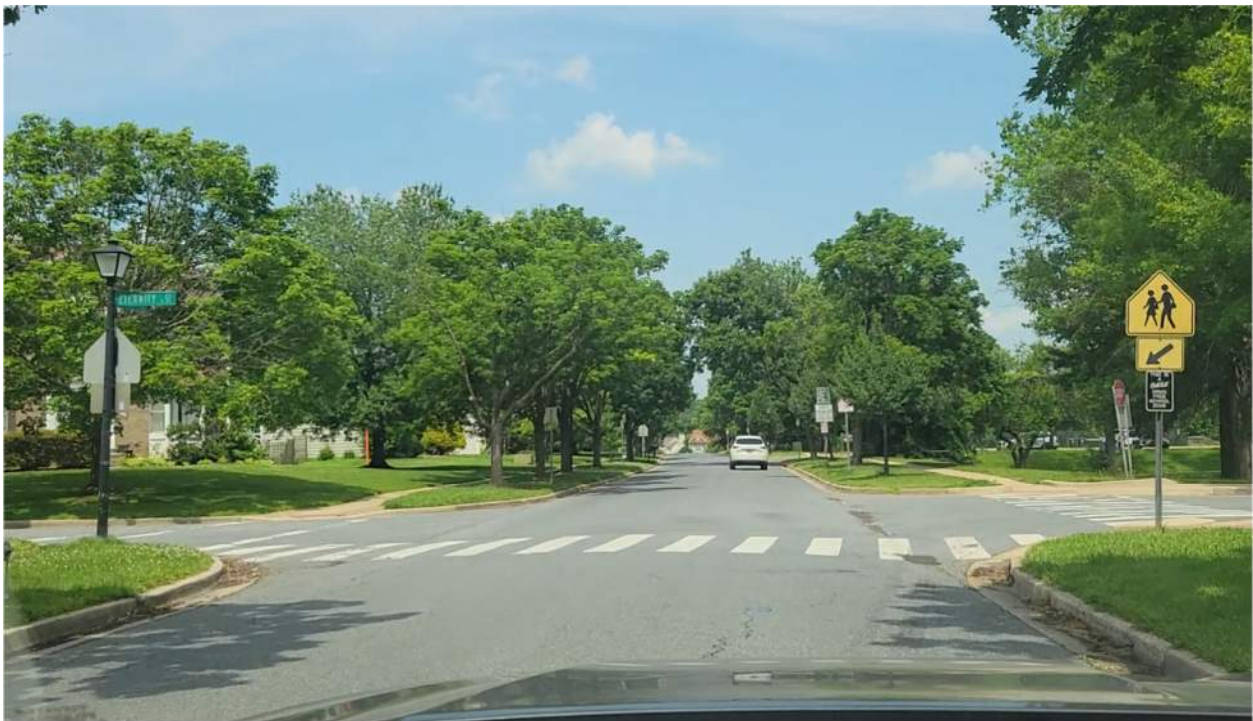
Photo 4. Taken along Eternity Road traveling north/westbound, looking at Eternity Court/driveway to Ronald McNair Elementary School.

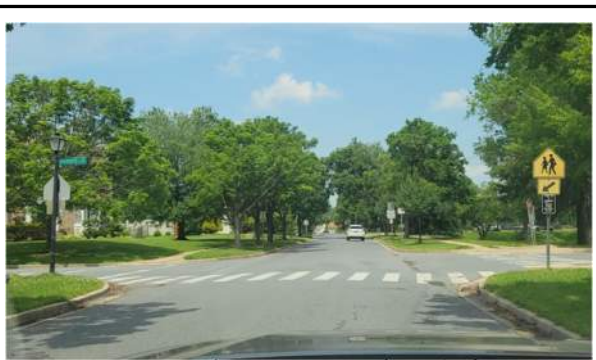
Northbound Eternity Road at Eternity Ct/ driveway to Ronald McNair ES

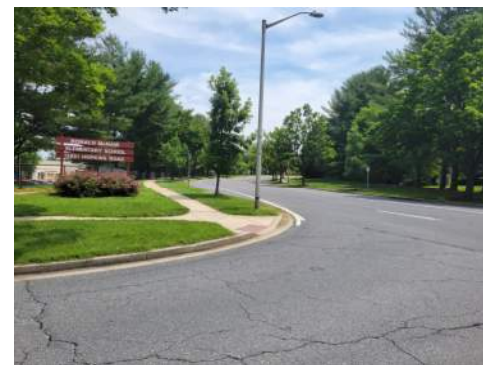
Westbound lane of Hopkins Rd opens to two lanes before the intersection, roadway could be narrowed to slow traffic from Hopkins Rd

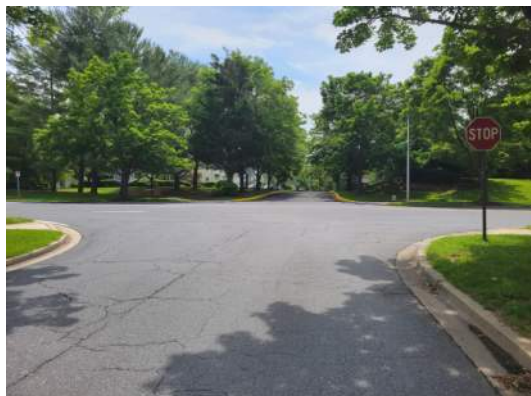
A painted stop line does not exist over Eternity Road at the intersection with Hopkins Road.

Pedestrian ramps are present but there are no marked crosswalks.

Looking southbound at the intersection of Eternity Rd and Hopkins Rd there is no stop line and an unmarked crosswalk

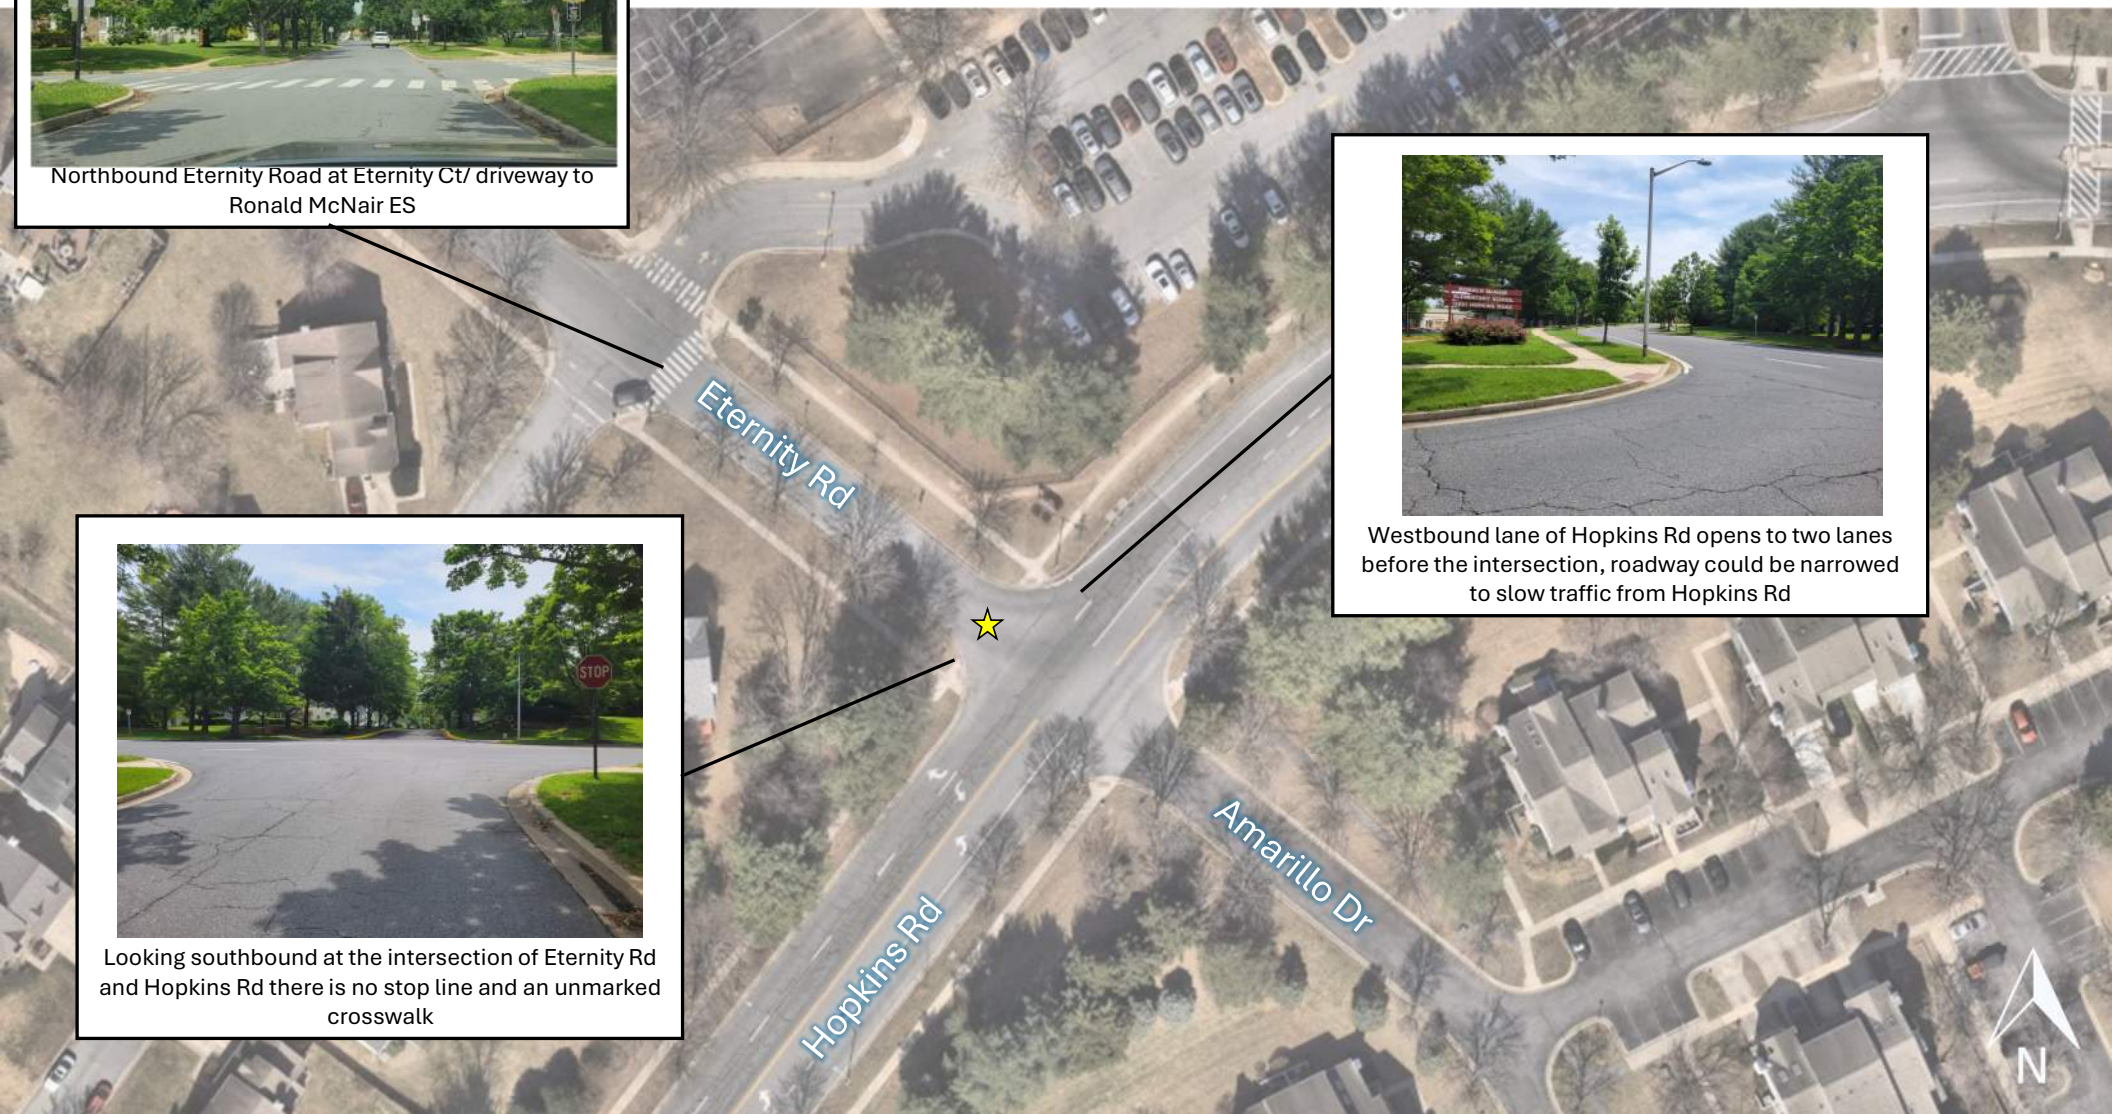
Figure 1 – Eternity Rd Corridor Observations

The Eternity Road at Hopkins Road intersection was evaluated to identify potential infrastructure, maintenance activities, and road user behaviors that contribute to increased safety risk at and in the vicinity of the school-related crash location. Please refer to **Figure 1** for additional information.

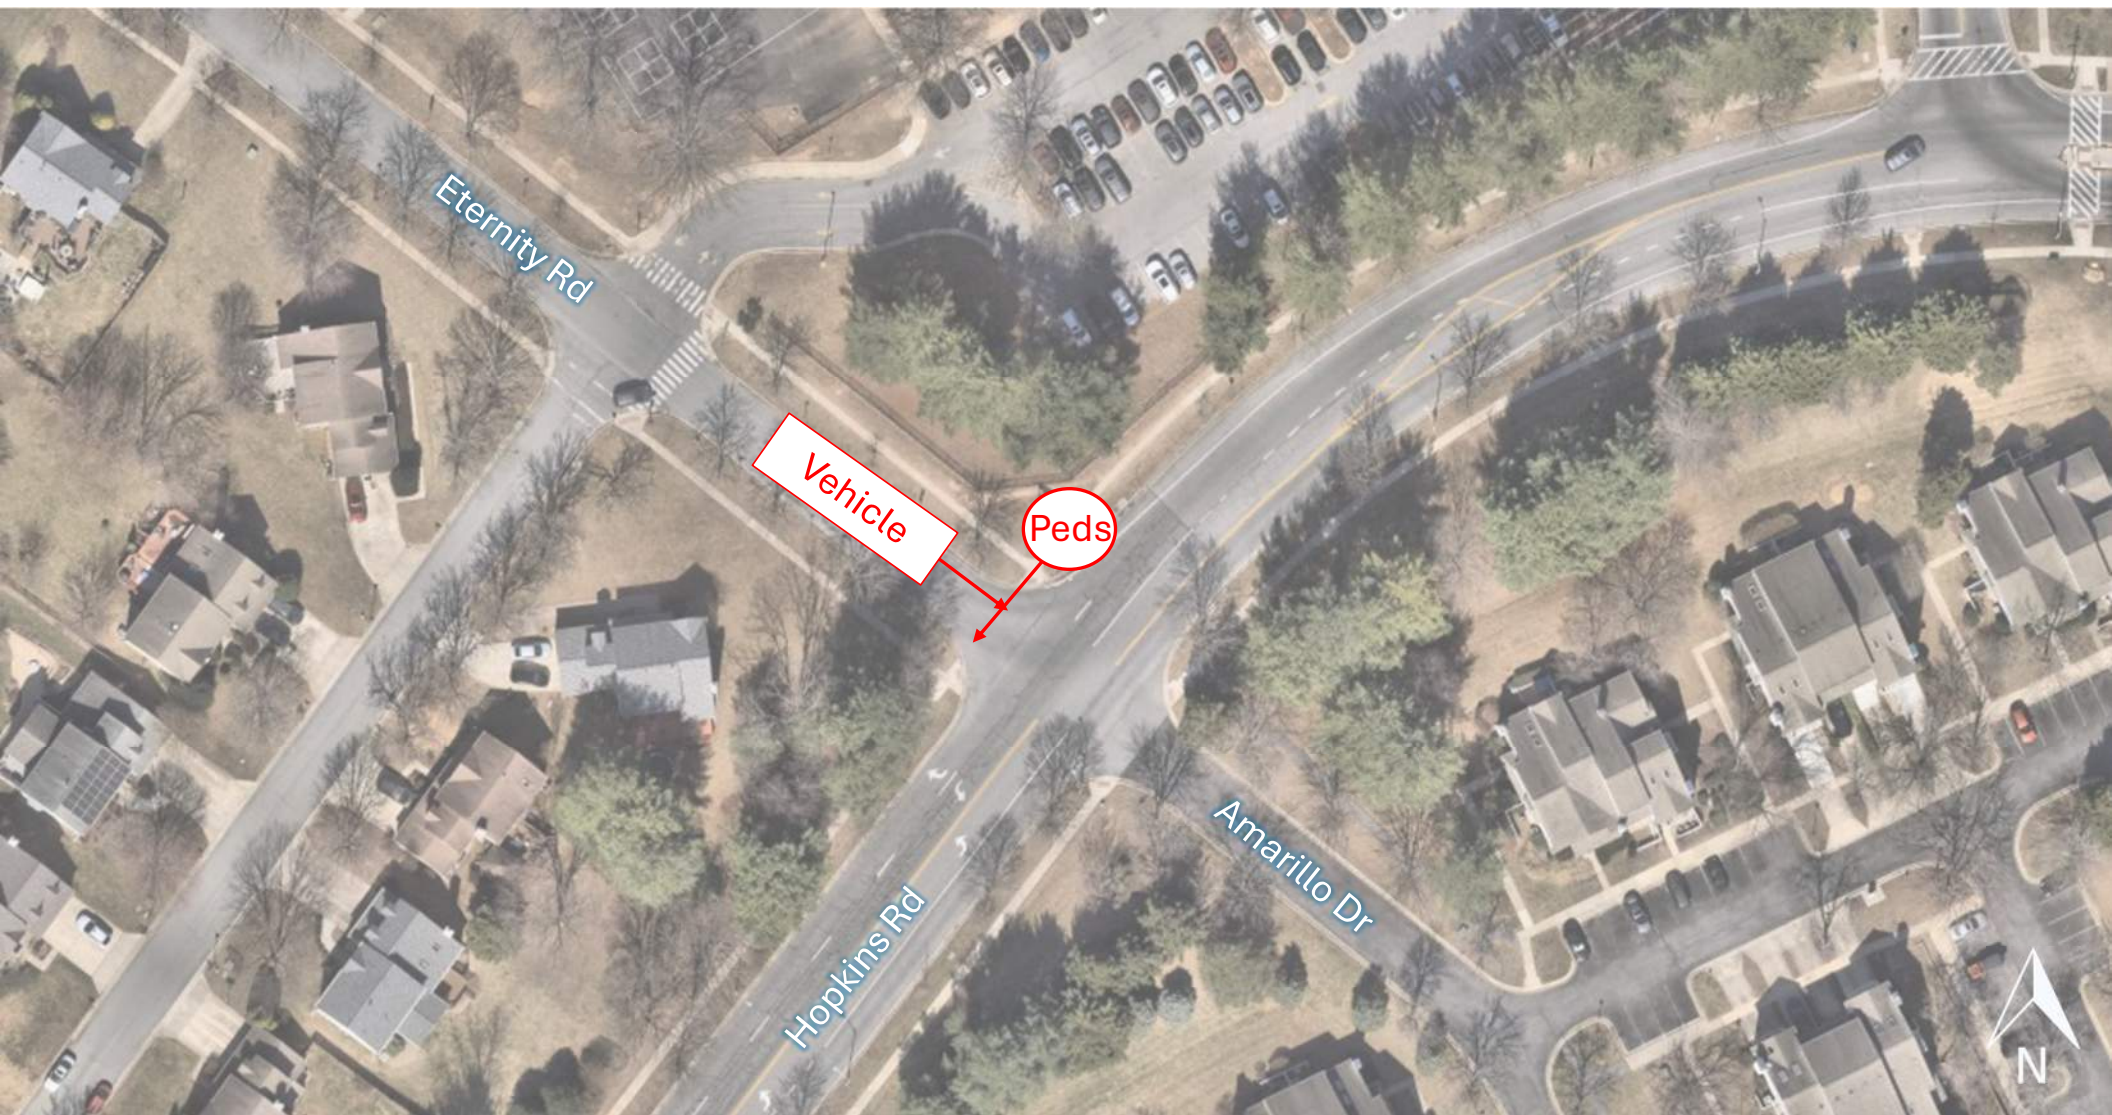
Figure 2 – Crash Diagram

On Thursday, October 7, 2024, at approximately 7:50 AM, two pedestrians were traveling across Eternity Road at an unmarked crosswalk at Hopkins Road. A motorist traveling southbound on Eternity Road failed to stop at the stop sign at Hopkins Road and struck the pedestrians. The crash report indicated that the pedestrians suffered no apparent injuries. The motorist was found to be at fault. Daytime weather conditions were clear, and the roadway surface was dry.

Figure 2 illustrates the crash location and direction of pedestrian and vehicle travel.

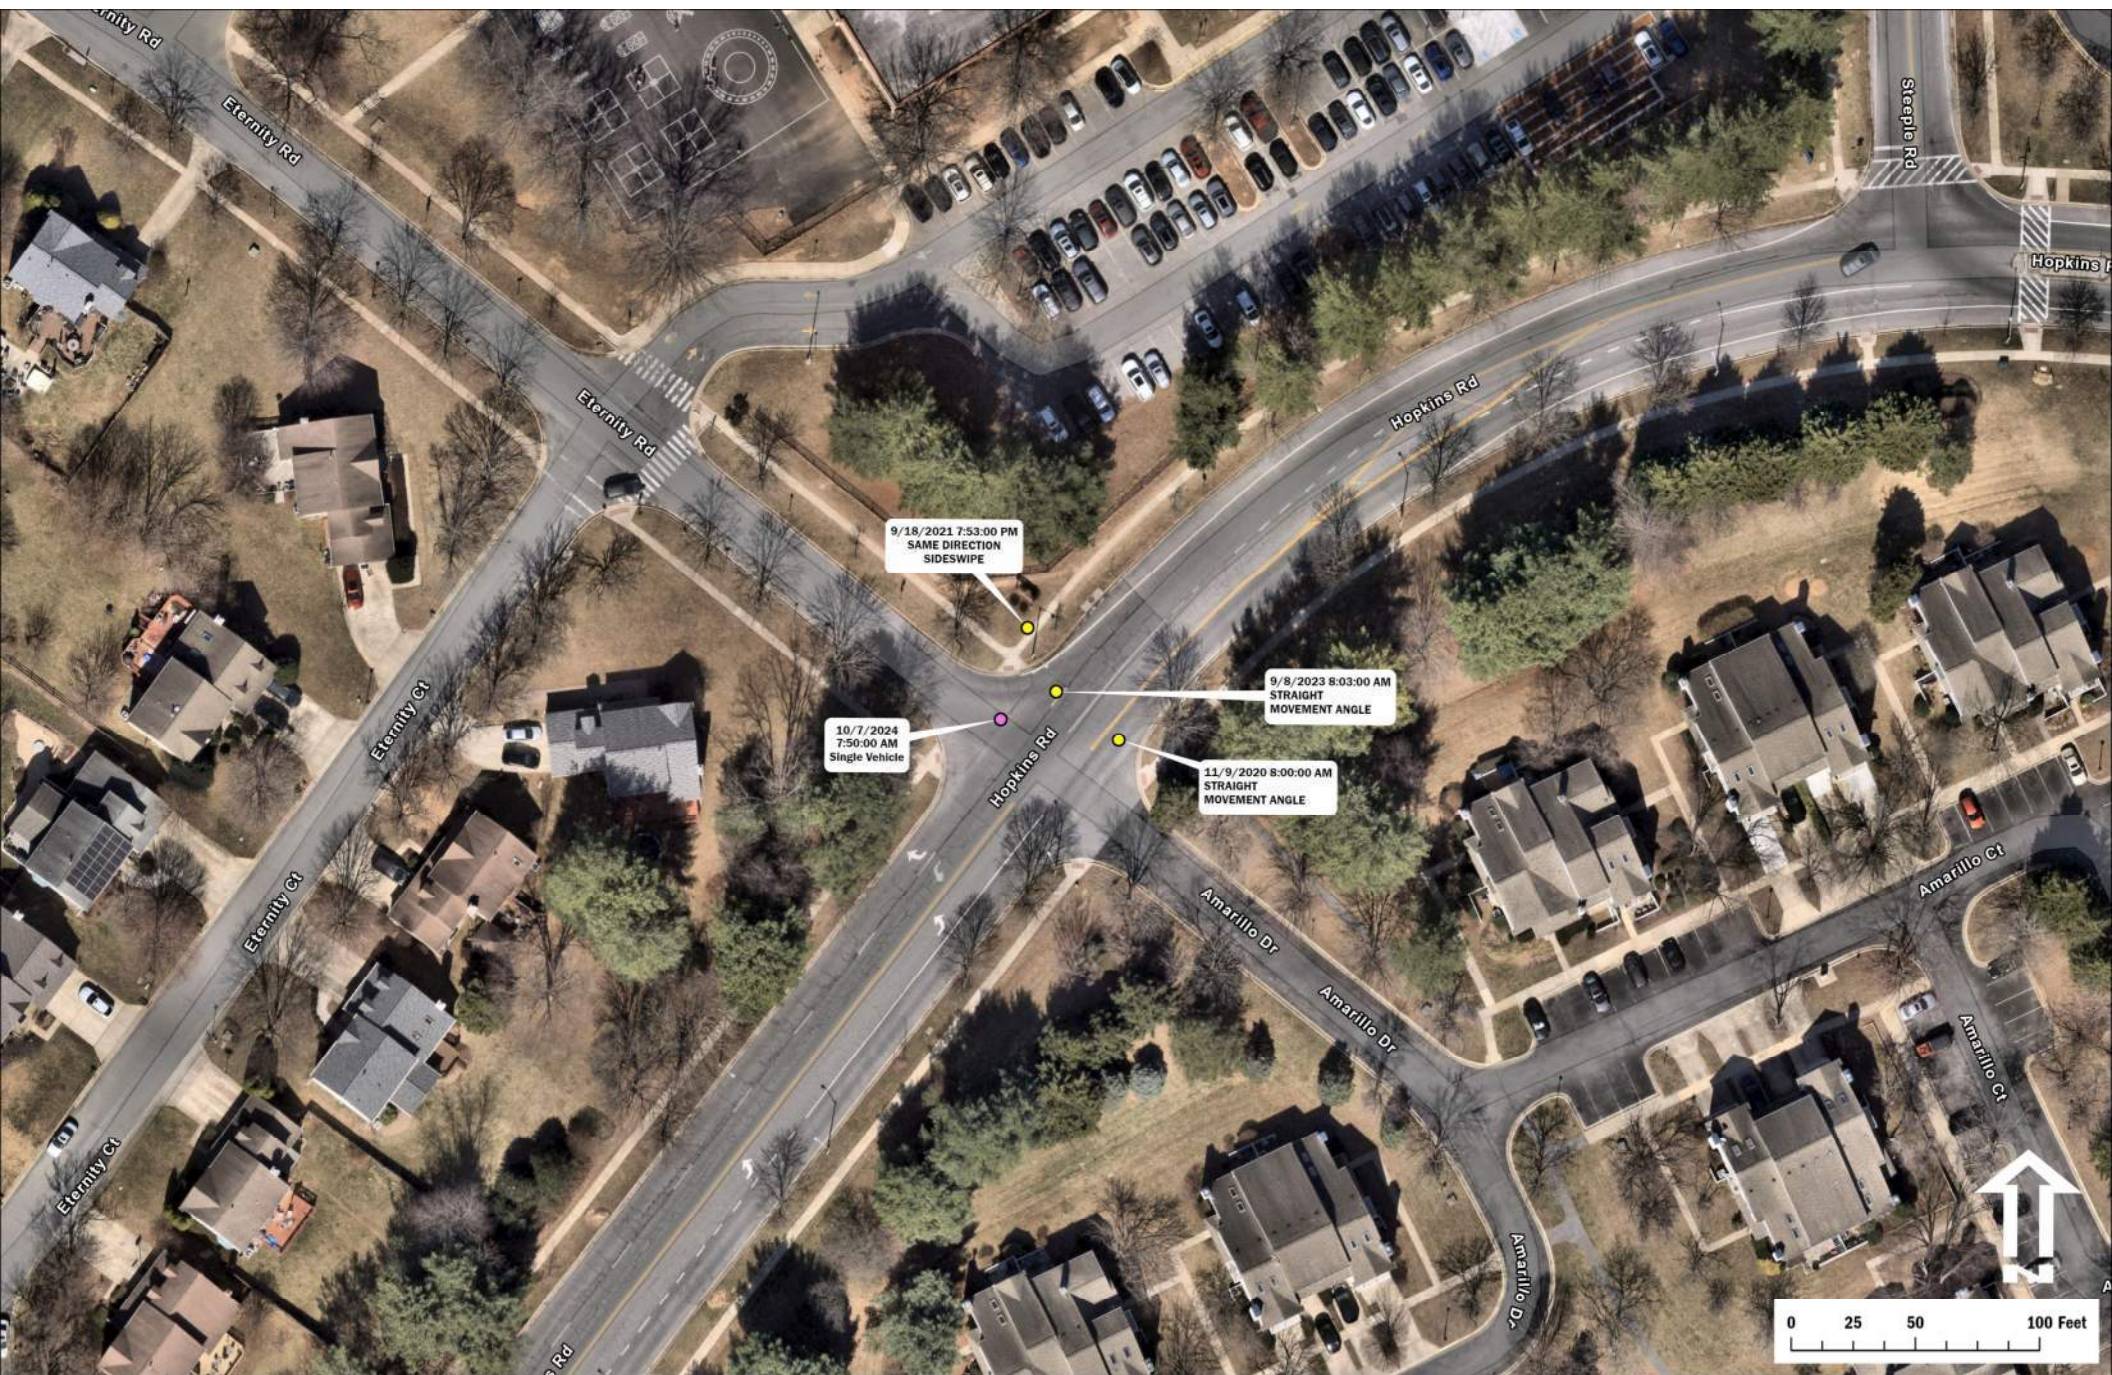
Figure 3 – Crash History (2020-2024)

Crash data obtained from dataMontgomery indicates that four (4) incidents occurred within the vicinity of the crash site between January 2020 and December 2024, including the subject crash. These 4 crashes include two (2) injury crashes and two (2) property damage crashes, consisting of two (2) angle collisions, one (1) sideswipe collisions, and one (1) pedestrian-related crash at this intersection. Of these collisions, one (1) occurred at night, one (1) took place during foggy weather, and all occurred along a dry surface.

The incidents are illustrated on **Figure 3**.
