Fatal Crash Review

Location: School Drive and Big Acre Square, Gaithersburg MD 20878

Crash Date: Tuesday, November 8, 2022

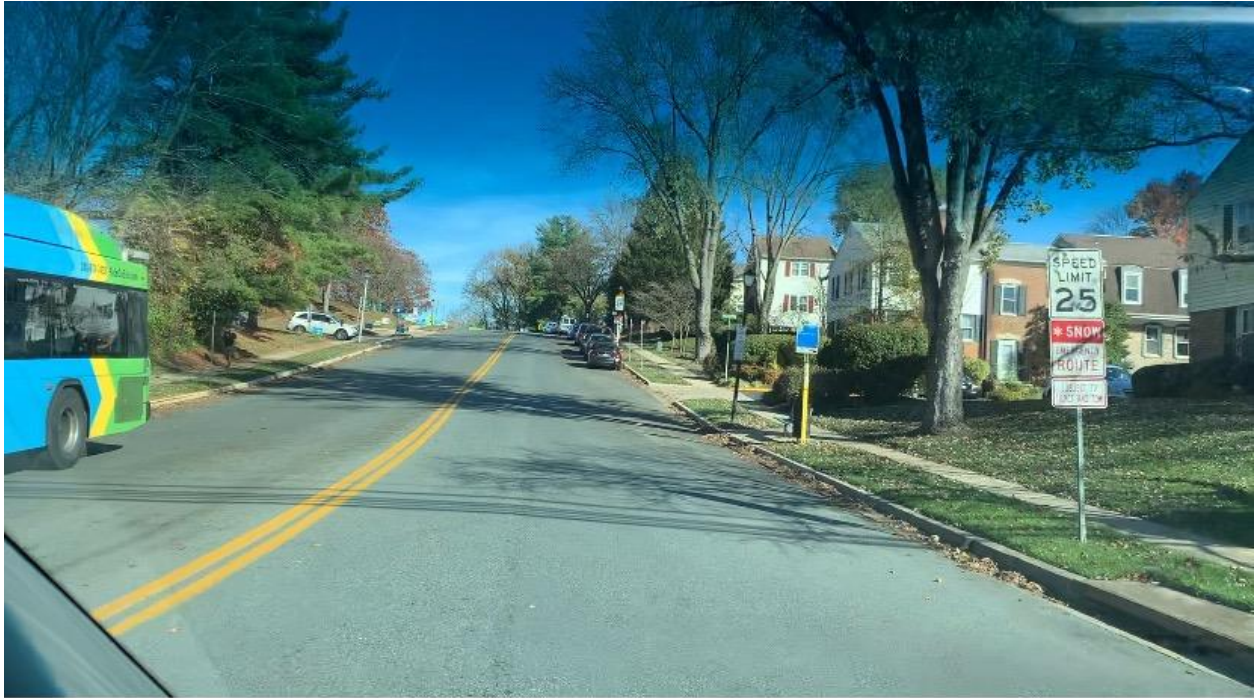
Westbound School Drive, approximately 350' east of crosswalk

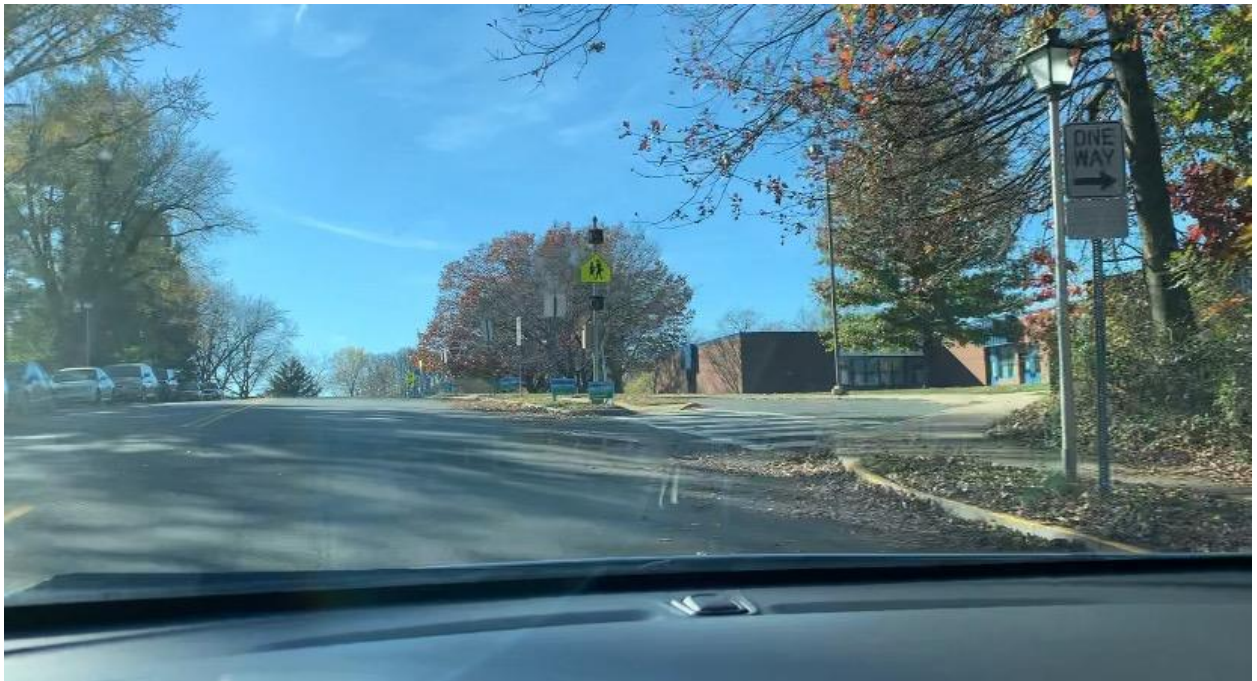
Westbound School Drive, approaching flasher (approximately 250' east of crosswalk)

- 1) A designated school zone needs to be provided.
- 2) Provide consistent signage at the flashers. (The flasher on the eastbound approach has a "*Speed Limit 25 mph when flashing*" sign; however, the posted speed is 25 mph. The flasher on the westbound approach has a *School* sign.)
- 3) Provide consistent signage on both approaches to the school/crossing
- 4) Install advance pedestrian warning signs on both approaches.

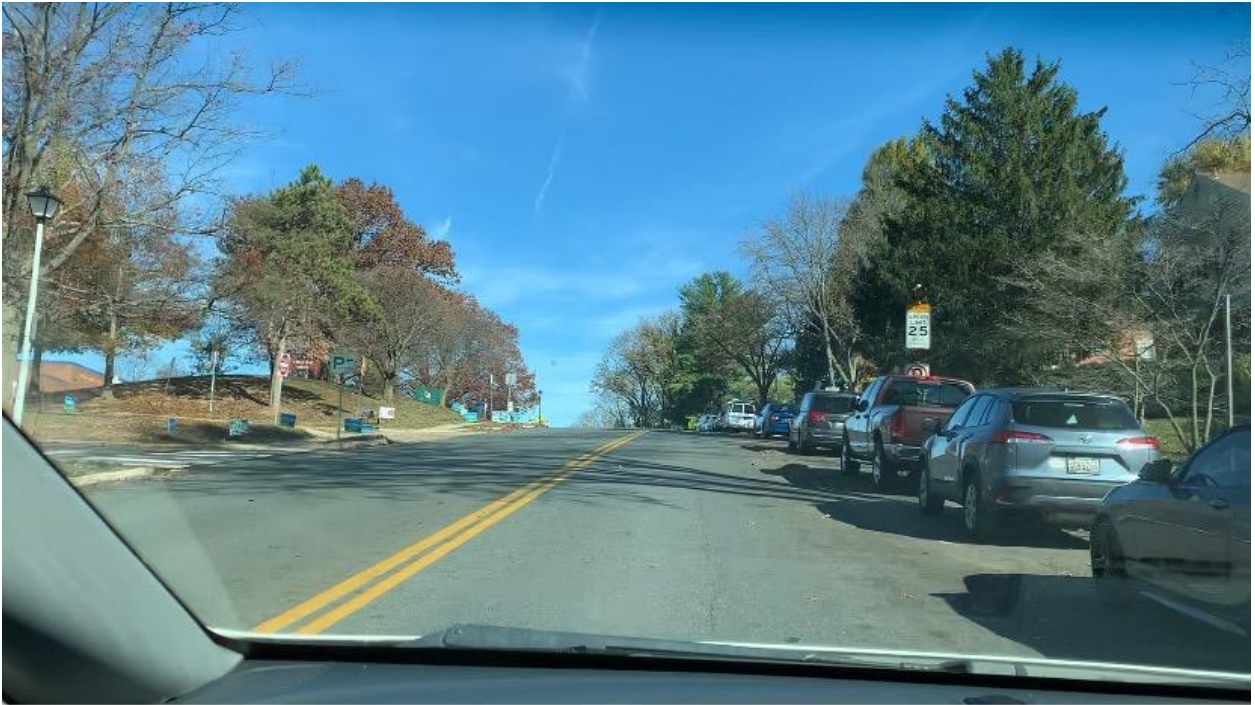
Eastbound School Drive, approaching flasher (approximately 450' west of crosswalk)

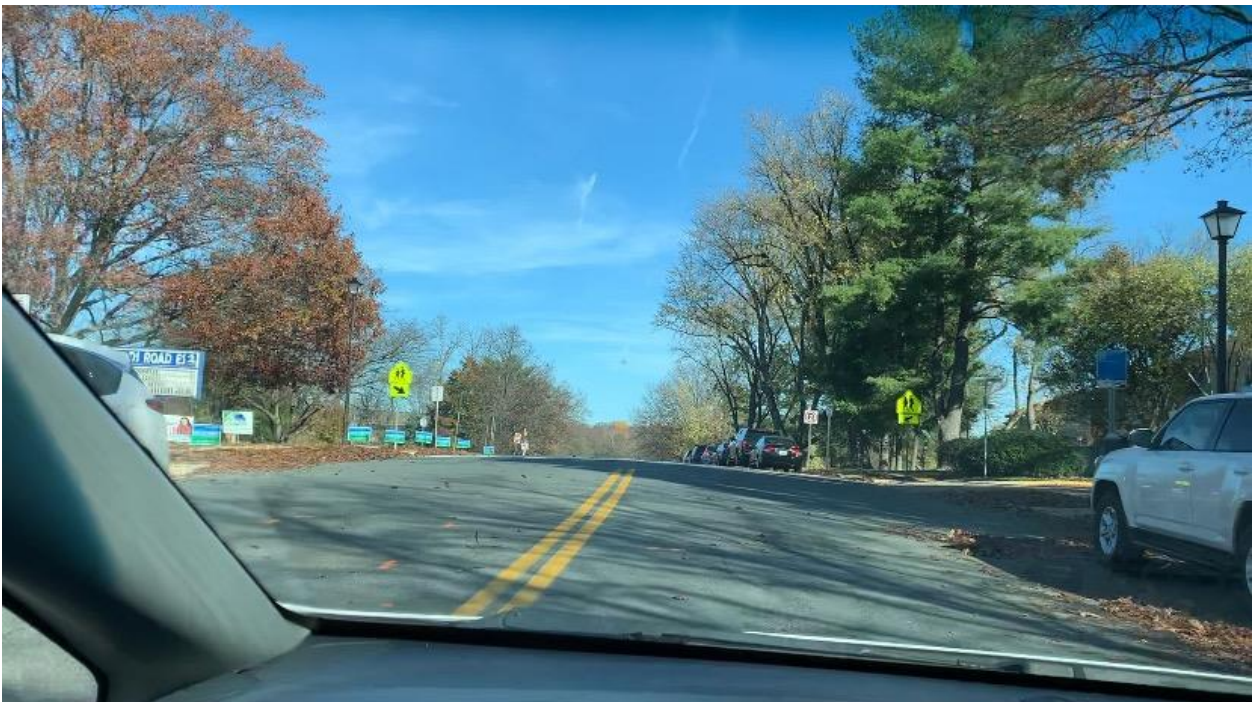
Eastbound School Drive, approaching flasher (approximately 100' west of crosswalk)
