## Fatal Crash Review

Location: 17500 block of Norwood Road near Ashton Forest Way

Crash Date: Wednesday, October 2, 2024

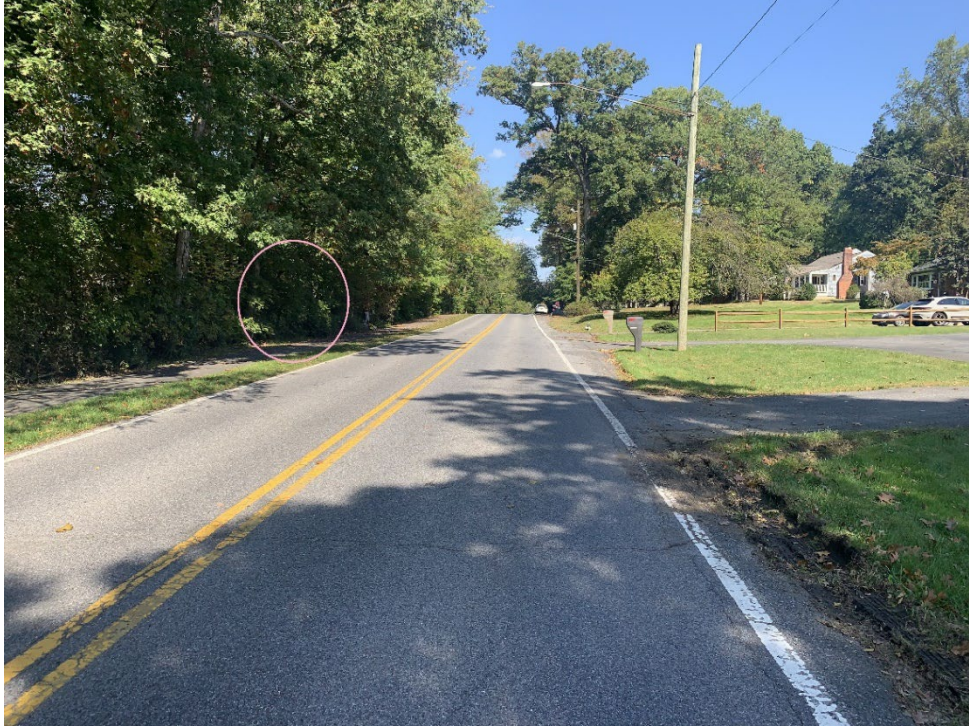
Northbound Norwood Road south of crash location

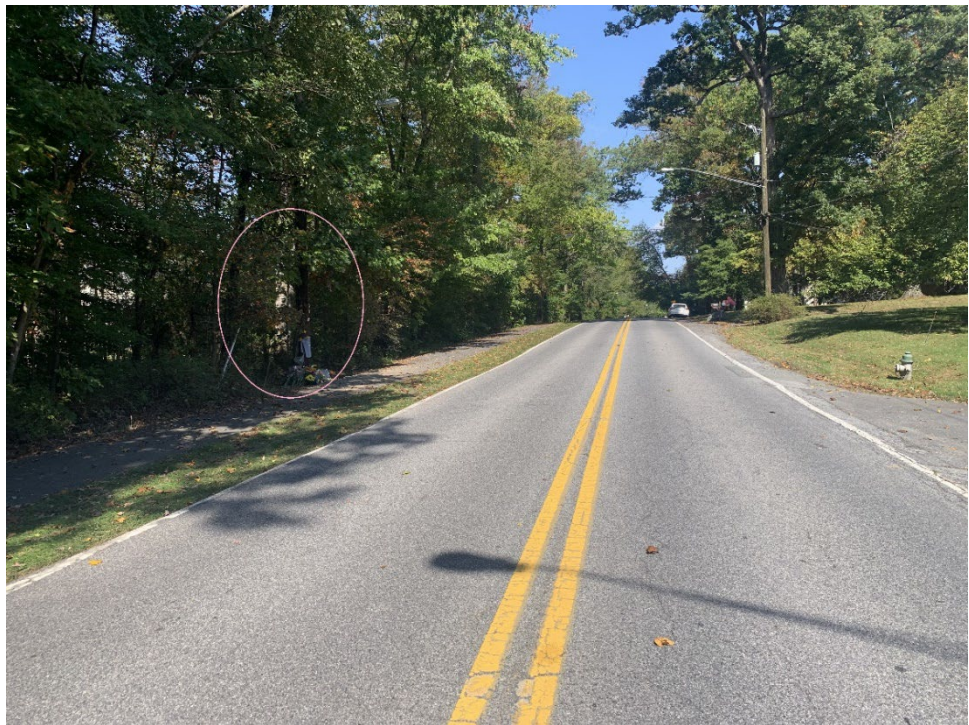
Northbound Norwood Road south at crash location
