## Fatal Crash Review

Location: Montrose Road (WB/L) at MU 2932 –  
Tildenwood Drive

Crash Date: Sunday, October 5, 2025

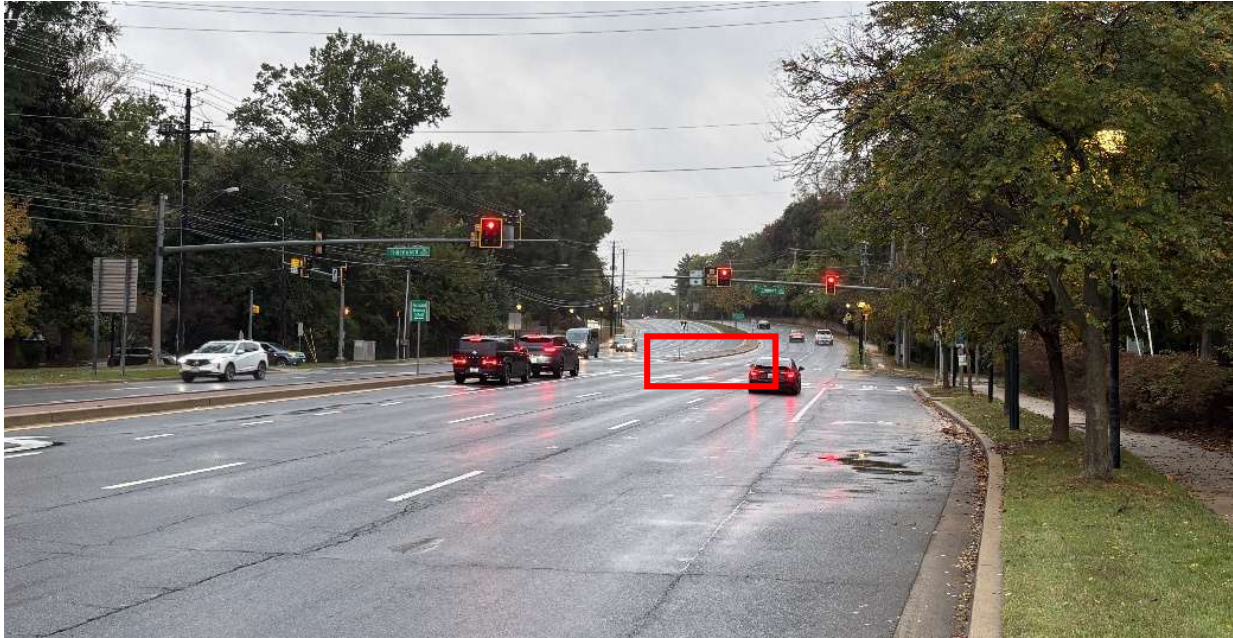
Montrose Road westbound approach to Tildenwood Drive (Looking west) – Motorcycle traveling in middle through lane at intersection.

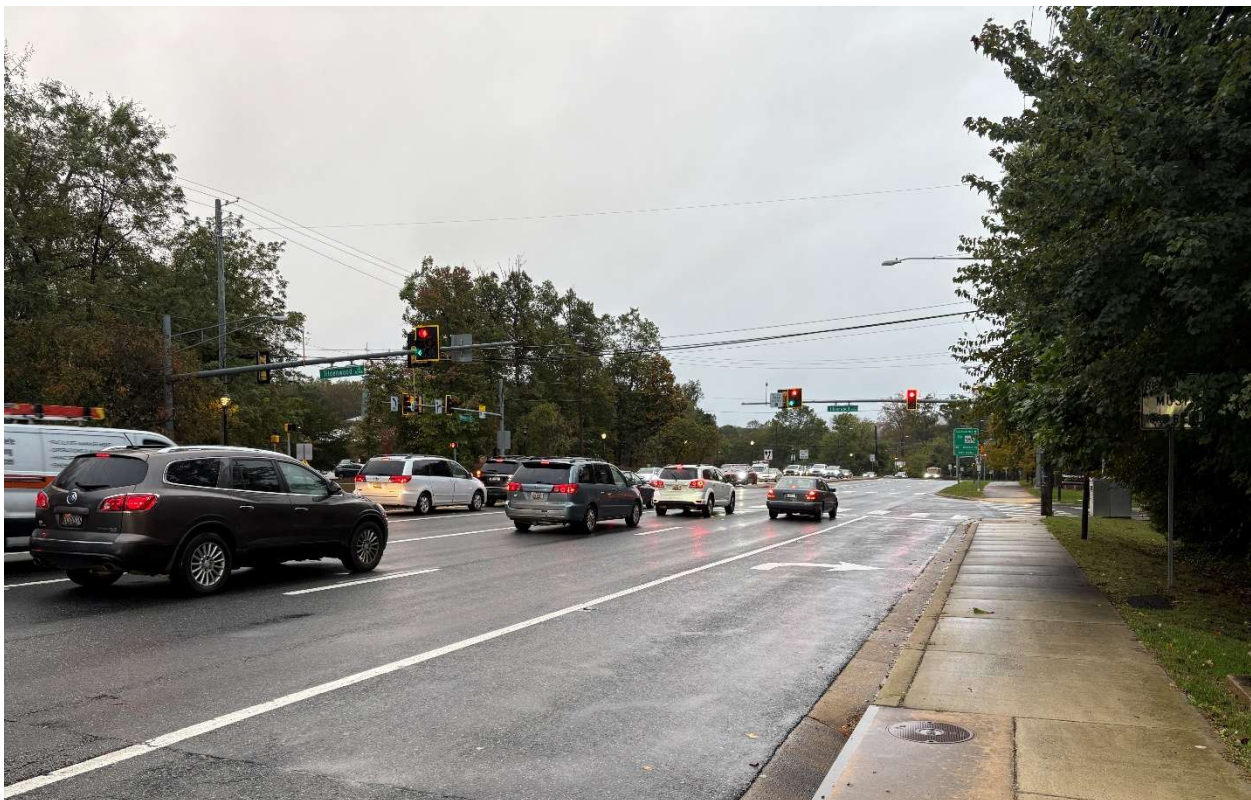
Montrose Road eastbound approach to Tildenwood Drive (Looking east) – Vehicle turning from eastbound left-turn lane at intersection.

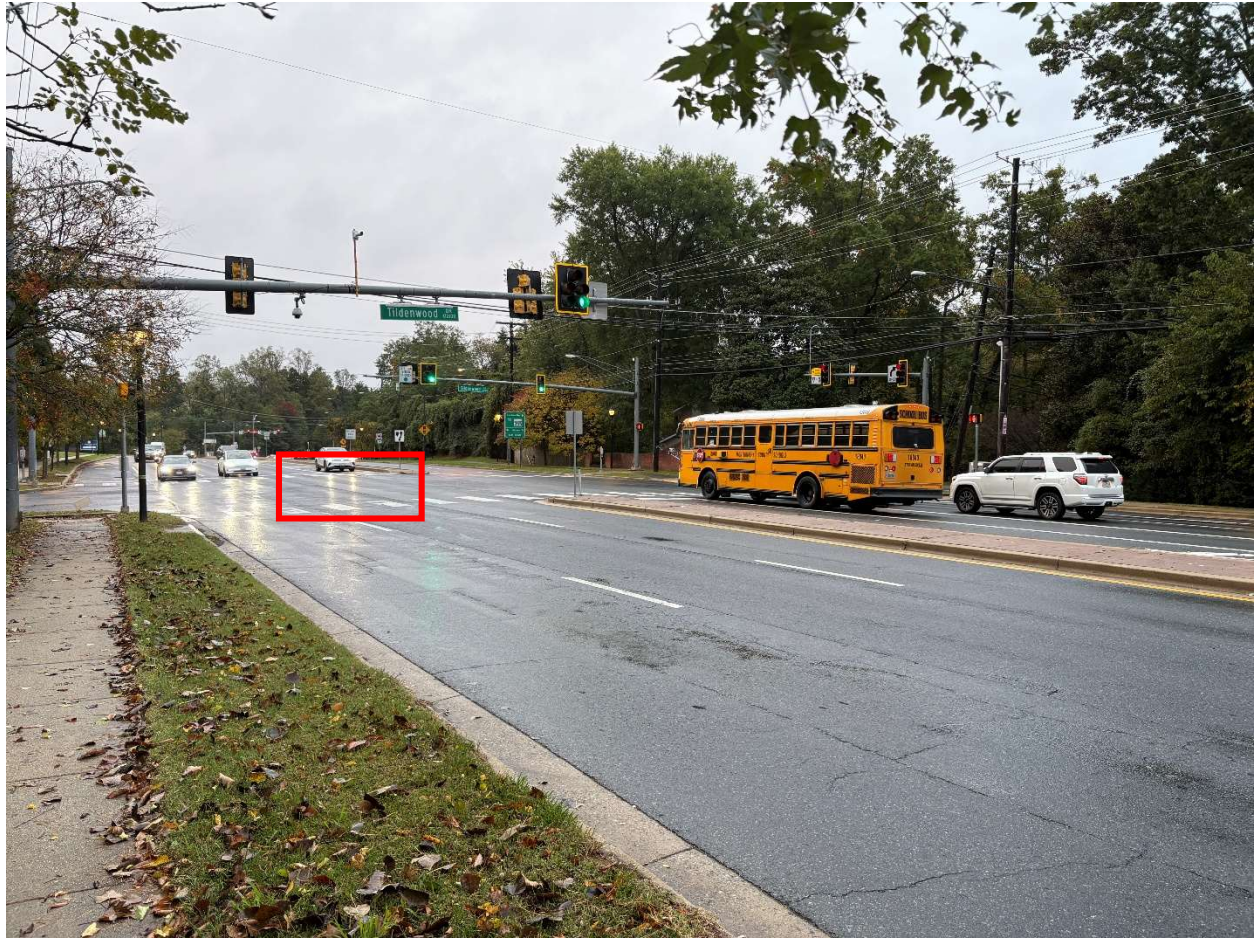
Montrose Road westbound receiving lane (Looking east) – Motorcycle traveling in middle through lane at intersection while vehicle executing eastbound left-turn from exclusive left-turn lane.
